J Cardiothorac Trauma. 2019 ; 4(1): 59–62. doi:10.4103/jctt.jctt_13_19.

Rescue Re-Do Inline Osteosynthesis with Wire Cerclage for Failed Rib Plating of Multilevel Rib Nonunion

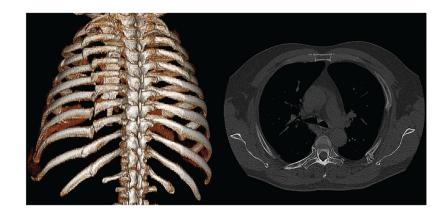
Figure 1:

Computed tomography demonstrating multiple healed posterior rib fractures of ribs 2 through 12 with chronic rib fracture nonunion of ribs 6 through 10

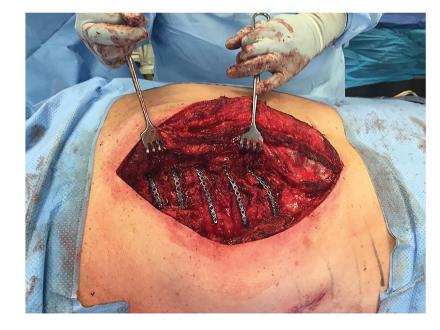
Figure 2:

Intraoperative image of the original in-line osteosynthesis of ribs 6–10. Patient is in prone position with left paraspinal incision with head toward left of the picture

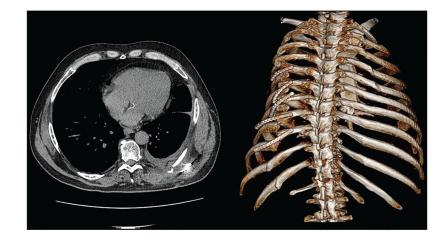
Figure 4:

Computed tomography demonstrating hardware failure with pull out of the screws from rib stump and chest wall collapse

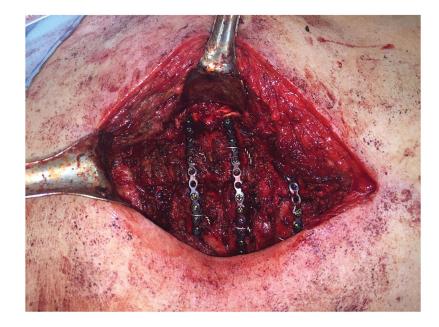
Figure 5:

Intraoperative image of rescue in line rib osteosynthesis with wire cerclage of ribs 6-through 9

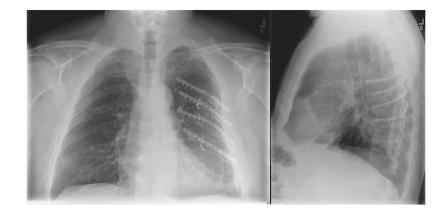
Figure 6:

Postoperative imaging of the rescue repair after lower plate explanation 6 months after rescue repair. Hardware remains competent
