Article

Experimental Investigation of Impact Concrete Slab on the Bending Behavior of Composite Bridge Girders with Sinusoidal Steel Web

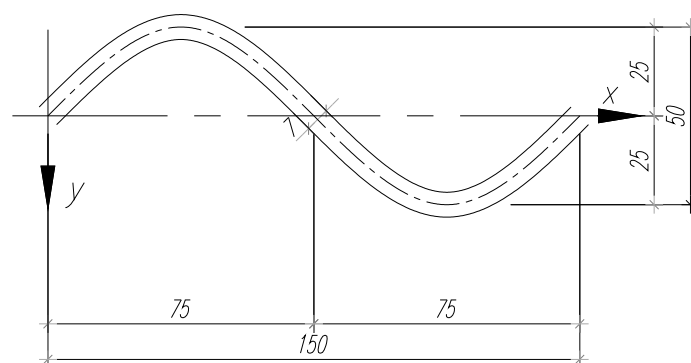
Figure 1. Sinusoidal corrugation geometry (mm).

It was assumed that the beams corresponded to the behavior of bridge girders [39]. Steel sections in bridge structures are larger than in industrial buildings, due to the higher load requirements. Accordingly, it was assumed that the web was 7 mm thick and 350 mm high. Figure 1 shows the sinusoidal corrugation geometry.

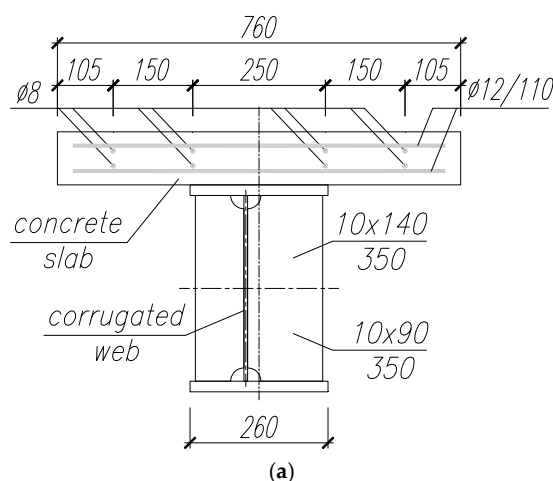
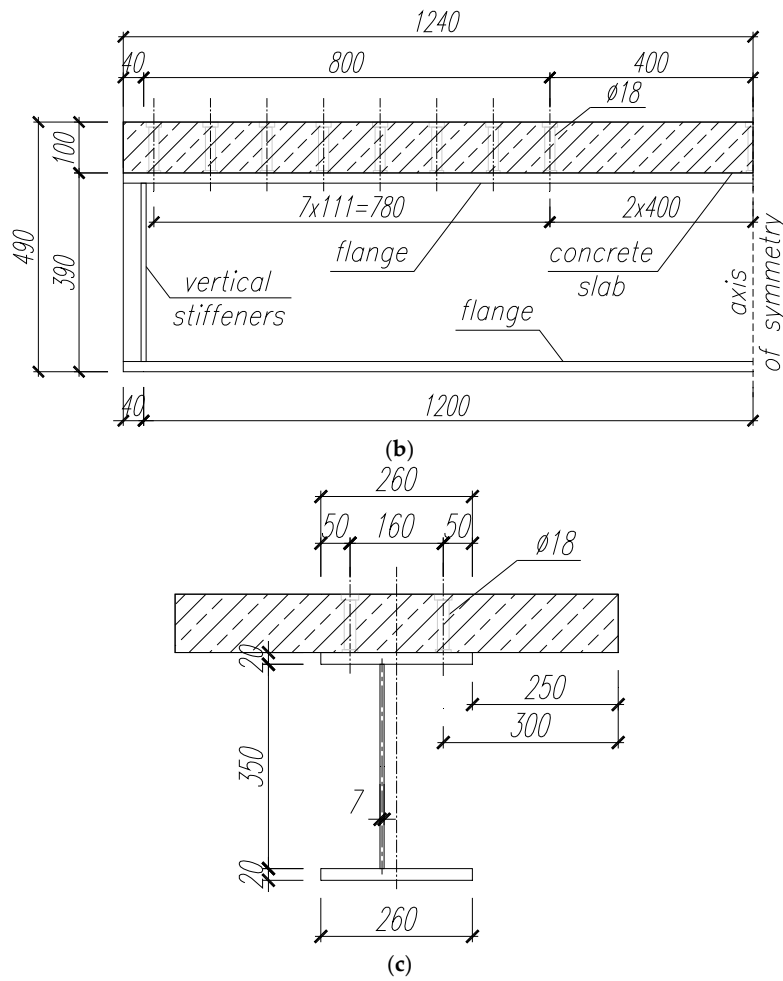
Figure 2. Geometric parameters of the tested beams (mm): (a) Transverse cross-section with the slab reinforcement arrangement; (b) longitudinal section with a pin arrangement; (c) transverse cross-section with a pin arrangement.

Figure 2 presents other geometric parameters of the tested beams. The upper and lower flange were made of flat sheets with a thickness of 20 mm, a width of 260 mm, and a total length of 2480 mm. At a distance of 40 mm from the beam ends, on each side of the web, were attached vertical rib stiffeners made of 10 mm thick flat sheets of full web height. Due to the location of corrugations relative to the flange axis of symmetry, the ribs were 90 mm wide on one side and 140 mm on the other (Figure 2a).

The latter width was on both ends of the same side of the beam. The ribs marked the beam support centerlines on the test stand. There were no other web stiffeners attached along the span length.

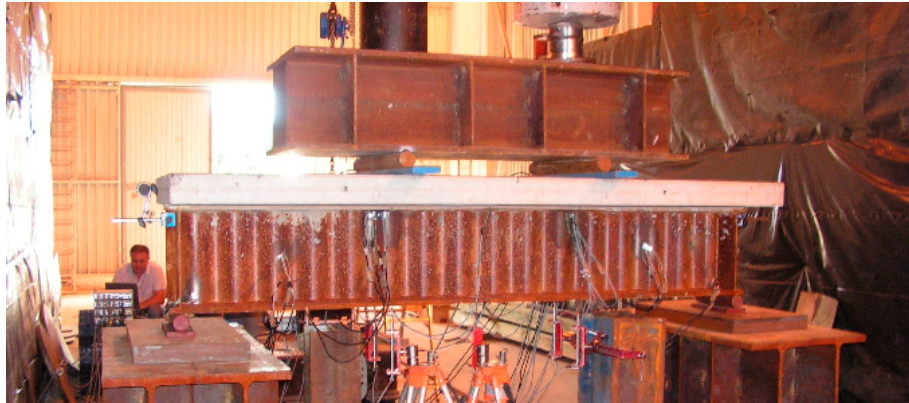
Figure 3. View of the typical four-point bending test setup.

The beams were subjected to a four-point bending test to obtain a constant bending moment at beam mid-span (Figure 3). One of the supports was made as a non-sliding articulated support, while the other was made as a sliding articulated support. Loads were applied at a distance of 840 mm from the test specimens' ends. The distance between the test specimens' ends was 800 mm (Figure 4). The external load was carried out using two actuators.

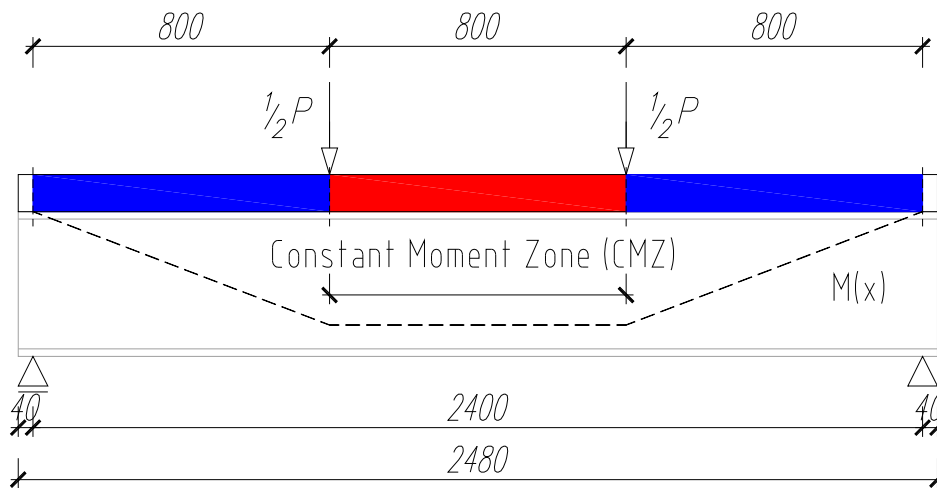
Figure 4. Load diagram for the tested beams—the distribution of moments along the length of the beam (mm).

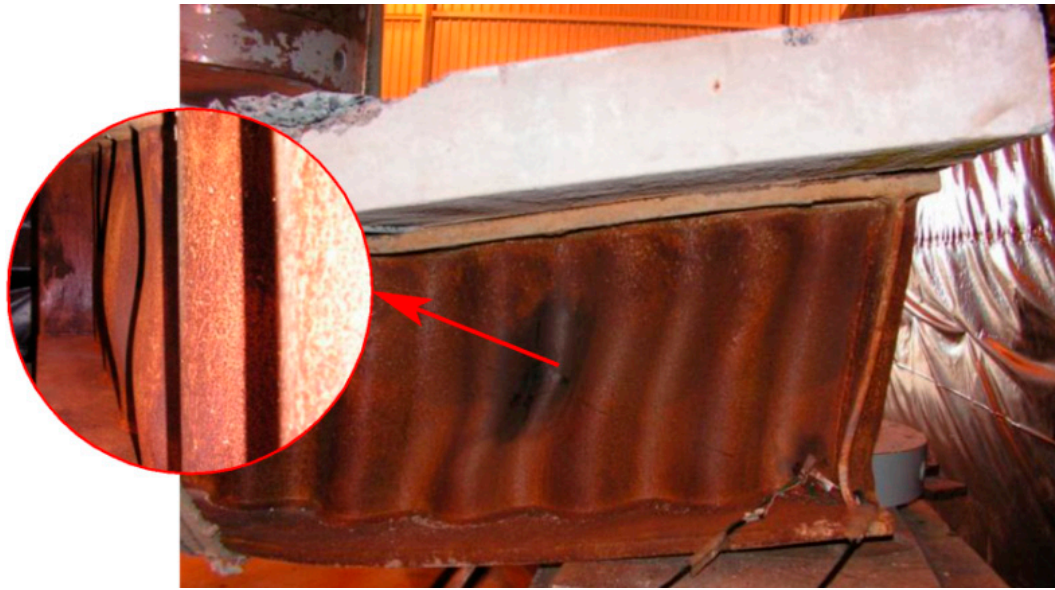
Figure 6. An example of a typical failed beam.

Across all loads in composite beams, there were no deformations in the steel part of the plate girder until the first concrete cracks started to appear in the compression zone. The result of damage to the reinforced concrete slab, at the point of transferring the external load, was the destruction of the flanges and ultimately the web. The appearance of the failed web clearly demonstrates global web buckling. Corrugation deformations fade towards the end of the beam. Figure 6 shows an example of a typical failed beam.

The failure occurred abruptly in the zones under constant transverse loads, in which the bending moment decreased towards the support. The largest deformations are visible along the section close to the point of loading. This means that the beams had reached their ultimate strength due to the large bending moment and shear force occurring at the same time.

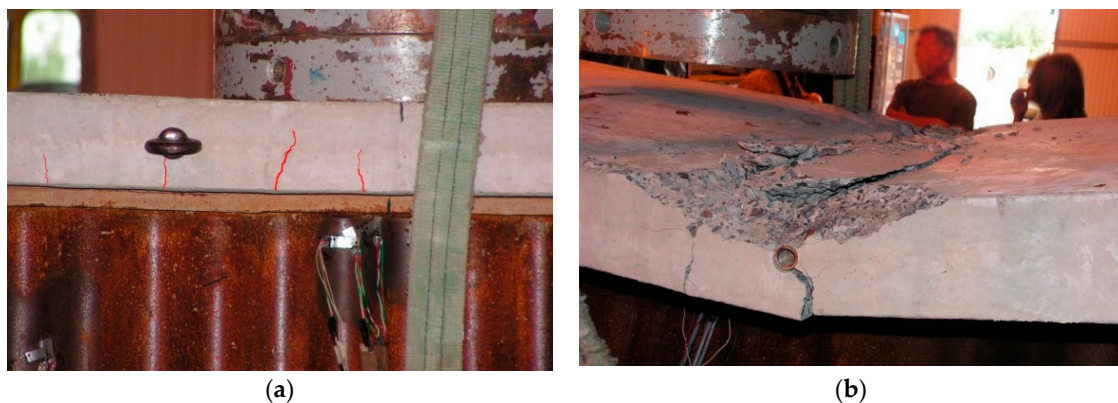
Figure 7. Reinforced concrete slab damage: (a) Crack morphology; (b) concrete crushing.

Ultimately, the beam failed because of concrete crushing within the loading zone (Figure 7), and the absence of the shear-force balancing effect in the web.

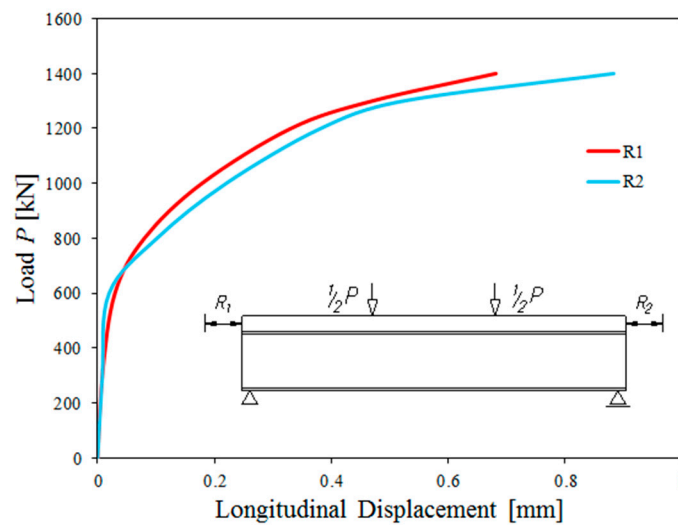
Figure 8. Typical reciprocal longitudinal displacement of the reinforced concrete slab and beam at all load ranges.

One of the reasons why the composite beams failed might also have been a detachment between the reinforced concrete slab and the steel beam due to the connection shear failure [40]. Therefore, the reciprocal longitudinal displacements of the slab and beam on each side of the component were measured (Figure 8).

At a load of 1400 kN (85% of the failure load), reciprocal displacements did not exceed 0.9 mm. At this load, the displacement sensors were removed for safety reasons. Such small reciprocal displacements, even after cracking, representing 0.07% of vertical displacements, proved that the attachment was complete [43]. After the completion of the destructive tests, visual tests were carried out on the basis of which it was found that the pins were not cut.

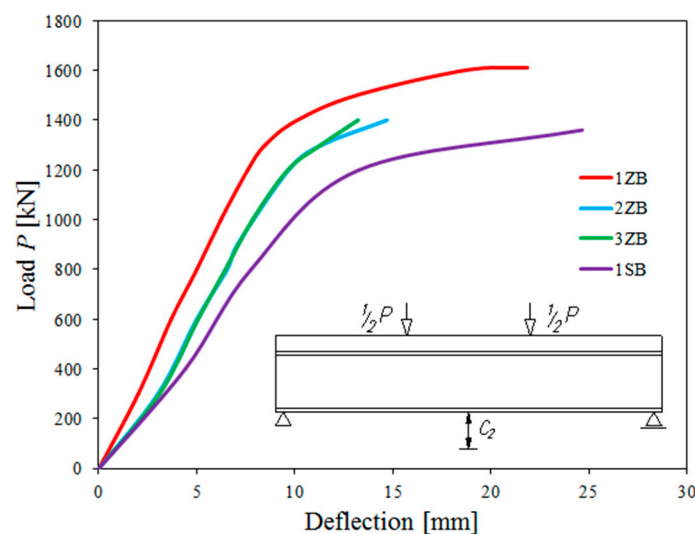
**Figure 9.** Vertical displacements of tested components at midspan (sensor C2 measurement).

Figure 9 shows the relationship between the composite-beam midspan deflection and the applied external load. For comparison, it includes corresponding charts for the reference beam (1SB).

The study proved that composite beams with corrugated webs provided higher cross-sectional stiffness and strength than non-composite beams with corrugated webs. During the tests, the transverse stiffness of the composite beams substantially reduced the global displacement of the system. Vertical beam displacements in the elastic deformation region were low, at about 20% relative to the deflections at the limit load.

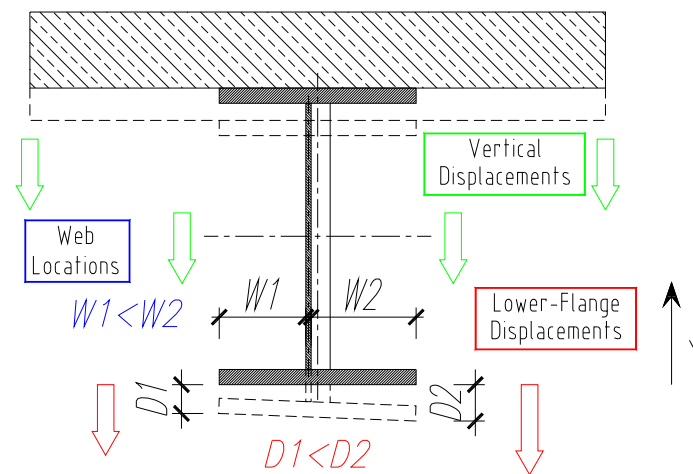
Figure 10. Lower-flange displacements in the transverse plane at the point of external load.

cycles, the displacements at the end edges of the lower flange, within the same transverse cross-section, differed by about 30% (Figure 10).

This effect was due to the flange projection changing along with the web shape. As the load increased, with the decreasing web impact on flange stiffness, this difference grew systematically smaller until the test ended. At a load of 1600 kN, this difference was 2% for measurement point C1 and 10% for measurement point C2.

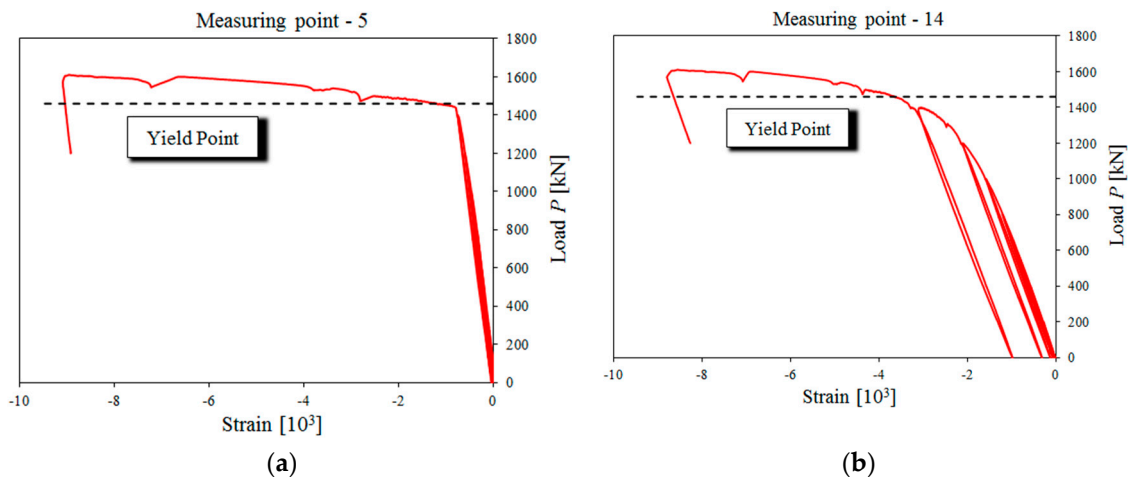
Figure 12. Strain increase at: (a) Measurement point 5; (b) measurement point 14.
