# Iatrogenic Iliac Vein Injury Following Extracorporeal Membrane Oxygenation Cannulation in a Patient with May-Thurner Syndrome: A Case Report and Literature Review

Seok Jin Hong, MD , Sang Min Lee, MD\* , Jung Ho Won, MD

Department of Radiology, Gyeongsang National University School of Medicine, Gyeongsang National University Hospital, Jinju, Korea

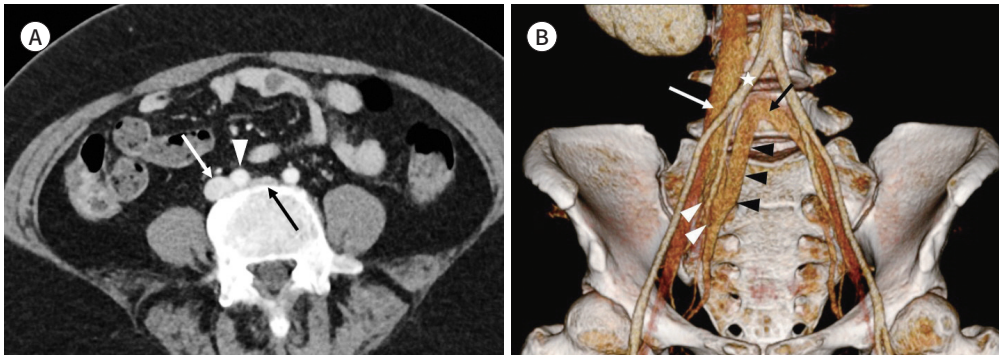
**Fig. 1.** Iatrogenic iliac vein injury with May-Thurner syndrome in a 53-year-old woman.

**A.** Axial CT shows compression of the left common iliac vein (black arrow) by the right common iliac artery (arrowhead). The white arrow indicates the right common iliac vein.

**B.** A 3D reconstructed CT scan shows communicating veins (black arrowheads) from the left common iliac vein (black arrow) to the right internal iliac vein (white arrowheads). The white asterisk and white arrow indicate the right common iliac artery and vein, respectively.

The patient's left common iliac vein (CIV) was compressed between right common iliac artery (CIA) and lumbar vertebral body, which was confirmed by abdominal CT taken 8 days ago. Thus, we suspected May-Thurner syndrome. And there was an iliac vein variation that was a communicating vein from the right internal iliac vein (IIV) to the contralateral CIV (Fig. 1A, B) (2). An urgent angiography through the left common femoral venous access was performed using the 7-Fr vascular sheath, which revealed contrast extravasation arising from the left CIV (Fig. 1C). The vascular injury caused by an ECMO cannulation was strongly suspected. Thus, balloon tamponade for five minutes was initially attempted for the bleeding using a 10 mm × 60 mm Mustang balloon (Boston Scientific, Galway, Ireland). Because post-angiography showed persistent bleeding, a larger balloon (12 mm × 60 mm) (Boston Scientific) was applied for 5 minutes. However, the bleeding was not stopped on the post-balloon angiography. After that, we decided on placement of the stent-graft. The diameter and length of the proximal and distal landing zone were determined base on the abdomen CT. In general, an oversizing of 10–15% and a proper landing zone of > 20 mm are required. Because proximal and distal diameter of left CIA were 12 mm and 10 mm, the largest, 12 mm × 60 mm, stent-graft (S&G Biotech, Seongnam, Korea) in our institution was selected. To avoid a back-

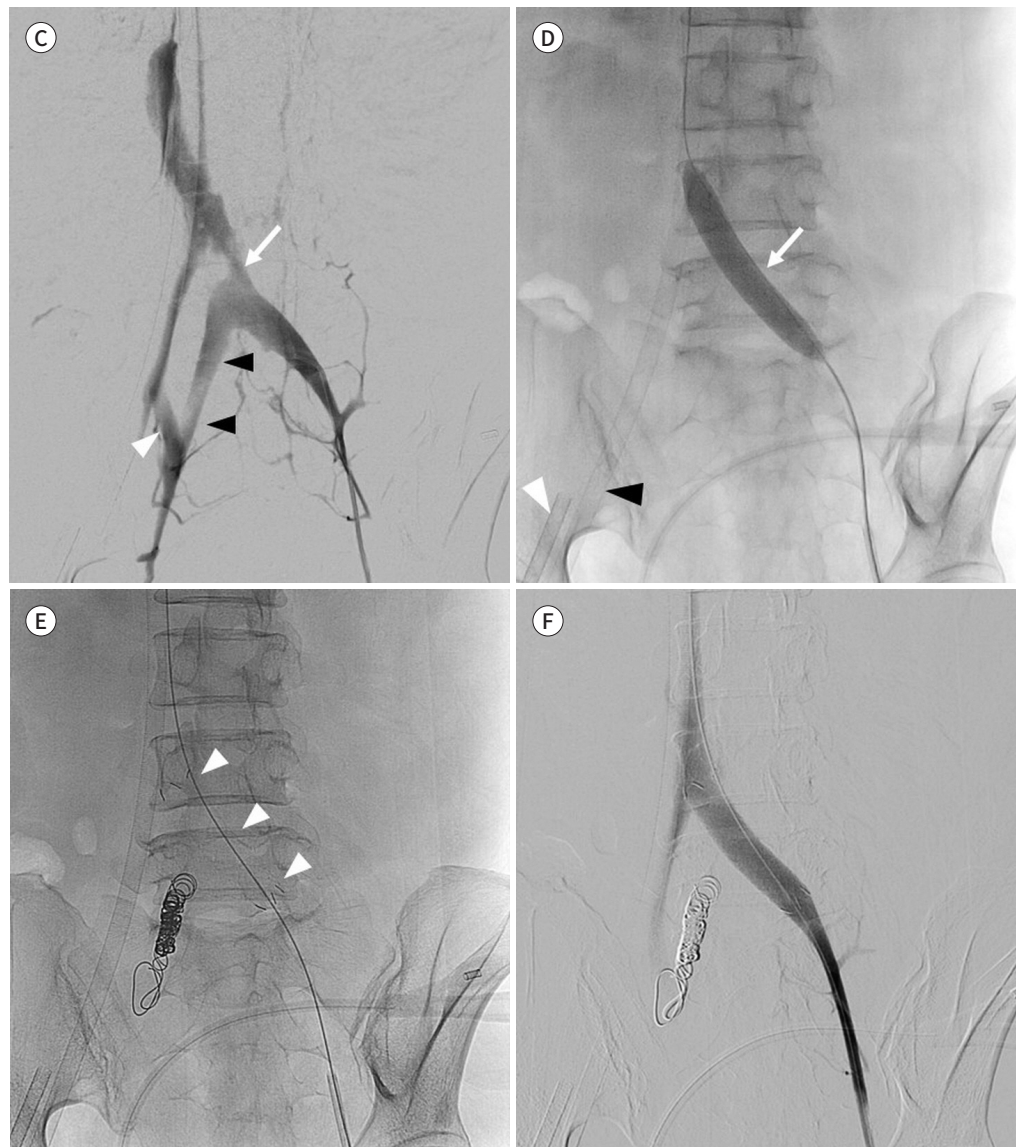
**Fig. 1.** Iatrogenic iliac vein injury with May-Thurner syndrome in a 53-year-old woman.

**C.** The left iliac venogram shows contrast extravasation from the rupture site (arrow) of the left common iliac vein. A communicating vein (black arrowheads) is noted between the left common iliac vein and the right internal iliac vein (white arrowhead).

**D.** A balloon tamponade is initially attempted to stop the bleeding using a 10 mm × 60 mm balloon catheter (arrow). Veno-arterial extracorporeal membrane oxygenation cannulas are inserted through the right femoral artery (white arrowhead) and vein (black arrowhead).

flow from the communicating vein, it was superselectively catheterized using 2.2-Fr microcatheter (Progreat, Terumo, Tokyo, Japan) and was embolized using detachable microcoils such as three Interlock coil (Boston Scientific, Cork, Ireland) (size: 12 mm × 30 cm, 14 mm × 30 cm, 18 mm × 50 cm) and one Concerto coil (Covidien, Plymouth, MN, USA) (size: 16 mm × 40 cm). Subsequently, the stent-graft were deployed over a 0.035-inch wire to cover the 15 mm distance between the proximal CIV and rupture site. After deployment, the stent-graft was dilated using a 12 mm × 40 mm Mustang balloon to achieve proper sealing. Post-procedure angiogram showed complete exclusion of the ruptured left CIV (Fig. 1D-F). Although the bleeding was successfully stopped with stabilized vital signs, the patient expired due to rapid aggravation of pulmonary infection three days after the procedure.

**E.** After the left internal iliac vein is embolized with detachable microcoils to avoid a backflow from the communicating vein, a 12 mm × 6 cm stent-graft (arrowheads) is deployed from the left common iliac vein to the external iliac vein.

**F.** After placement of the stent-graft, the venogram shows that there is no contrast extravasation and that patency of the left iliac venous system is restored.
