# CASE REPORT

# Pseudotumor complicating a well-fixed ceramic-on-polyethylene total hip arthroplasty

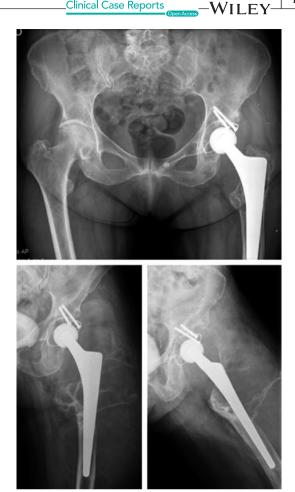
Figure 2. Radiographs of the pelvis and left hip, showing osteolysis of the greater trochanter

Radiographs of the affected hip were performed (Figure 2). These confirmed a well-positioned cup, without signs of migration or significant wear. Decreased bone density at the proximal femur was noted at this time.

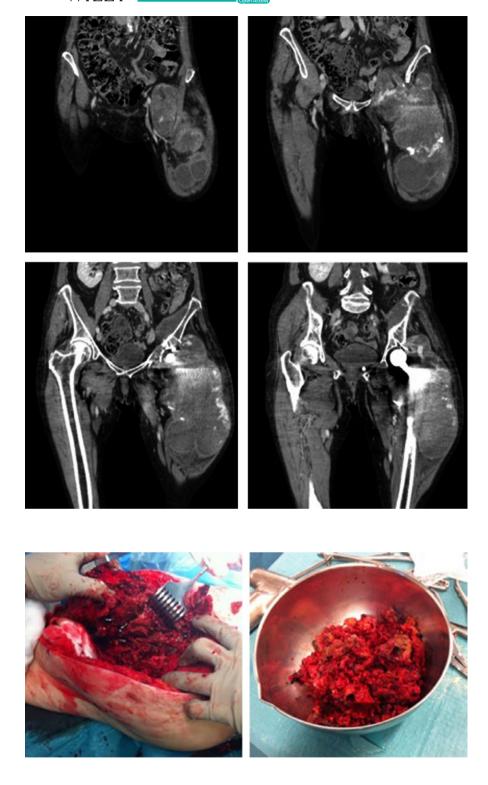
**Figure 3.** A coronal TC image of the pelvis showing a well-defined soft tissue mass anterolateral to the greater trochanter, with intra-pelvic extension Intraoperatory findings

Further investigation of the tumor was performed, with a pelvic computerized tomography (CT) (Figure 3).

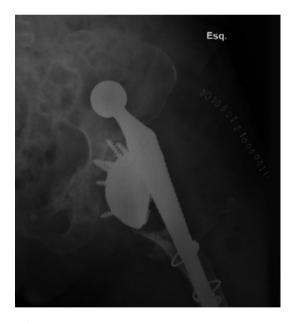
Figure 6. THA dislocation, 1 wk after revision

One week later, the patient had a hip dislocation, and as seen in the radiography (Figure 6), associated with a total loosening of the acetabular component. In face to these findings, we proposed another revision surgery.

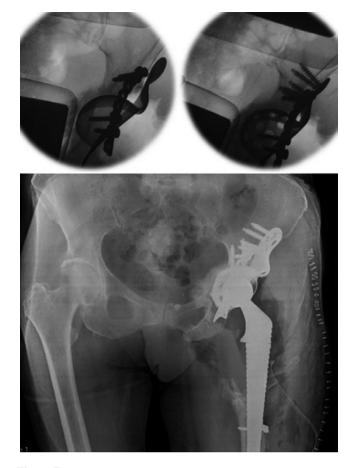
**Figure 7.** Peri- and postoperative radiographs of acetabular reconstruction

Intraoperatively we detected a total loosening of the acetabular component, associated with a pelvic discontinuity. Acetabular reconstruction with plate, allograph, and a Burch-Schneider ring was performed (Figure 7).
