# Mitral Regurgitation due to Entrapment of Cut Mitral Chordal Apparatus in a Bileaflet Disk Prosthesis

Ramesh C. Bansal, MD, FASE, and David G. Rabkin, MD, *Loma Linda, California*

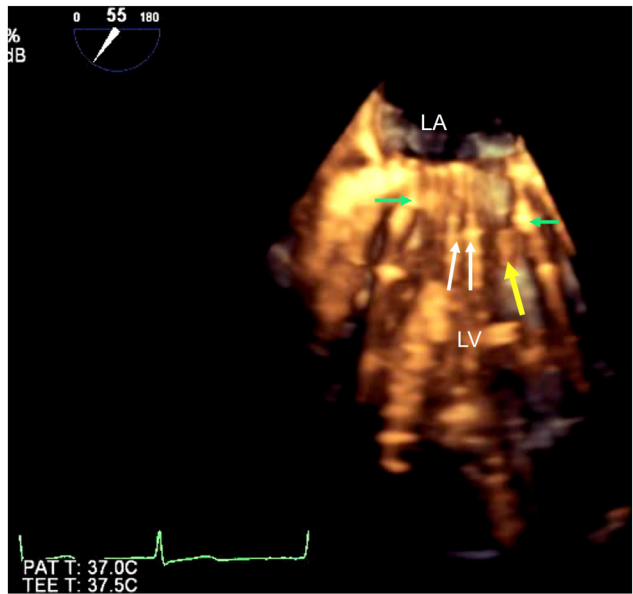
**Figure 5** Real-time three-dimensional TEE, midesophageal 2-chamber (55°) view, volume-rendered display in end diastole, demonstrates normal opening of disks (white arrows) and entrapment of the subvalvular mitral apparatus (yellow arrow). Housing of the bileaflet disk prosthetic valve is between the green arrows. LA, Left atrium; LV, left ventricle.

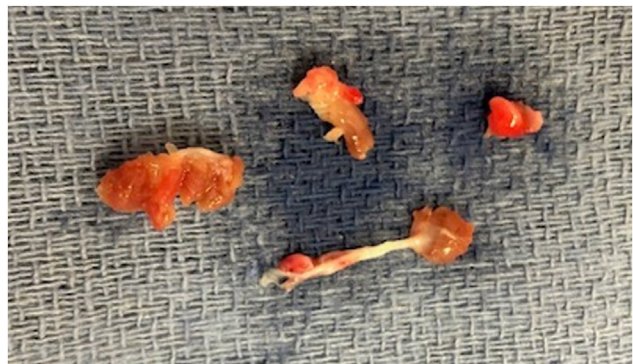
**Figure 6** Intraoperative surgical photograph of the resected surgical specimens of residual lateral PM and chordae, which were entrapped.

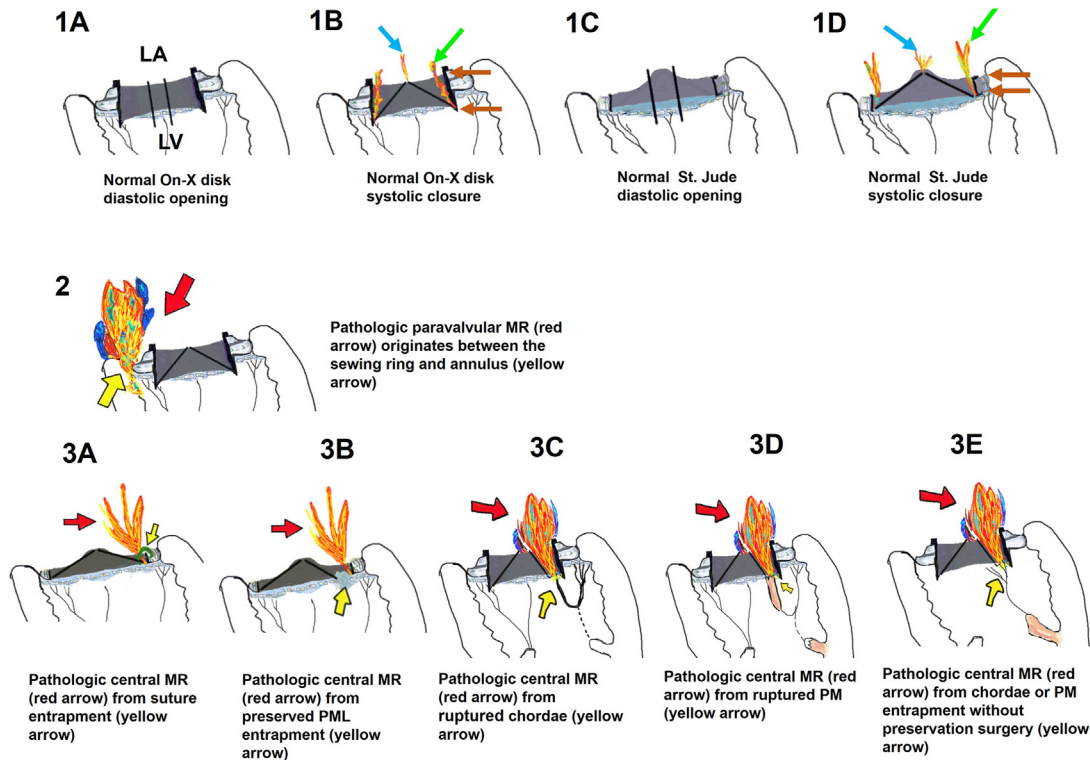
**Figure 9** Schematic representation of On-X (1A, 1B) and St. Jude (1C, 1D) bileaflet prosthetic MVs demonstrates normal physiologic MR. Normal prosthetic MR originates from between the disks (*blue arrows*) and between the disks and housing (*green arrows*). The height of the housing is higher with the On-X compared to the St. Jude MVR (*brown arrows*). Paravalvular MR (panel 2) and various mechanisms of central MR (panels 3A-3E) are also demonstrated.

space between the 2 disks (Figures 9-11). A frustrating problem with MVR is residual MR, which can be paravalvular or central (Figures 9-11). The distinction between paravalvular and central MR is, of course, critical to guiding the surgical management.<sup>1</sup> Comprehensive TEE examination with the transgastric short-axis view of the MVR, midesophageal scan from 0° to 180°, and select three-dimensional imaging with color Doppler will identify the site, mechanism, and severity of prosthetic MR (Figures 9-11). Understanding the surgical techniques

Most often, MR after MVR is paravalvular,<sup>1</sup> resulting from inadequate apposition between the prosthesis and the mitral annulus due to mitral annulus calcification and infective endocarditis (Figure 9, panel 2, Figure 11). Rarely the MR can be intraprosthetic or central (Figure 9, panel 3A-3E), noted predominantly in mechanical prothesis. In the acute setting, central MR after MVR can be due to multiple etiologies and a wide differential is warranted (Figure 9, panel 3A-3E).<sup>4-12</sup> The height of the valve housing differs among 2 of the more common mechanical mitral prostheses: On-X (Artivion) and St. Jude Medical (Abbott Cardiovascular), with the former having a greater height. This difference has implications for the mechanism of obstructed leaflet as illustrated (Figures 9-11). If the MR develops later, remote from the index operation, thrombus, vegetation, pannus formation, and newly untethered tissue from ruptured chordae are likely culprits.<sup>1,6-12</sup>

Most cases of malfunction due to entrapment of the preserved native valve tissue or chordae have been reported several days after surgery (Figure 9, panel 3B, 3C).<sup>7-9</sup> Agostini *et al.*<sup>9</sup> reported a case of MR due to entrapment of ruptured chords (Figure 9, panel 3C) 4 years after the MVR. Fijalkowski *et al.*<sup>10</sup> reported MR due to

entrapment of the ruptured proximal head of the PM in a patient with ischemic heart disease (Figure 9, panel 3D) 2 weeks after MVR. Delayed rupture of chords and rupture of a PM in these cases likely occurred due to increased stress on the chordae during the PML-sparing replacement procedure.
