Case Report

Extra-articular migration of the patellar component following total knee arthroplasty

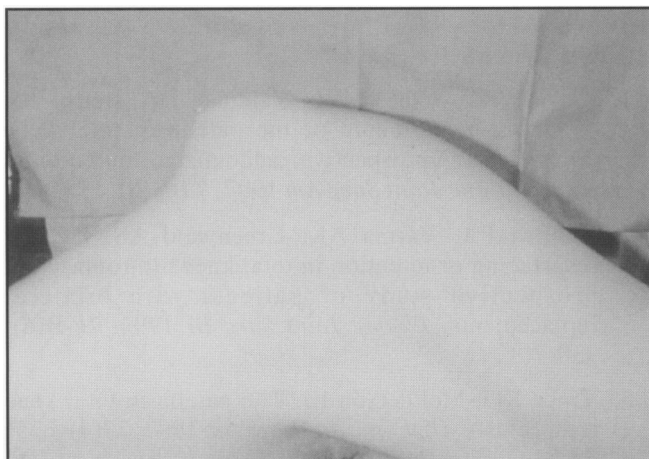
Fig 1. Photograph of left knee in flexion demonstrating the preoperative appearance (note tenting of the overlying skin).

On examination of the swelling which had appeared, a well defined, hard, mobile, sharp edged swelling was evident over the anterior aspect of his left knee which became more prominent on knee flexion, with blanching of the skin (Figure 1). Radiographs revealed separation of the polyethylene button from the patella (Figure 2). At operation via a minimal skin incision utilizing the old scar, the patellar button was found extra-articularly within the soft tissues. A local defect was noted in the lateral retinaculum. The button was retrieved (Figure 3) and the defect closed with interrupted vicryl sutures.

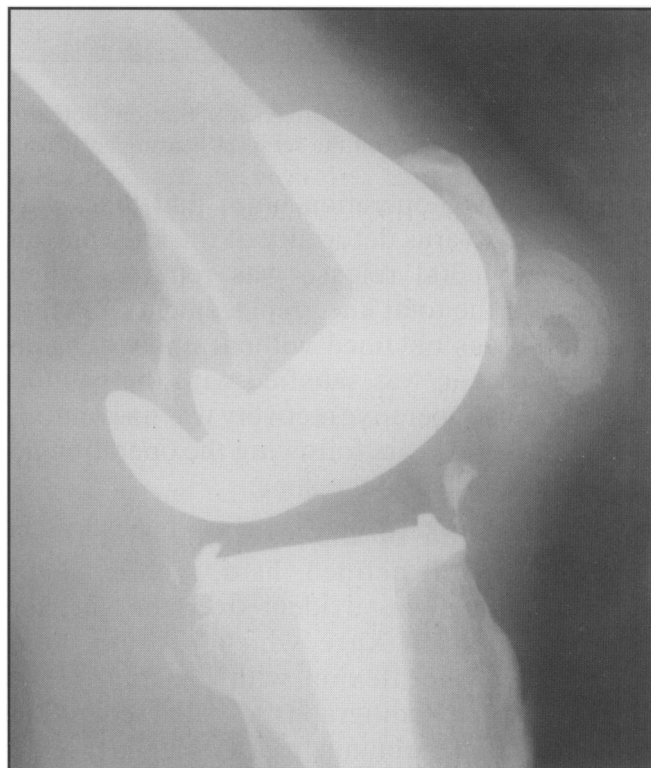
Fig 2. Lateral radiograph of left knee, demonstrating separation of the patellar prosthesis from the patella.

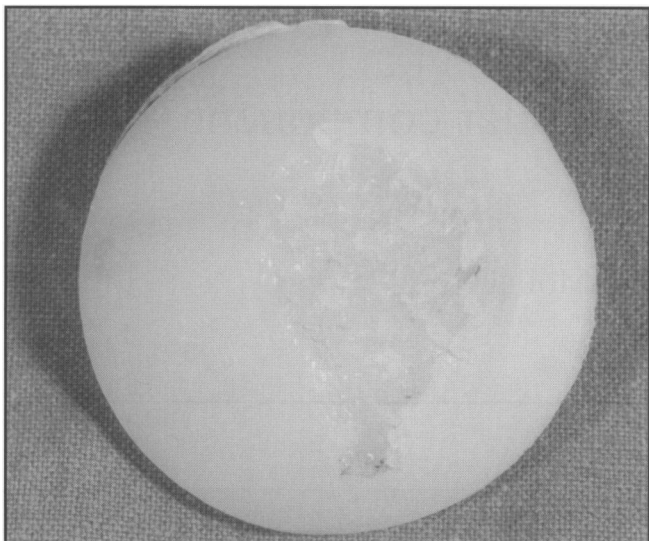
Fig 3. Patellar button as removed at operation (note the degree of wear on the femoral bearing surface).

The relationship between the articulating surface of the patellar and femoral components of a knee replacement is of great importance in the development of complications. The articular surface of the patella must conform with the geometry of the femoral component. With an all-polyethylene dome prosthesis, as was used in this case, small contact areas with the femoral component and high contact stresses are common.⁵

Hsu and Walker⁶ designed a machine to replicate the forces applied to the patellar component during flexion and extension of the knee. They found that the contact areas of polyethylene patellae increased rapidly due to deformation. Such creep deformation reduces contact stresses. However, the underlying supporting surface also became subject to deformation. They concluded that all-polyethylene patellar domes with low conformity with the femoral condyles are prone to deformation with potential for failure of the underlying bone and loosening.⁶ We postulate that patellar dome deformation, as seen in Fig 3, led to deformation of the underlying bone followed by loosening and then separation of the patellar dome. Weakness of the lateral retinacular fibres probably resulted from incision at the previous synovectomy and allowed extrusion of the patellar component into the extra-articular soft tissues.
