## International Journal of Surgery Case Reports

# Ceramic liner fracture in ceramic on ceramic Total hip arthroplasty: A case report

**CASE REPORT:** 29 year old male case of bilateral hip avascular necrosis operated for bilateral hip THA presented 30 months after with complaint of squeaking, x-ray showing left ceramic liner fracture without any history of trauma. Revision of ceramic liner and head with ceramic on polyethylene was done.

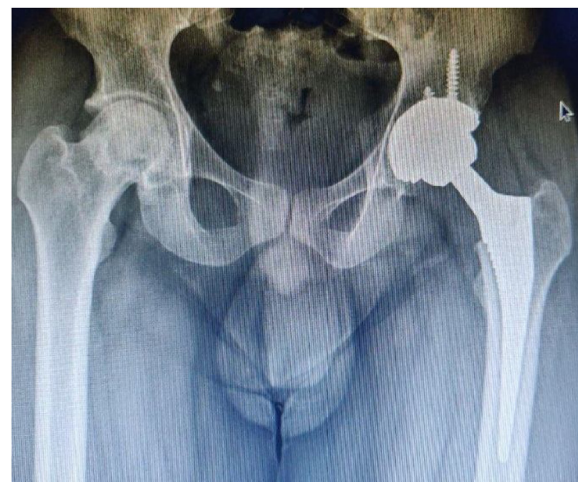
**Fig. 1.** Showing postoperative AP radiograph a normal seated acetabular component and liner.

(32 mm + 9.0) and 32 mm neutral liner were used as bearing surfaces. The inclination of acetabular cup was  $42^{\circ}$  and anteversion was  $12^{\circ}$ . Fig. 1 demonstrate the post-operative anteroposterior radiograph.

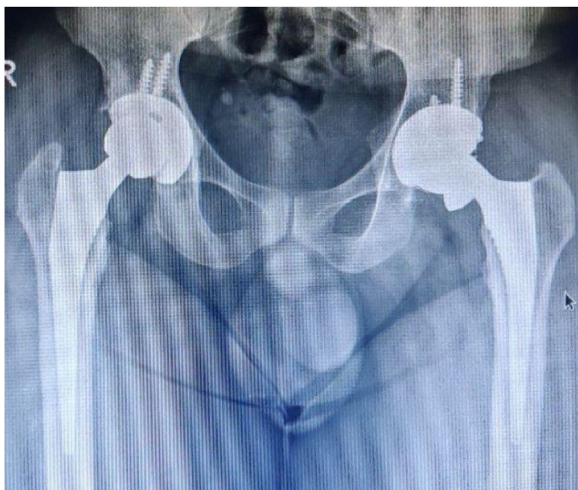
After 30 month he presented with squeak in her hip. He had no problem in gait and no history of trauma and squatting. There was no evidence of infection around left hip. Fig. 2 showing the anteroposterior radiograph.

Fig. 2. Shows a left side ceramic liner fracture.

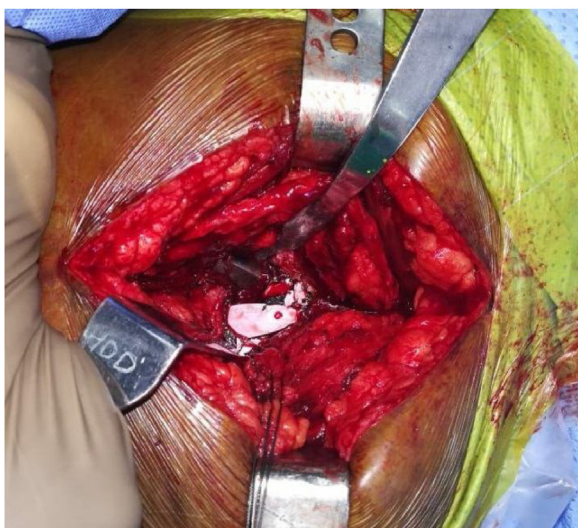
Fig. 3. Intraoperative photographs shows Fractured Ceramic liner.

particles were observed (Fig. 3). Intraoperatively, ceramic fragments were meticulously removed, and extensive capsulectomy was performed. The ceramic liner was exchanged for a polyethylene liner and a new ceramic head (Polyethylene liner 32 mm + 4 mm 10°, Biolox delta ceramic 32 mm + 5.0). Thus, femoral stem and acetabular cup was well fit so retain. After the removal of all components, massive irrigation and extensive synovectomy were done to remove microscopic ceramic fragments.

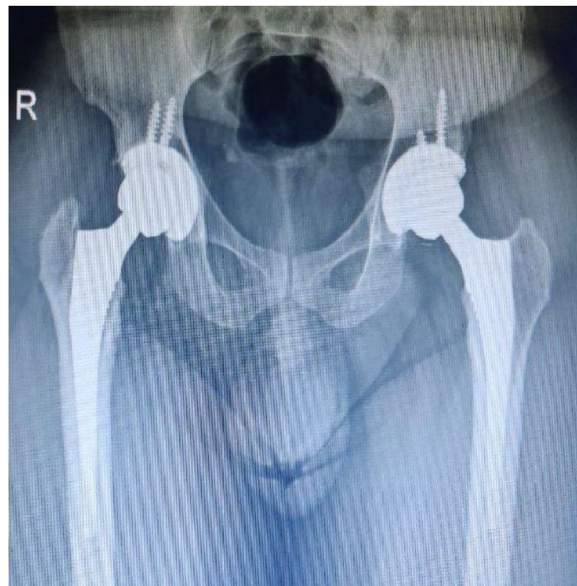
At his 12 months follow-up, he could return to her previous level of activity, and had Harris hip score of 93. In radiographs, the implant showed stable fixation without sign of osteolysis or loosening (Fig. 4).

Fig. 4. Radiograph after revision of ceramic Head and liner.
