Biopsy Proven Focal Osteolysis in a Stainless-Steel Limb-Lengthening Device: A Report of Three Cases

JAAOS Glob Res Rev 2021;5:1-6

ABSTRACT

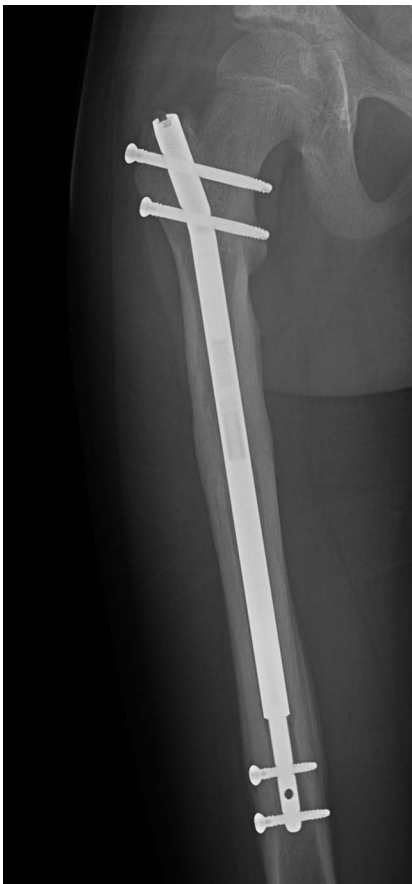
Figure 1

AP radiograph demonstrating a right femur approximately 5 months postimplantation of a stainless-steel intramedullary lengthening nail.

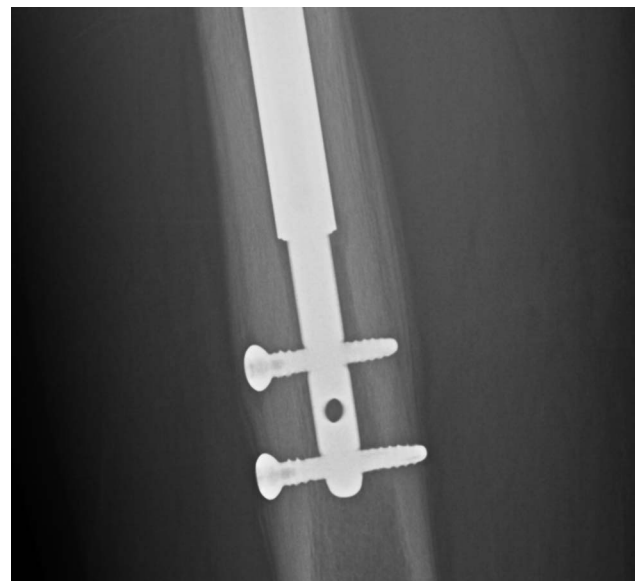
Figure 2

AP radiograph (with 135% magnification) of a right femur demonstrating that a punched-out appearance resembling osteolysis is appreciated medial to the modular junction. Onion skinning resembling periosteal reaction is appreciated along the medial femoral shaft adjacent to the modular junction and around both ends of the distal locking screws.

The first patient was a 14-year-old adolescent boy with a history of posttraumatic limb-length discrepancy (LLD) of the right femur who underwent intramedullary lengthening. Preoperative LLD measured 2.1 cm, and serum chromium level measured 0.8 $\mu\text{g/L}$ (normal range: 0.1 to 2.1). At the time of rod removal, radiographs demonstrated osteolysis at the modular junction of the telescopic nail (Figures 1 and 2). To determine the etiology of the osteolysis, a biopsy was done using the Reamer Irrigator Aspirator system (DePuy Synthes). The intramedullary guide rod was manipulated through the residual hole in the diaphysis from the interlocking nails. A cannulated drill bit was used to drive the guidewire and reamer into the medial cortex of the femur, which was disproportionately affected by the osteolysis (Figure 3). The reamer was pushed to the level of the lesion without activating the reamer. The irrigation/aspiration and reaming were then activated 1 cm above the lesion and deactivated 1 cm distal to the lesion. Intramedullary contents were collected in the suction trap. The remainder of the canal was then reamed and collected as a separate specimen. The biopsies were processed

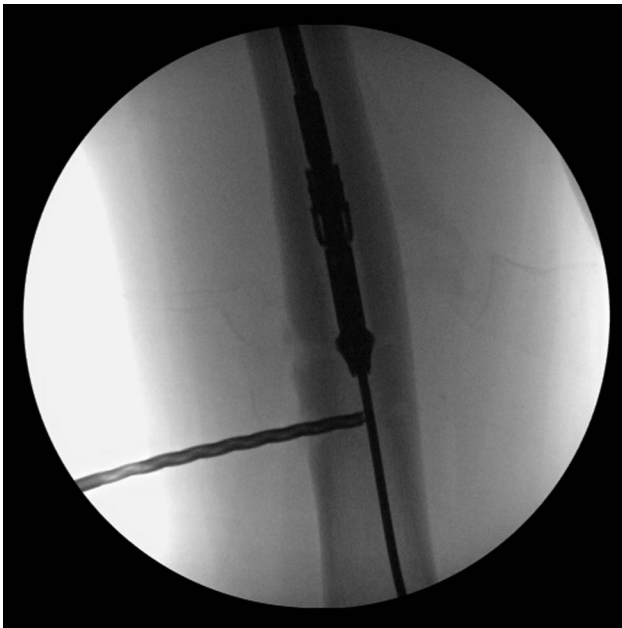
Figure 3

Intraoperative fluoroscopy image demonstrating the Reamer Irrigator Aspirator system reamer placement in the femoral canal at the level of the previously removed modular junction of a stainless-steel intramedullary lengthening nail.

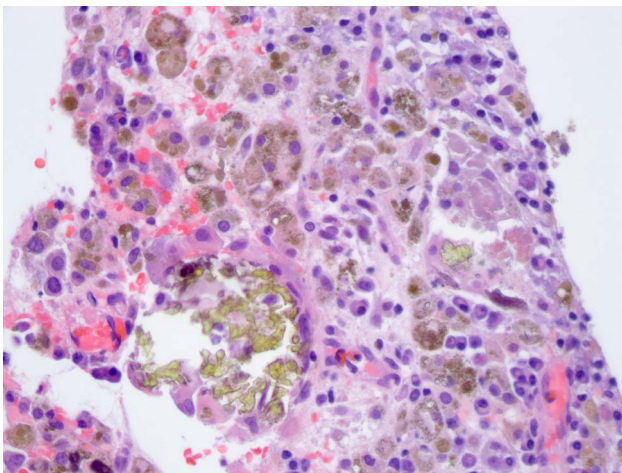
Figure 4

Image from reamings on case 1 showing macrophages full of granular dark particles and extracellular, larger greenish-gold crystalline debris particles ($\times 400$). Although the intracellular particles show morphologic overlap with hemosiderin, the larger crystalline fragments are not typical of hemosiderin deposition.

taken up by macrophages and large crystalline fragments with a green-yellow color (Figure 4). These larger fragments are similar to those described in 2001 by Jones et al,¹⁷ which were found to contain chromium, consistent with stainless-steel components. In our patient, there was also abundant clear, refractile, non-birefringent material consistent with silicone debris (Figure 5). Postoperative evaluation of the explanted nail demonstrated significant corrosion at the modular junction (Figure 6).

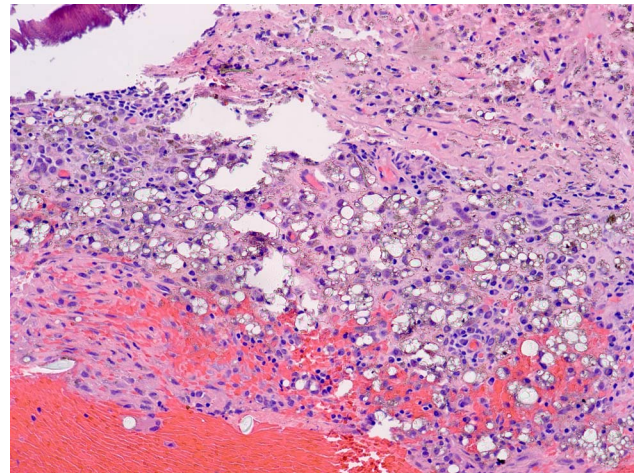
Figure 5

Image from reamings on case 1 showing abundant fragments of refractile, clear material, both intracellular and extracellular ($\times 200$). The material was not birefringent, consistent with silicone debris.

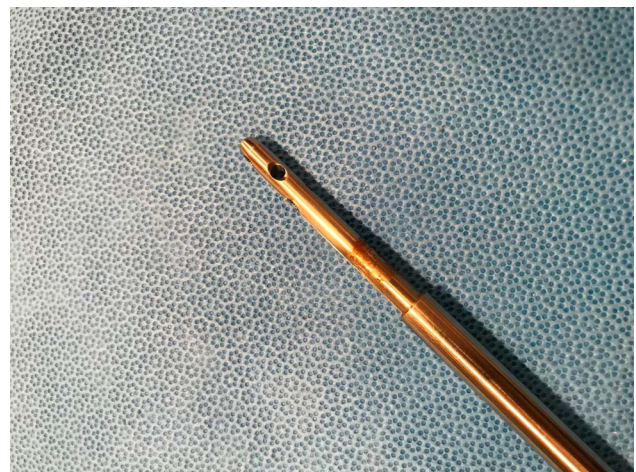
Figure 6

Photograph showing the explanted lengthening nail of case 1. Nail distracted to reveal corrosive changes at the male end of the modular junction.

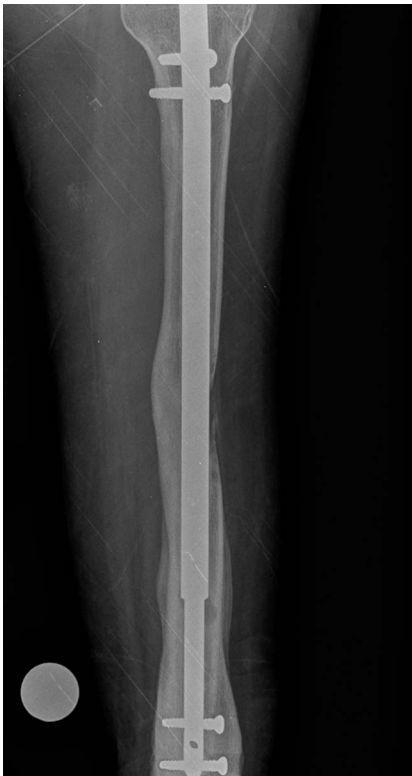
Figure 7

AP radiograph of a right tibia demonstrating a punched-out appearance distal and medial to the modular junction resembling osteolysis.

The second patient was a 17-year-old adolescent girl with a history of right lower extremity congenital limb deficiency who underwent intramedullary lengthening of the right tibia. Approximately 22 months after implantation, osteolysis was suspected (Figure 7), and tibial nail removal was completed with prophylactic plating given suspicion for possible osteomyelitis (later determined to be negative). Preoperative LLD measured 4.0 cm, and serum chromium level measured 1.9 $\mu\text{g/L}$. Biopsies were taken from a defect on an anterolateral defect of the tibia, and a medial bridge plate was placed. The reamings showed abundant crystalline debris and macrophages full of granular dark material; however, silicone debris was not observed.

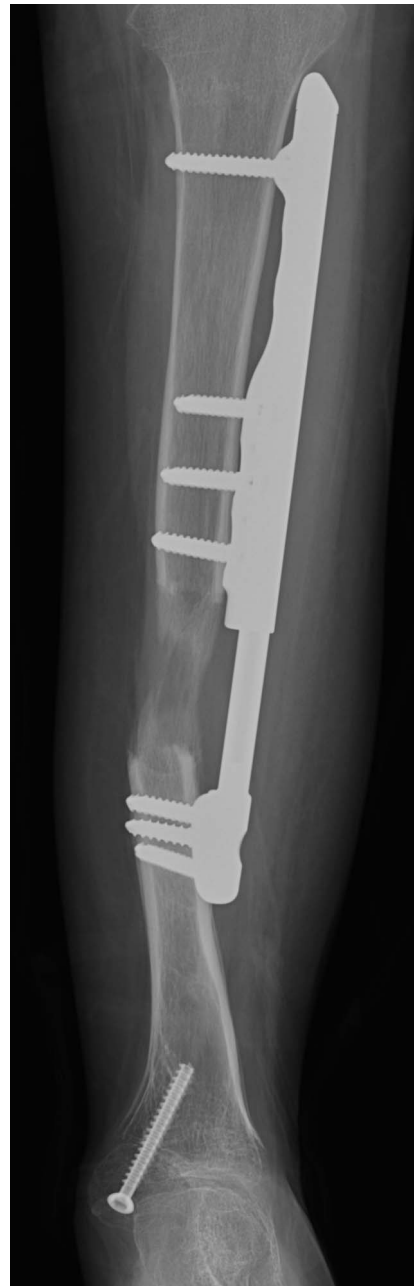
Figure 8

AP radiograph demonstrating a left tibia approximately 2 months after placement of an extramedullary stainless-steel limb-lengthening device. Tibial valgus deformity is appreciated.

The third patient was a 10-year-old boy with a history of congenital femoral deficiency and fibular hemimelia who underwent removal of a left tibial-lengthening plate. Preoperative LLD measured 6.0 cm. Hardware failure at the distal fixation block created a tibial residual valgus/procurvatum deformity during distraction with

2.5 cm length achieved (Figure 8). Fixator-assisted plating was used to correct the deformity (Figure 9). Biopsy samples were taken from the superficial and deep surface of the plate and the underlying bone. The soft tissue adjacent to the plate in this patient showed abundant particle-laden macrophages and greenish-gold crystalline debris, similar to that seen in the first patient (Figure 10). Silicone debris was present in this patient,

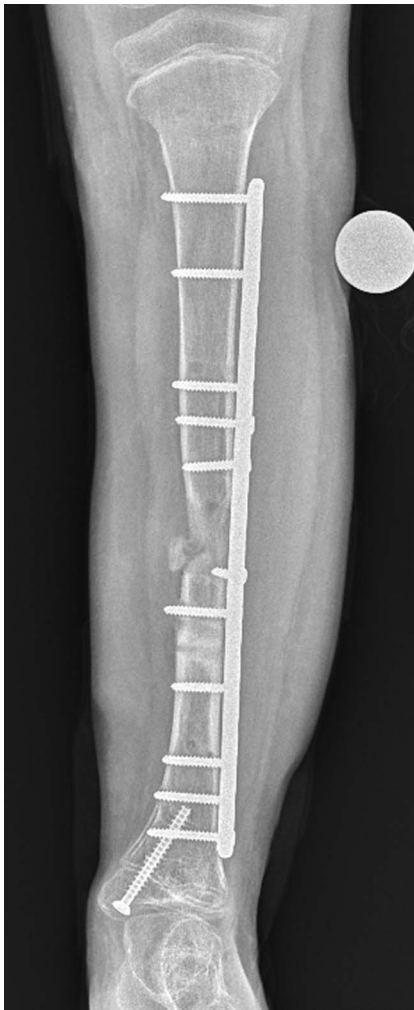
Figure 9

Postoperative AP radiograph demonstrating a left tibia after an external fixation-assisted plate exchange for tibial realignment.

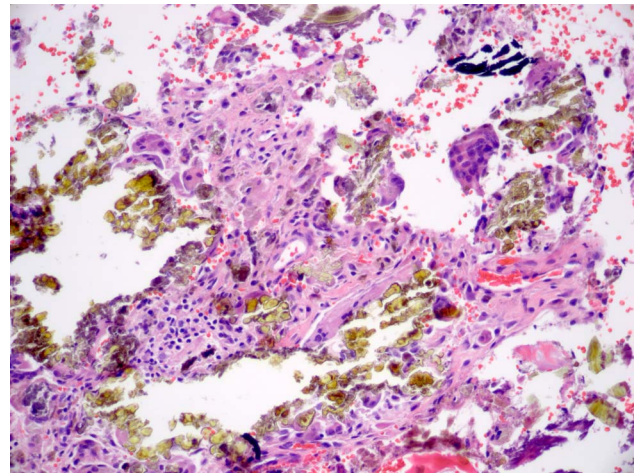
Figure 10

Image from case 3 showing abundant fragments of golden-brown crystalline debris and occasional fragments of black metallic material (top right; $\times 200$). Foreign body giant cells and lymphoplasmacytic inflammation are present.
