Research Article

Influence of Different Damage Patterns of the Stem Taper on Fixation and Fracture Strength of Ceramic Ball Heads for Total Hip Replacement

Danny Vogel

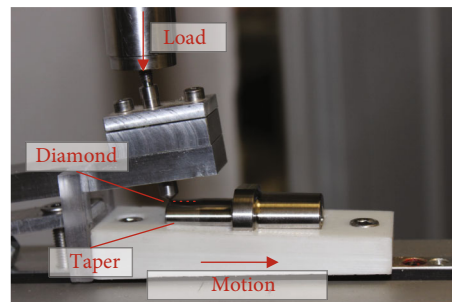
FIGURE 1: Setup to apply a scratch to the taper surface.

The first damage pattern was a defined scratch at the taper surface perpendicular to the ridge structure, which could possibly occur during the implantation procedure (e.g., from careless instrument handling). The scratches were produced using a self-constructed scratch test setup with a diamond point loaded with 400 N by a universal testing machine Zwick Z050 (ZwickRoell GmbH & Co. KG, Ulm, Germany) (Figure 1). The scratches had a mean depth of $73\ \mu\text{m}$ and a width of $411\ \mu\text{m}$.

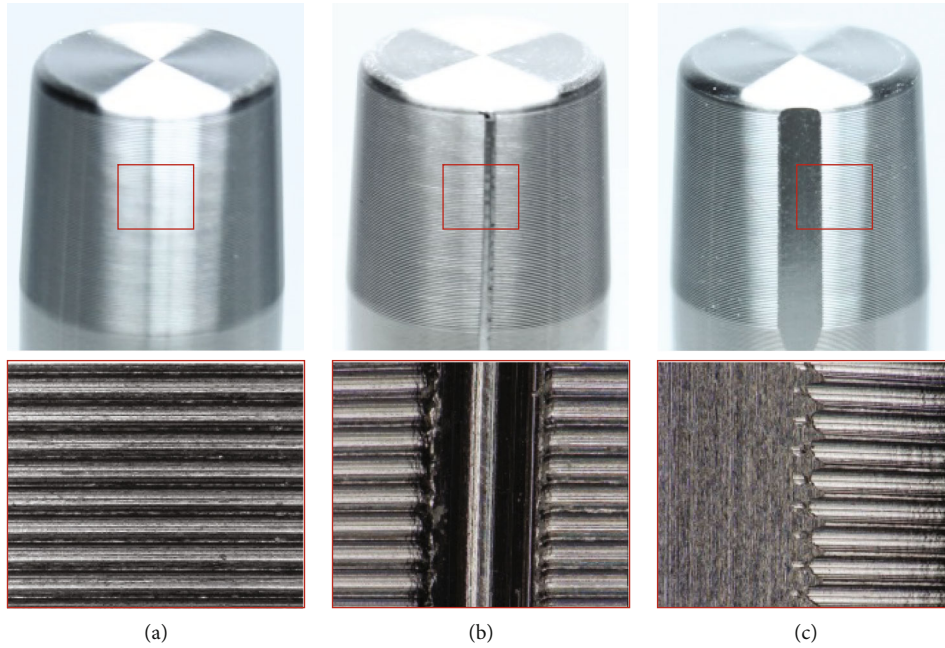
FIGURE 2: Depiction of the damage patterns of the stem tapers: (a) intact, (b) scratched, and (c) truncated.

The second damage pattern was chosen to represent a truncated taper that could occur due to abrasion over time [6]. This damage pattern was realized by a 0.1 mm deep groove in the axial direction of the stem taper, resulting in an approximate volumetric material loss $1.8\ \text{mm}^3$. The different taper damage patterns are shown in Figure 2.

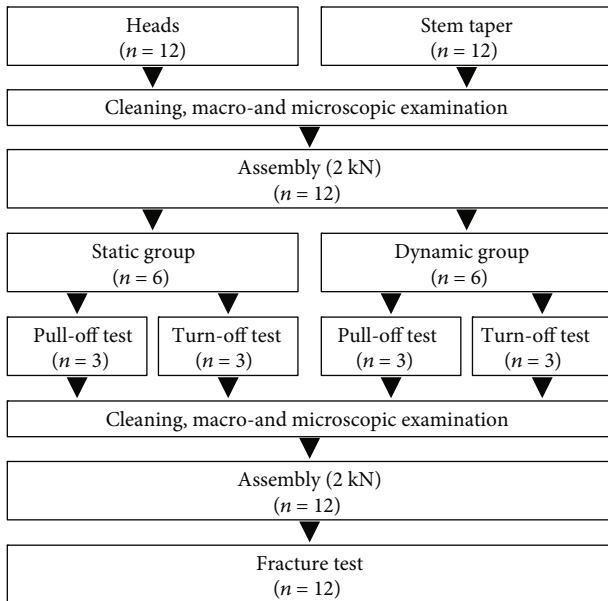
FIGURE 3: Scheme of the experimental test design. This procedure was carried out for each of the three groups of tapers resulting in a total of 36 heads and tapers.

contaminants. Thereafter, the assembled heads were divided into two subgroups. In the case of the first group, the pull-off (PO) and turn-off (TO) tests were carried out after the assembly without further applied loads (static group: ST). The second subgroup was dynamically loaded over 1.5 million cycles in a standard hip simulator (EndoLab GmbH, Rosenheim, Germany) according to ISO 14242-1 [27], with load of the normal gait cycle between 0.3 and 3.0 kN and a frequency of 1 Hz (dynamic group: DYN). Due to the dynamic loading in the hip simulator, the taper connection was subjected to frictional and additional bending moments. Figure 3 shows the test groups and the experimental design.

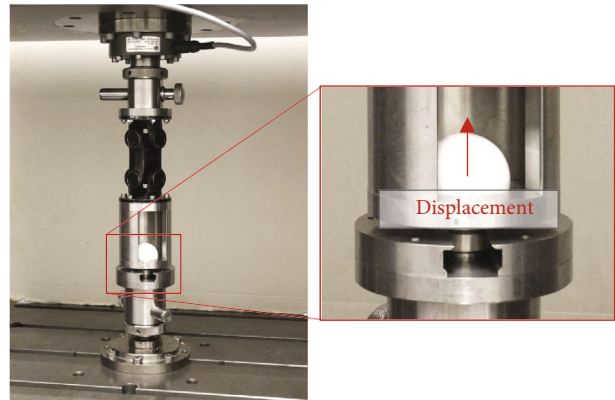
FIGURE 4: Setup for the pull-off test using a universal testing machine.

2.2. Pull-Off Test. The pull-off test of the femoral heads was carried out through the universal testing machine Zwick Z050 (ZwickRoell GmbH & Co. KG, Ulm, Germany). The taper was clamped in a fixation device, while the head was pulled off the taper with a constant displacement rate of 0.05 mm/s (Figure 4). The test was terminated when a sudden drop of the load was detected, with the peak load giving the pull-off force. The pull-off forces were measured in accordance with ASTM 2009 [25].

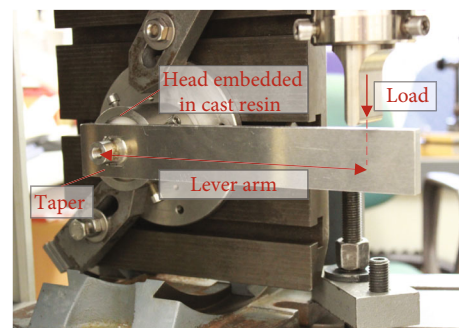
FIGURE 5: Setup for the turn-off test using a universal testing machine.

2.3. Turn-Off Test. The turn-off tests of the femoral heads were carried out through the universal testing machine Zwick Z050 (ZwickRoell GmbH & Co. KG, Ulm, Germany) as well. Turn-off moments were measured based on ISO 7206-13 [28]. The ceramic heads were therefore embedded in two-component cast resin (Component 1: RenCast FC 52 BD Polyol; Component 2: RenCast FC 52/53 BD Isocyanate; Huntsman AG, Salt Lake City, UT, USA), and the taper was orientated horizontally. A lever arm with a length of 200 mm was fixed to the taper, horizontally aligned, and loaded perpendicularly with a load rate of 1 N/s (Figure 5). Thus, a torsional moment was applied to the taper, loosening the taper-head connection. The test was terminated when a sudden drop of the load occurred or an angle limit of 20°

was reached. Maximal torsional moments were calculated from the recorded load and the lever arm length.

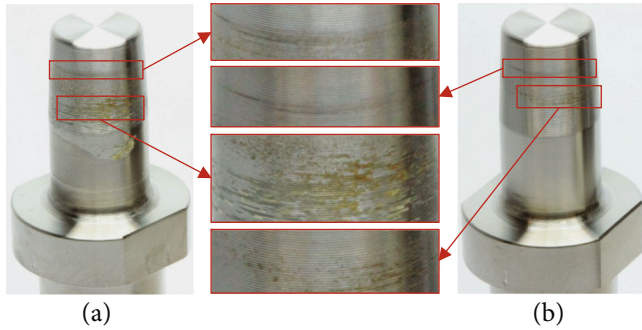
FIGURE 6: Discoloration of an intact taper after dynamic loading (left) and after cleaning (right).

3.1. Macroscopic Examination. After removal of the implant specimens from the hip wear simulator, all dynamically loaded stem tapers were covered in a mixture of creamy-colored dried serum and had darker orange to brown discolored areas. The serum and most parts of the darker discolorations were removed after the cleaning protocol. However, in 10 of 18 stem tapers (4x intact taper, 4x scratched, and 2x truncated), discolorations were observed after cleaning (Figure 6). No deformations, additional scratches, or abrasions were macroscopically visible, and therefore, the damage pattern conformed to Goldberg score 1.

Stem taper damage was analysed by visual examination in our current study. Serum residues were observed on the stem taper surface after disassembly, indicating that fluid had entered the crevice. Slight dark and dull ring-shaped discolorations were detected on nearly every dynamically loaded taper, which were assumed to be a mild form of corrosion. According to Kurtz et al. [9], the determined amount of

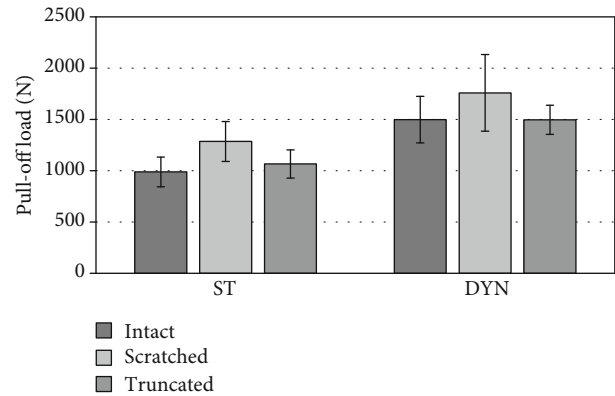
FIGURE 7: Differences of the pull-off forces in dependency on taper damage and the loading condition. ST: statically loaded; DYN: dynamically loaded.

3.2. Pull-Off Test. The pull-off forces increased between 36.8% and 51.6% (effect size 0.45-0.80) after the dynamic loading. In the statically loaded group, the scratched tapers showed the highest pull-off forces ($1,284.8 \text{ N} \pm 194.9 \text{ N}$), followed by the truncated ($1,065.4 \text{ N} \pm 137.9 \text{ N}$) and intact ($987.6 \text{ N} \pm 144.9 \text{ N}$) tapers. In the dynamically loaded groups, the scratched tapers showed the highest pull-off forces ($1,757.9 \text{ N} \pm 373.7 \text{ N}$) followed by the intact ($1,497.5 \text{ N} \pm 227.0 \text{ N}$) and truncated ($1,496.0 \text{ N} \pm 141.5 \text{ N}$)

tapers. None of the differences were statistically significant (Figure 7).

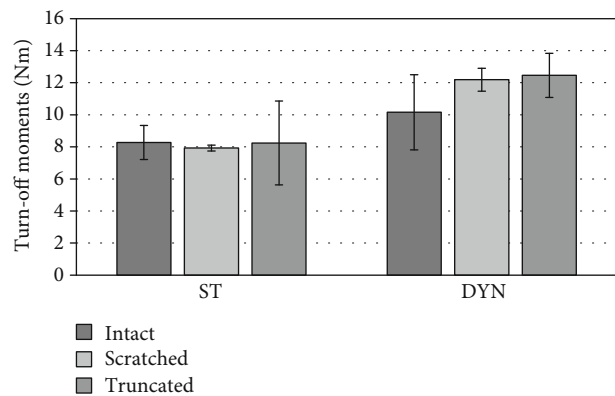
FIGURE 8: Differences of the turn-off moments in dependency on taper damage. ST: statically loaded; DYN: dynamically loaded.

3.3. Turn-Off Test. Apart from the pull-off forces, the turn-off moments increased between 22.8% and 53.8% (effect size 0.45-0.80) after the dynamic loading. In the statically loaded group, the intact tapers showed the highest turn-off moments ($8.3 \text{ Nm} \pm 1.1 \text{ Nm}$), followed by the truncated ($8.2 \text{ Nm} \pm 2.6 \text{ Nm}$) and scratched ($7.9 \text{ Nm} \pm 0.2 \text{ Nm}$) tapers, respectively. In the dynamically loaded group on the other hand, the truncated tapers ($12.5 \text{ Nm} \pm 1.4 \text{ Nm}$) showed the highest turn-off moments followed by the scratched ($12.2 \text{ Nm} \pm 0.7 \text{ Nm}$) and intact ($12.2 \text{ Nm} \pm 2.3 \text{ Nm}$) tapers. None of the differences were statistically significant (Figure 8).

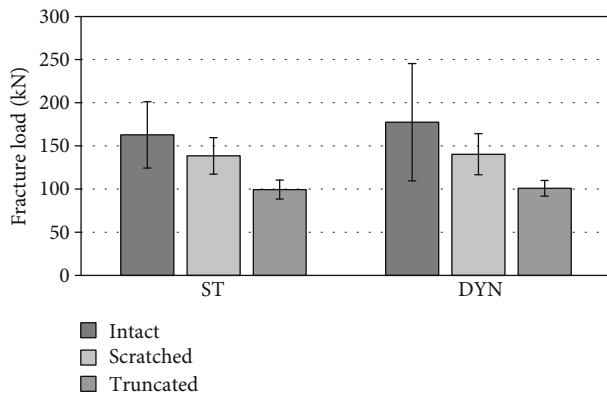
FIGURE 9: Differences of the fracture loads in dependency on taper damage and the loading condition. ST: statically loaded; DYN: dynamically loaded.

3.4. Fracture Loads. Higher fracture loads were determined in the case of the intact tapers (static: 162.8 kN; dynamic: 177.6 kN), compared to the damaged tapers. The fracture load was decreased by about 15.0% to 20.9% in the case of the scratched tapers and by about 38.9% to 43.1% in the case of the truncated tapers. The differences were statistically significant and had a large effect size, when the truncated tapers were compared to the intact or scratched tapers. When the scratched tapers were compared to the intact tapers, a

medium effect was determined, but statistical significance was not observed.

Comparing statically and dynamically loaded stem tapers, the dynamically loaded tapers showed a 1.4% to 9.1% increased fracture strength. This finding was not statistically significant (Figure 9).

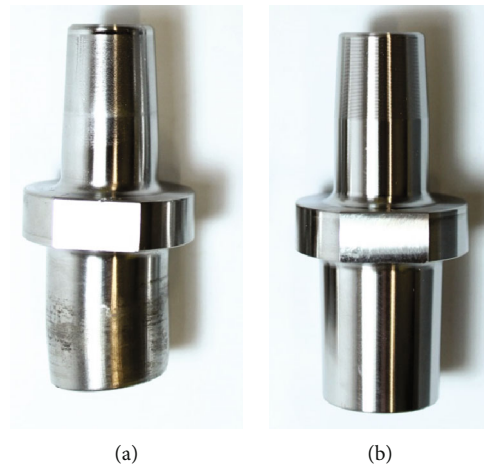
FIGURE 10: Comparison of a plastic deformed (a) and intact (b) stem taper.

However, in some fracture tests, a plastic deformation of the stem taper was detected before the ceramic femoral head fractured (Figure 10). A plastic deformation was determined in the case of 11 stem tapers (6x intact, 4x scratched, and 1x truncated). These measurements were excluded from the result analysis.
