Physical Properties of Five Brands of K-Files

Arash Izadi ^a, Arash Shahravan ^{b*}, Hoda Shabani Nejad ^c

Original Article

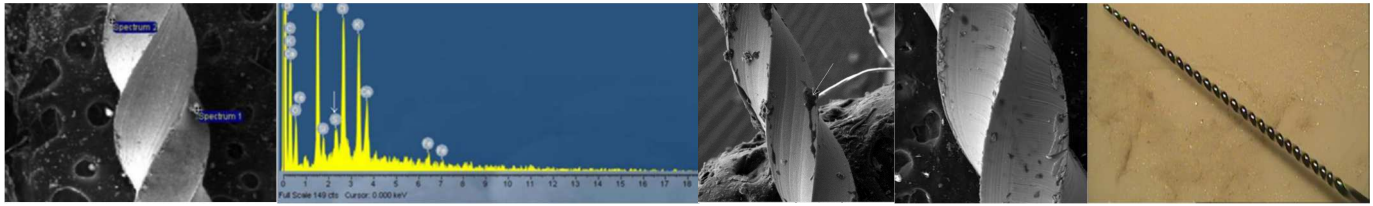
Figure 1. A) SEM micrograph of a file. Note the cavities on the surface of the file ($\times 250$ magnification); B) EDX spectrum of the cavities, C) A #25 Mani instrument under $\times 250$ magnification. The white arrow shows debris in the middle of the file; D) A #25 Larmrose instrument under $\times 250$ magnification. Machinery defects in the middle of the file, E) The flutes of a #25 Mani instrument under $\times 40$ magnification.

The existence of any cavity on the surface of the files was considered as a sign of corrosion [21]. Figure 1A shows the SEM micrograph of a file. Some small cavities are obvious on the outer surface of the file. These corroded points were assessed by energy dispersive x-ray microanalysis (EDX). The presence of sulfur in the EDX spectrum confirms the occurrence of corrosion [22]. For instance, Figure 1B shows the results of EDX analysis for the cavities in Figure 1A. The presence of sulfur in the spectrum confirms occurrence of some corrosion in the file.

SEM micrographs ($\times 250$ magnification) were taken to detect the machining debris in tip, middle and end of the file (Figure 1C).

Any visible defect in the file structure is considered as a machinery defect. This includes discontinuity of flutes, flute curvature, metal flushes or any other observable structural defect after opening the package of the files [23]. In Figure 1D, machinery defects are clearly seen in the middle of the file.

The number of shiny points in the stereomicroscope micrograph (under $\times 40$ magnification) is defined as flutes number. For instance, the number of flutes in the file shown in Figure 1E is 27.

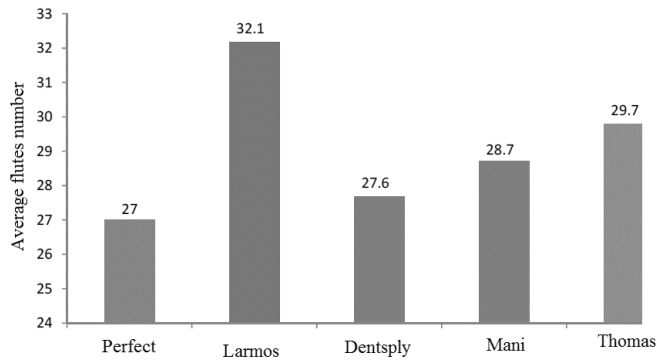
Figure 3. The number of flutes in the studied files

The average flutes number in the studied files is shown in Figure 3. The Larmrose files showed the highest flutes number, while the lowest number of flutes was found in Perfect files. A significant difference was observed between these two brands while the other brands showed no significant difference.

Newman *et al.* [26] demonstrated that the higher number of flutes in a file, can improve its cutting performance. In the present study, the highest flutes number was observed in Larmrose files. Files of the Perfect brand showed the lowest flutes number. It can be assumed that Larmrose files can remove tissues more effectively than Perfect files, but it remains matter of discussion for future studies in this field.
