Conformational changes during in vitro balloon fracture of internal aortic annuloplasty ring

Sandeep N. Bharadwaj, MD,^a Tom X. Liu, MD,^a Keith B. Allen, MD,^b Christopher K. Mehta, MD,^a James Flaherty, MD,^c and S. Christopher Malaisrie, MD^a

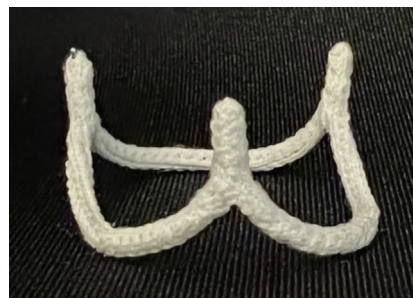
FIGURE 1. Standard, elliptical 21-mm HAART 300 (BioStable Science and Engineering, Inc) internal aortic annuloplasty ring.

The HAART 300 ring is an elliptical aortic annuloplasty ring with a 2:3 major-to-minor axis ratio and 3 commissural posts angled 10° outwards from the ring. The 19-mm, 21-mm, and 23-mm HAART 300 aortic annuloplasty rings were provided by BioStable Science and Engineering, Inc (Figure 1). The 23-mm, 24-mm, 25-mm, and 26-mm True Dilatation Valvuloplasty Balloons (BD) were also obtained. The noncompliant True Dilatation balloon was chosen because it is one of the most common balloons used for balloon valve fracture and is the standard balloon used for valve fracture in our institution. Balloon sizes for attempted fracture were chosen

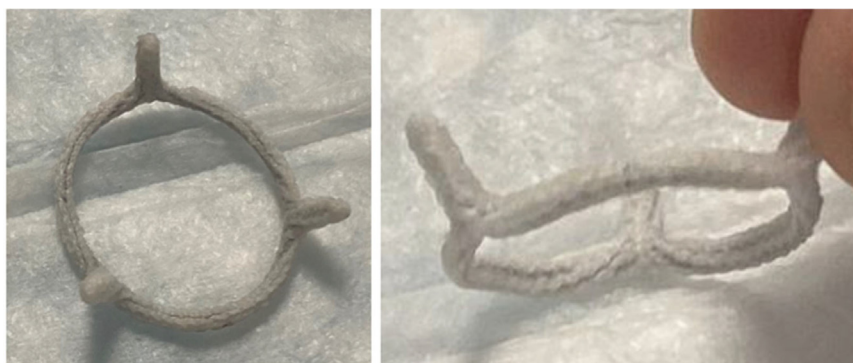
FIGURE 2. A 21-mm ring demonstrating circular deformation with posts flaring outward after dilation with a 24-mm balloon.

Upon valvuloplasty balloon inflation, all rings exhibited an irreversible conformational change from an elliptical, physiologic annular geometry to a more circular shape with ring posts flaring outward (Figure 2). These changes were maintained after balloon rupture or removal for upsizing. The maximal angle of outward flaring of the posts was not measured. Circular deformation was noted in all rings before reaching manufacturer-specified rated burst pressure, whereas all ring fractures were achieved at pressures above rated burst pressures.
