Un-“Mask”-ing the leak

Dear Editor,

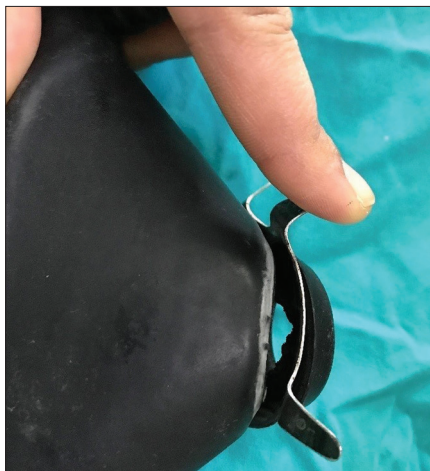
a flow of 6 L/min and an appropriate technique of mask holding, the bag was filling inadequately. It got corrected with increasing the flow to 10 L/min. After intubation, no leak was noticed during ventilation. The machine check, prior to taking up the patient, showed no evidence of a leak. On closer inspection, the mask showed a cut between the apex and body of the mask [Figure 1].

Wear and tear after multiple usages might have contributed to the tearing of the mask at this junction. Also, a quick eye-balling method of inspection might have missed this torn area of the mask because of it being hidden under the retaining hook. Machine preuse check recommendations help rule out a leak in the breathing circuit.^[2] However, the mask and other airway devices, such as supraglottic devices and endotracheal tubes, are not checked during the machine leak test. At least one previous correspondence showcased the limitation of the preuse check by describing an unusual cause for leak, which was from a likely manufacturing defect in the endotracheal tube.^[3] This case reiterates that it is important to physically check all airway equipment prior to use.

Figure 1: Mask showing tear at the junction of apex and body
