# The Possibility of Applying Acoustic Emission and Dynamometric Methods for Monitoring the Turning Process

Faculty of Marine Engineering, Gdynia Maritime University, 81-225 Gdynia, Poland; w.labuda@wm.umg.edu.pl

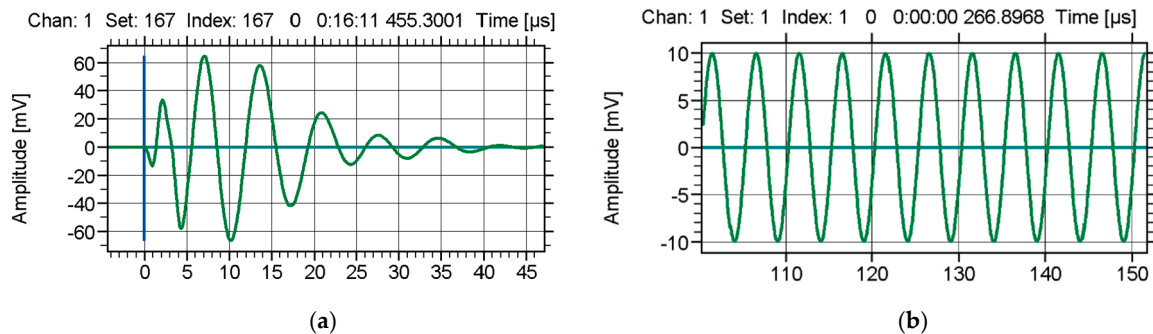
**Figure 1.** Examples of typical acoustic emission signals: (a) burst signal, (b) continuous signal [24].

Examples of AE signals are shown in Figure 1.

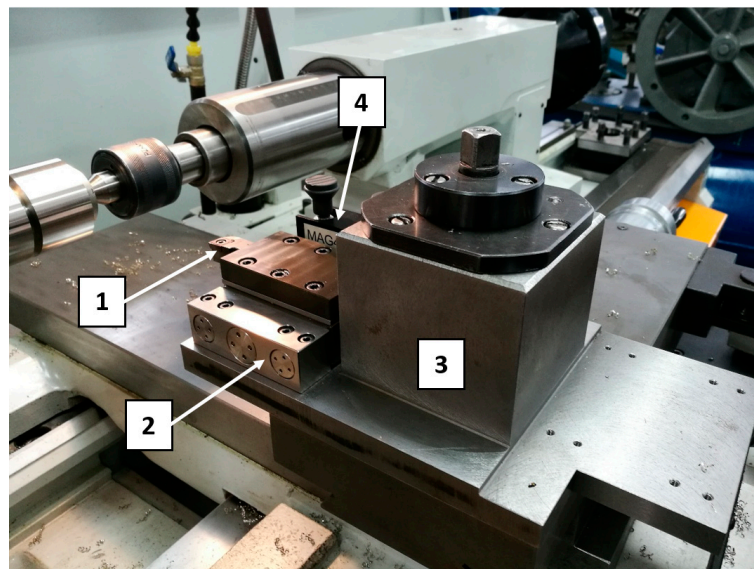
**Figure 2.** The equipment used in research: 1–tool, 2–dynamometer, 3–dynamometer grip, 4–acoustic emission sensor with holder.

The tool was mounted into Kistler dynamometer (Kistler Instrumente AG, Winterthur, Switzerland). Dynamometer allowed measuring the cutting forces during turning process, both on conventional or CNC lathe machines. It consists of 9119AA2 piezoelectric dynamometer (Kistler Instrumente AG, Winterthur, Switzerland), 5070 charge amplifier and computer with DynoWare software (DynoWare type 2825D-02, Version 2.6.5.1.6, Kistler Group, Winterthur, Switzerland) for acquisition and analysing of the data. This dynamometer allows measuring of dynamic and quasistatic forces:  $F_x$ -radial force,  $F_y$ -feed force and  $F_z$ -cutting force. The range of measured forces is  $-4 \div 4$  kN. The equipment measures the active force, regardless of the application point.

The view of tool and measuring equipment used in research is shown in Figure 2 and the view of shaft is presented in Figure 3.

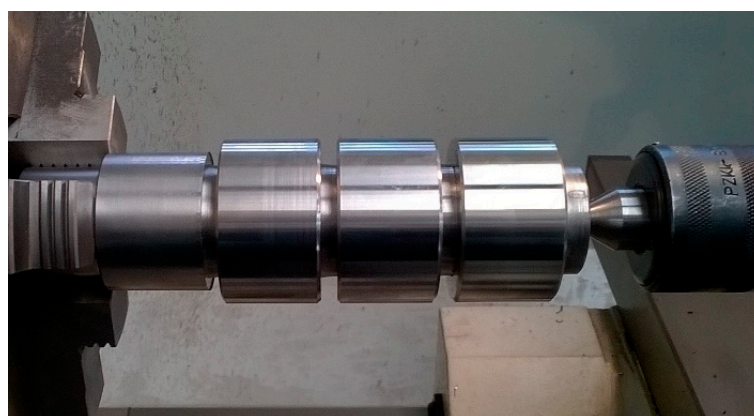
**Figure 3.** The shaft used in research.

The research was carried out on a universal lathe center (CU500MRD, ZMM Sliven, Sliven, Bulgaria). The specimens were shafts with a diameter of 60 mm, made of 304 L stainless steel, with hardness of 215 HB. There were the same length of shaft pins—35 mm. The turning of the shaft was conducted by a tool with CCET09T302R-MF (DIJET Industrial CO., LTD, Osaka, Japan) removable insert. Basic information about the insert: C—rhombic insert shape with point angle 80°; C—insert clearance angle 7°; E—tolerance (nose height  $\pm 0.025$  mm; thickness  $\pm 0.025$  mm; inscribed circle  $\pm 0.025$  mm;

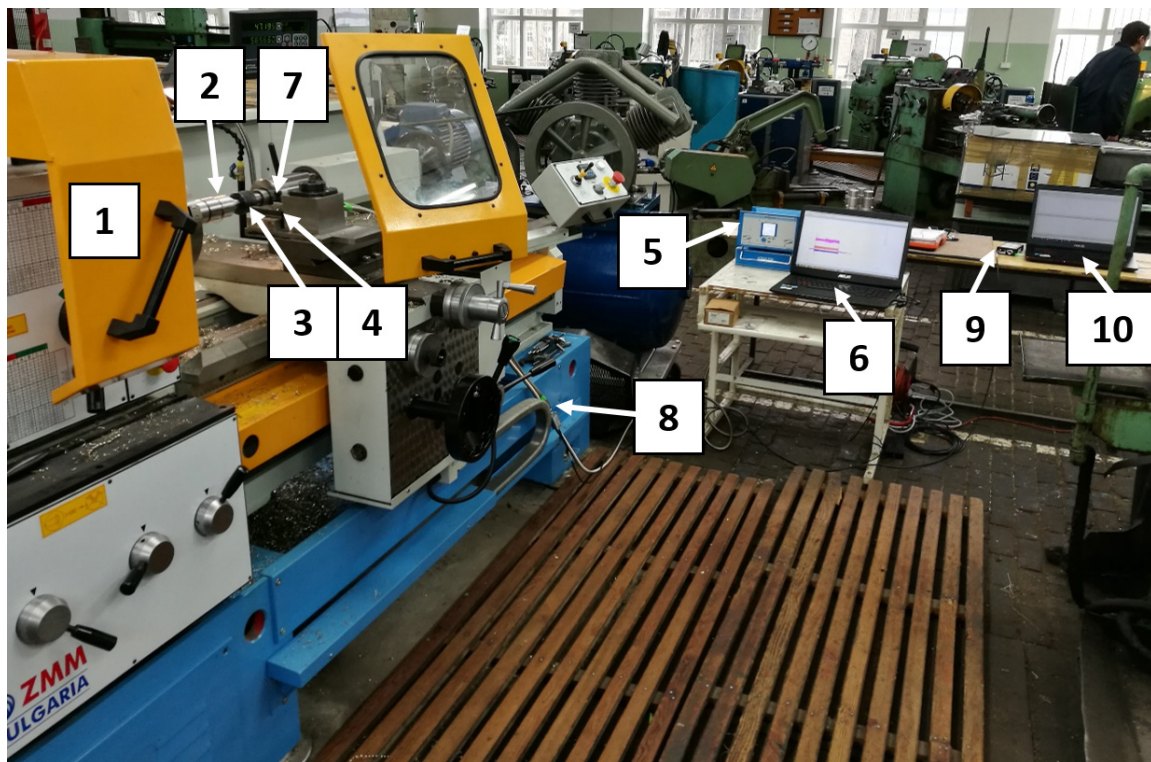
**Figure 4.** Laboratory stand: 1–lathing machine, 2–shaft, 3–tool, 4–dynamometer, 5–dynamometer recorder, 6–dynamometer computer, 7–AE sensor, 8–preamplifier, 9–AE recorder, 10–AE computer.

The sensor (VS 150M, Vallen Systeme, Icking, Germany) was fixed to the surface of the dynamometer by means of a MAG4M magnetic holder-designed for that sensor. Silicone grease was used between the sensor and the surface as a coupling fluid. An overall view of the laboratory stand is shown in Figure 4.

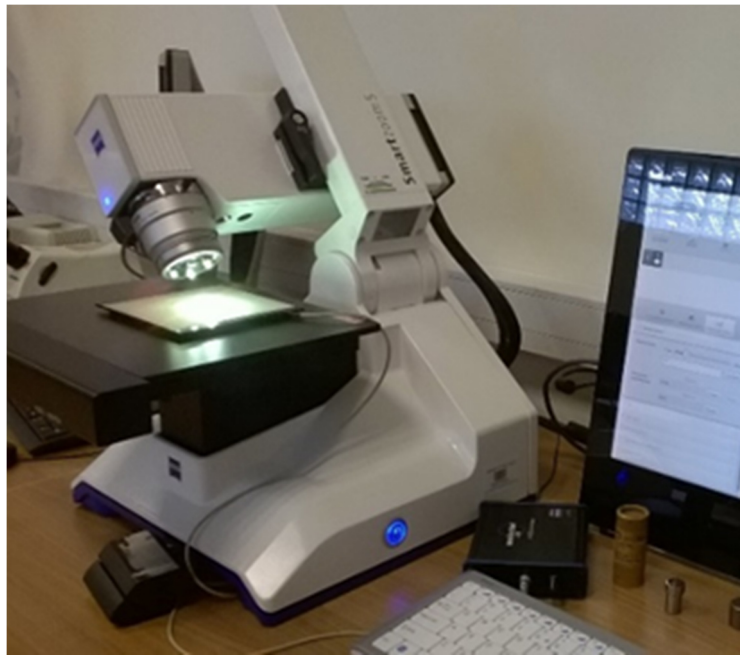
**Figure 5.** Measuring microscope used for observing wear degree of cutting insert.

The nose of cutting tool before and after every research stage was observed by digital measuring microscopy (Smartzoom 5, Zeiss, Oberkochen, Germany) Zeiss shown in Figure 5.

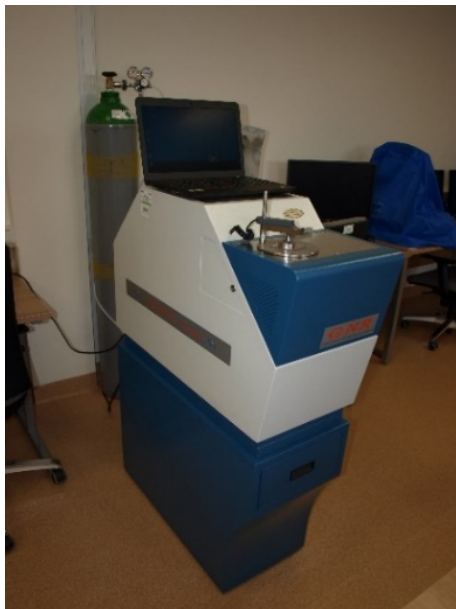
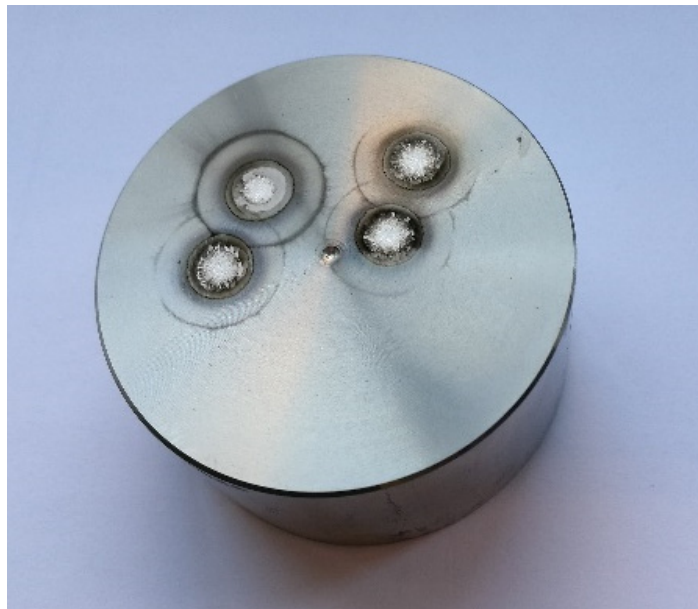
**Figure 6.** An optical spectrometer used for chemical composition test (a) and the view of the sample after four spark test (b).

The chemical composition of the shaft material was analysed. It was carried out by an optical emission spectrometer (Solaris-ccd plus, GNR, Novara, Italy) with spark excitation, shown in Figure 6a. The view of the sample after four spark tests is presented in Figure 6b.

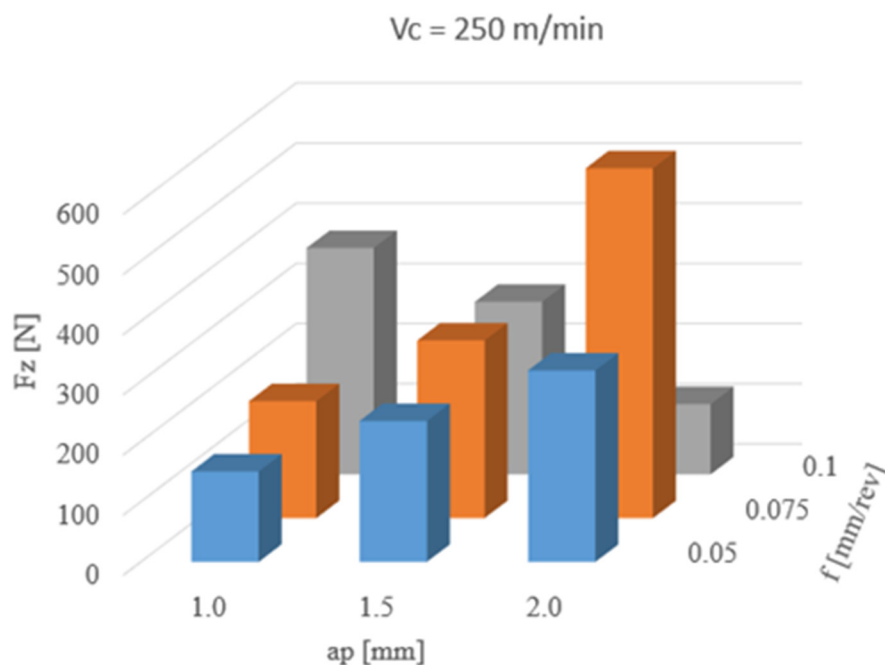
**Figure 7.** The results of changing cutting parameters on Fz.

The results of the influence of cutting parameters on the measurement of Fz force are shown in Figure 7. The highest Fz mean value (582 N) was obtained for the following parameters: a cutting depth 2.0 mm and feed 0.075 mm/rev. For feeds of 0.05 and 0.075 mm/rev and an increase of depth of cut in all ranges, the Fz force increases too. For feed 0.1, while ap increases, the Fz force decreases.

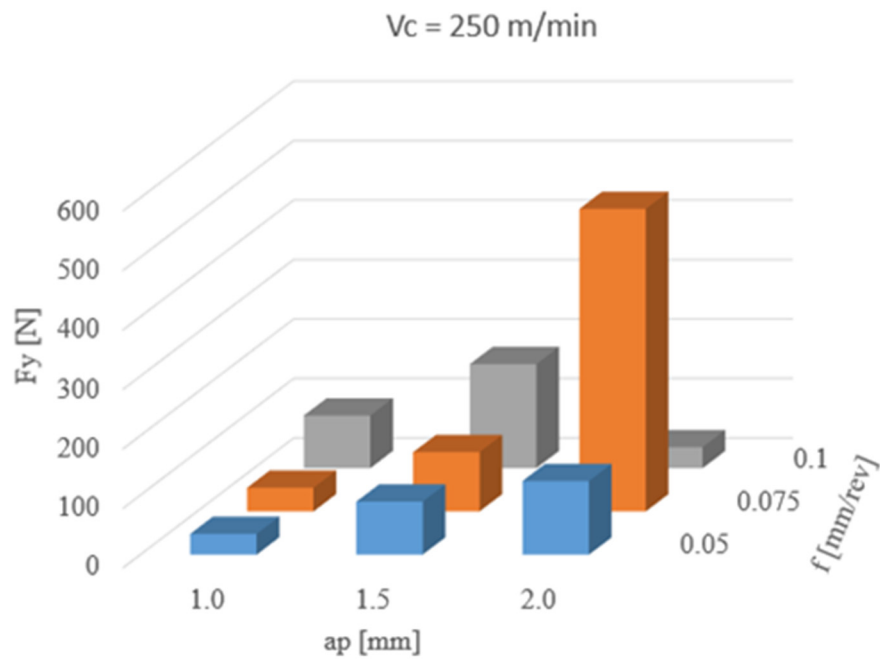
Figure 8. The results of changing cutting parameters on  $F_y$ .

Figure 8 presents the effect of changing such parameters as: ap and f on the feed force Fy. The highest Fy mean value (509 N) was observed for: a cutting depth of 2.0 mm and feed of 0.075 mm/rev. For other depths of cut, the mean values of feed force did not exceed 180 N. A significant increase of feed force testifies to an abrupt change of cutting conditions during the analyzed process.

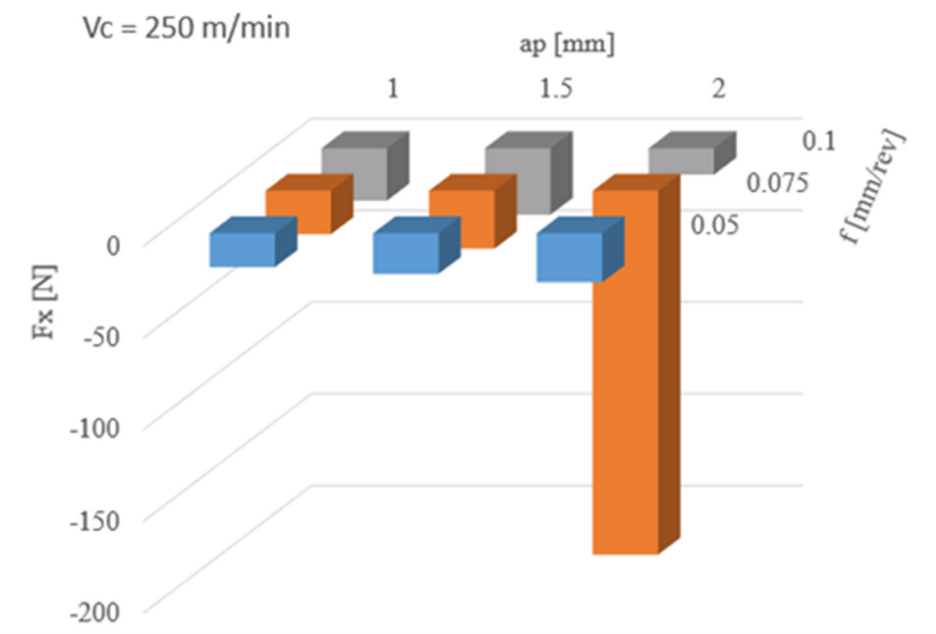
Figure 9. The results of changing cutting parameters on  $F_x$ .

Figure 9 shows the results of the influence of cutting parameter changes on the measurement of  $F_x$  force. The mean value of that force does not exceed  $-36$  N for depth of cut in the range of 1.0–2.0 mm. The highest  $F_x$  mean value ( $-198$  N) was obtained for: a cutting depth 2 mm and feed 0.075 mm/rev. A significant increase of radial force indicates a change in geometry of the cutting insert, and thus its damage or wear. This was confirmed during microscopic examination of the tool's treating zone.

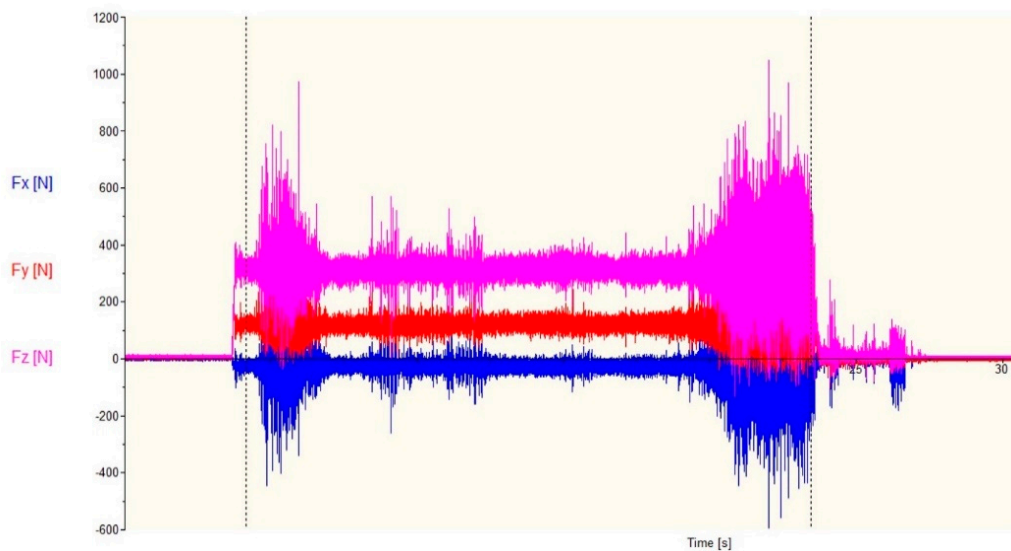
**Figure 11.** Cutting forces during turning with parameters:  $a_p = 2.0$  mm,  $f = 0.05$  mm/rev.

The analysis of forces during the turning process showed that, at the beginning of the cutting edge, the damage process can be observed for machining with cutting parameters  $a_p = 2.0$  mm and  $f = 0.05$  mm/rev (Figure 11). Increasing the feed to 0.075 mm/rev caused damage of the cutting insert nose, in the form of a loss of part of the cutting edge, which affected the change of conditions during the cutting process. Cutting forces registered during the study were shown in Figure 12, while relatively large standard deviation obtained confirm the unstable cutting process. Increasing the feed value with a damaged cutting insert allowed to obtain a fivefold lower value of the  $F_z$  force and a significant reduction of the radial and feed force.

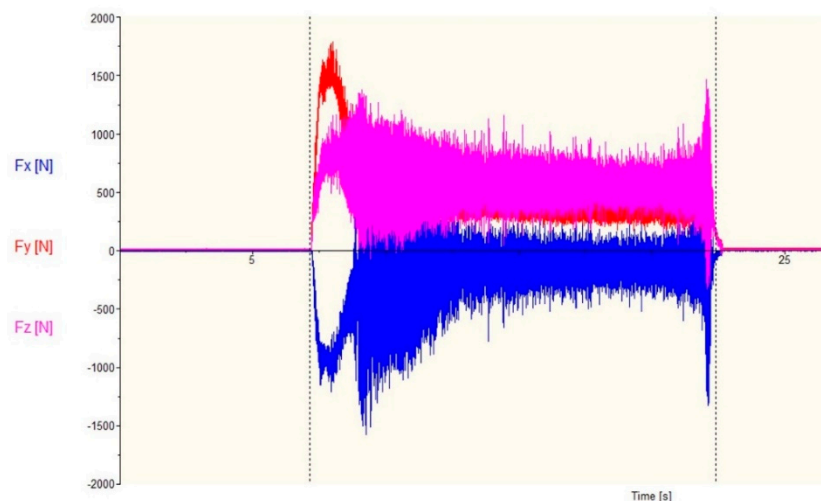
**Figure 12.** Cutting forces during turning with parameters:  $a_p = 2.0$  mm,  $f = 0.075$  mm/rev.

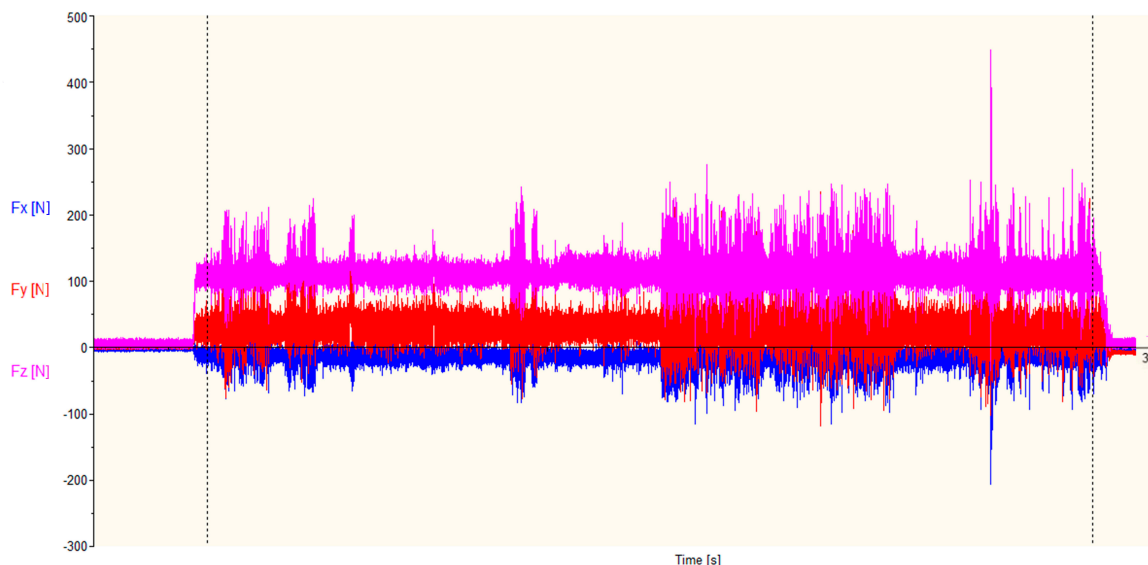
**Figure 13.** Cutting forces during turning with parameters:  $a_p = 2.0$  mm,  $f = 0.10$  mm/rev.

A further cutting process was performed with a cutting depth of 2.0 mm and a feed rate of 0.10 mm/rev, and despite the damage to the cutting insert, the analysed forces did not reach such significant values (Figure 13).

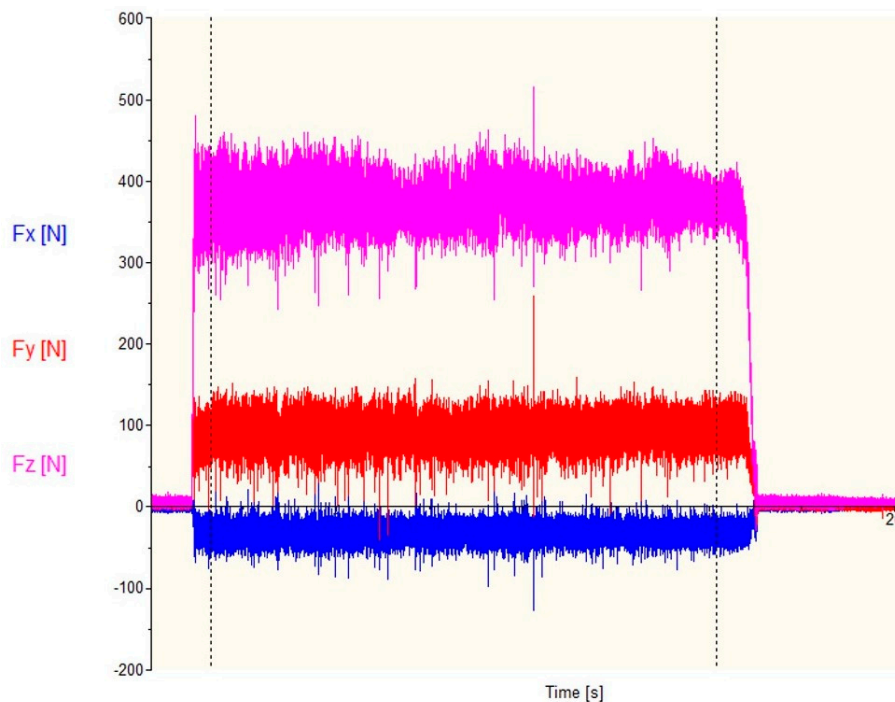
**Figure 14.** Cutting forces during turning by tool with new cutting insert with parameters:  $a_p = 2$  mm,  $f = 0.1$  mm/rev.

An example of a graph recorded during the study, showing the change of cutting forces over time, is shown in Figure 14. The graph shows cutting forces during turning by a tool with a new cutting insert.

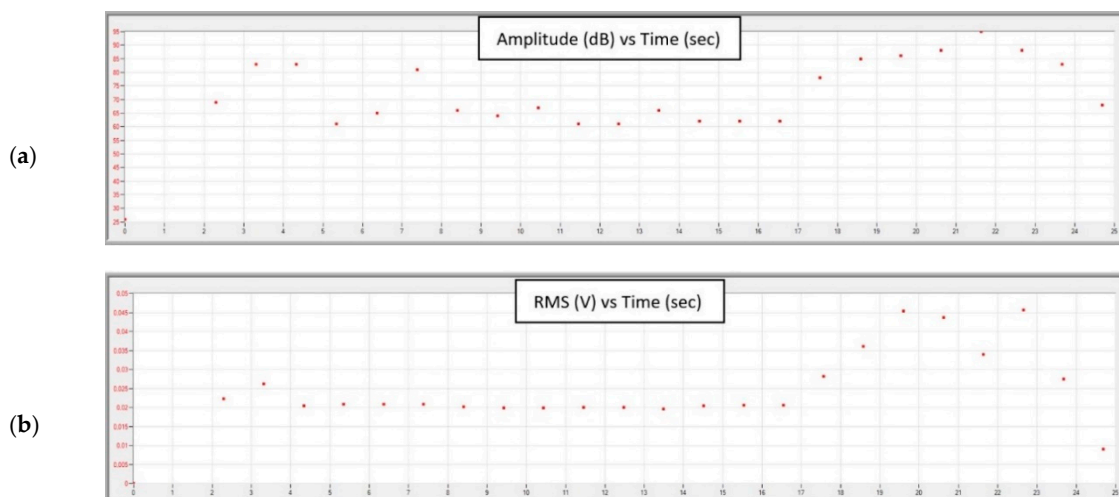
**Figure 15.** Charts of (a) amplitude and (b) RMS changing as a function of time during turning with parameters:  $a_p = 2.0$  mm,  $f = 0.05$  mm/rev.

In the final stage of turning with the parameters  $a_p = 2.0$  mm,  $f = 0.05$  mm/rev, an increase in the amplitude and RMS of the recorded signal is noticeable. The RMS signal rises sharply to  $50 \mu\text{V}$ ; about twice as high compared to turning with a sharp cutting edge. Relatively low frequency of the signal and the increase of its amplitude (Figure 16) indicates a significant increase in its energy. This sudden increase in the energy of the generated AE signal may indicate the beginning of the destruction process of the cutting insert.

An analysis of data recorded during the tests showed that it is possible to observe the beginning of a destruction of the nose of the cutting insert using the acoustic emission method. Figures 15 and 16 show a sudden increase in the amplitude and RMS of the signal in the final stage of turning with the parameters  $a_p = 2$  mm,  $f = 0.05$  mm/rev. The tool failure process was continued while turning with the same insert with the parameters  $a_p = 2$  mm,  $f = 0.75$  mm/rev. A signal with an average RMS value of about 70% higher than in the case of turning with previous parameters was recorded. Increasing the feed to  $f = 0.1$  mm/rev at the same  $a_p = 2$  mm caused an increase in the RMS signal, with mean values being characterized by a large spread, as evidenced by a relatively large standard deviation.

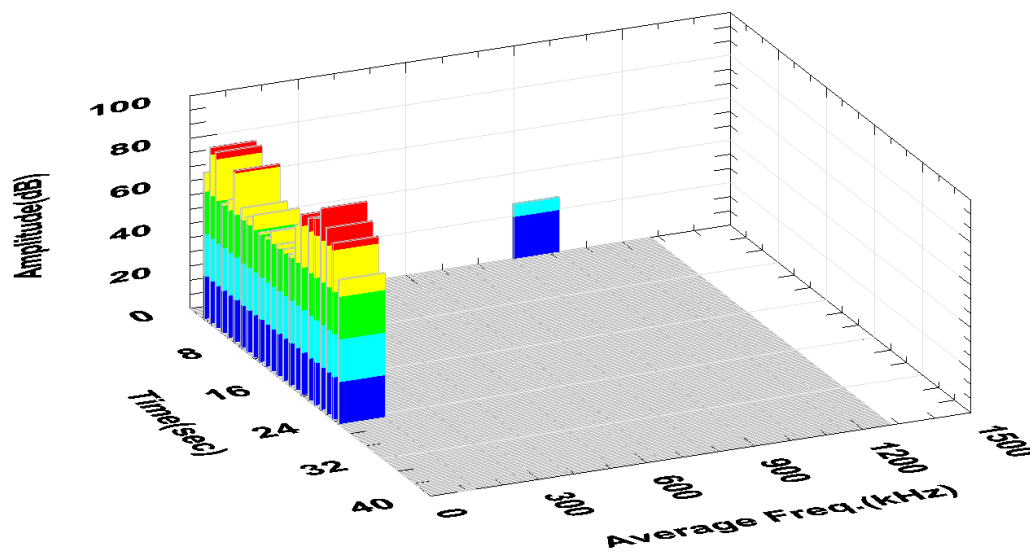
**Figure 16.** Chart of amplitude and average frequency changing as a function of time, during turning with parameters:  $a_p = 2.0$  mm,  $f = 0.05$  mm/rev. Different colours help to observe changes in amplitude-every 20 dB.

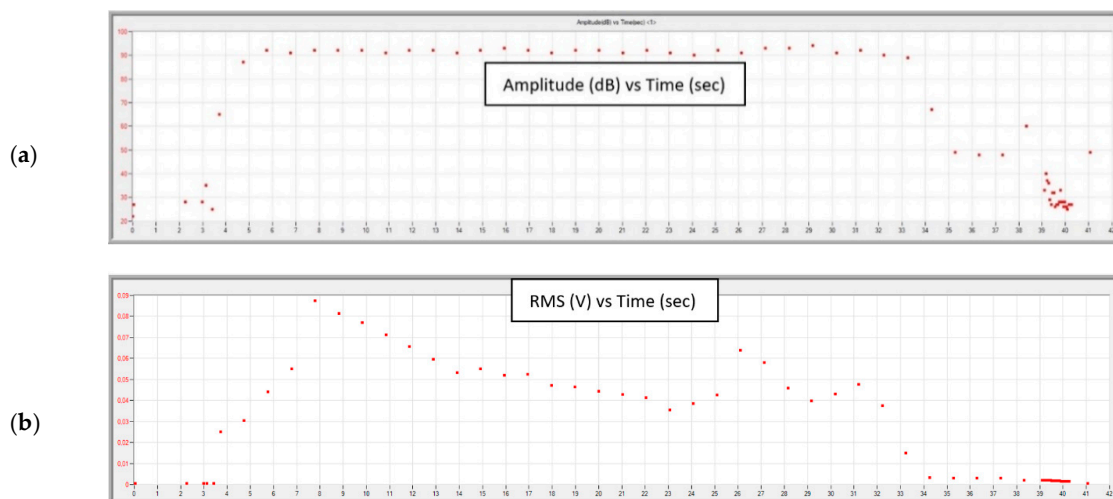
**Figure 17.** Charts of (a) amplitude and (b) RMS changing as a function of time during turning with parameters:  $a_p = 2.0$  mm,  $f = 0.075$  mm/rev.

Figures 17 and 18 show waveforms of signals recorded during turning with a cutting insert has a significant degree of wear. High RMS values (about  $40\text{--}50 \mu\text{V}$ ) of the signal indicate further damage of the insert. It is particularly visible in the initial turning phase with the parameters  $a_p = 2.0$  mm,  $f = 0.1$  mm/rev where the signal RMS was recorded to be about five times higher than the undamaged insert; the maximum value was  $111 \mu\text{V}$ . While the turning was performed in a good condition, this parameter was, on average, around  $20 \mu\text{V}$ .

A high RMS value and signal amplitude suggest further destruction of the tool. This is particularly evident in Figure 17 in the initial and final turning phases. Despite the significant damage of the nose of the cutting insert, the lathing process was stable. The relatively stable course of the process is evidenced by the decrease in the number of hits of recorded signal.

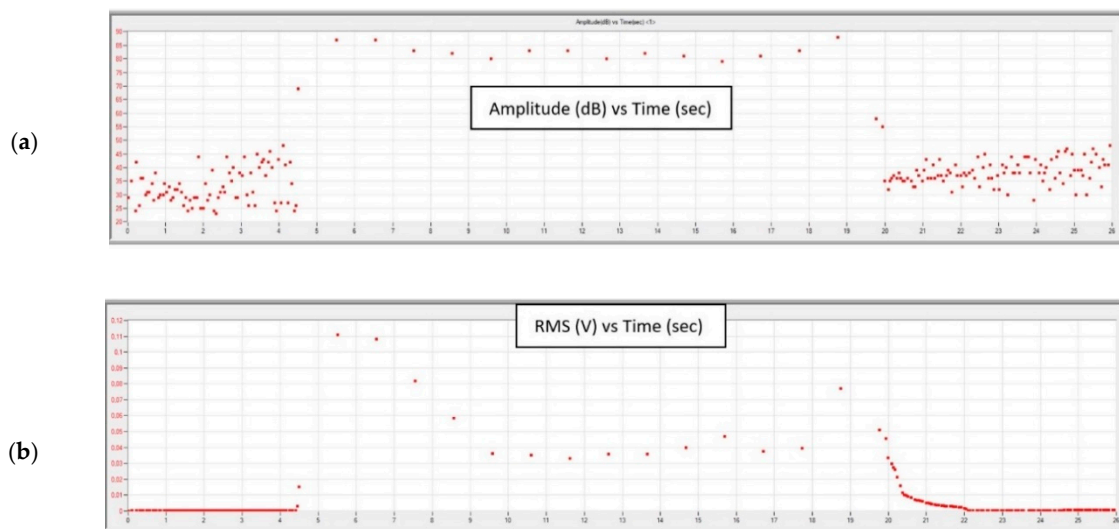
**Figure 18.** Charts of (a) amplitude and (b) RMS changing as a function of time during turning with parameters:  $a_p = 2.0$  mm,  $f = 0.1$  mm/rev.
