## Case Report

# Traumatic periimplant fracture after nail arthrodesis of the knee in a limb reconstruction case<sup>☆</sup>

Lukas Zak, Thomas M. Tiefenboeck, Gerald E. Wozasek\*

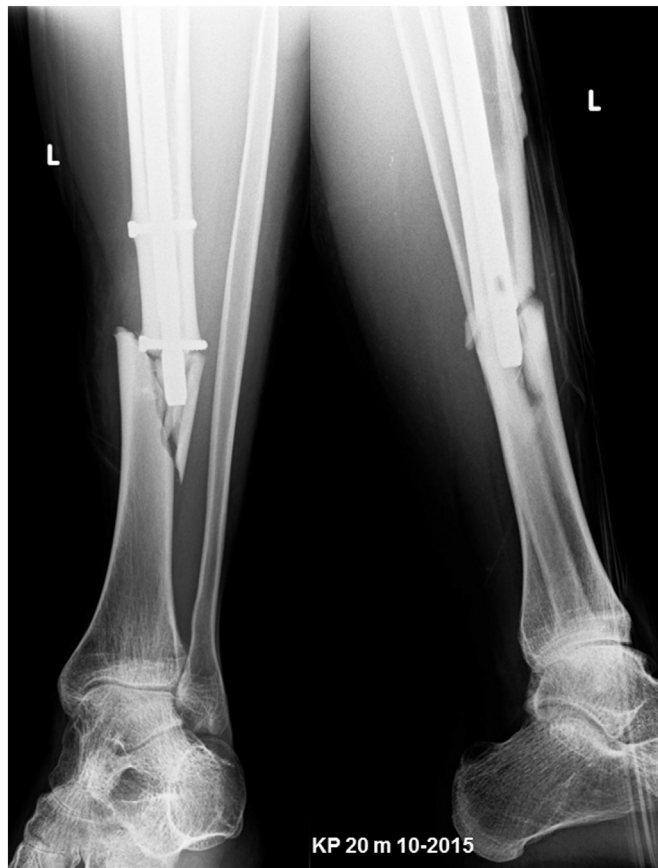
**Fig. 1.** Radiological findings after the second MVA suffering from a tibial fracture below the arthrodesis nail (a.p. and lateral).

below the arthrodesis nail. Initial radiographs showed 1 cm (0.4 in.) of axial impaction (Fig. 1), a fibular fracture at a higher level and a fracture line combined with nail-bending at the level of the tibial bone regenerate.

Preoperative conventional radiographs showed malalignment of about 10° varus, dislocation of half shaft and impaction of about 1 cm/0.4 in. which could not be corrected preoperatively and had to be immobilized in the cast until definite surgery. This influenced the nailing procedure as removal of the distal bolt was difficult.

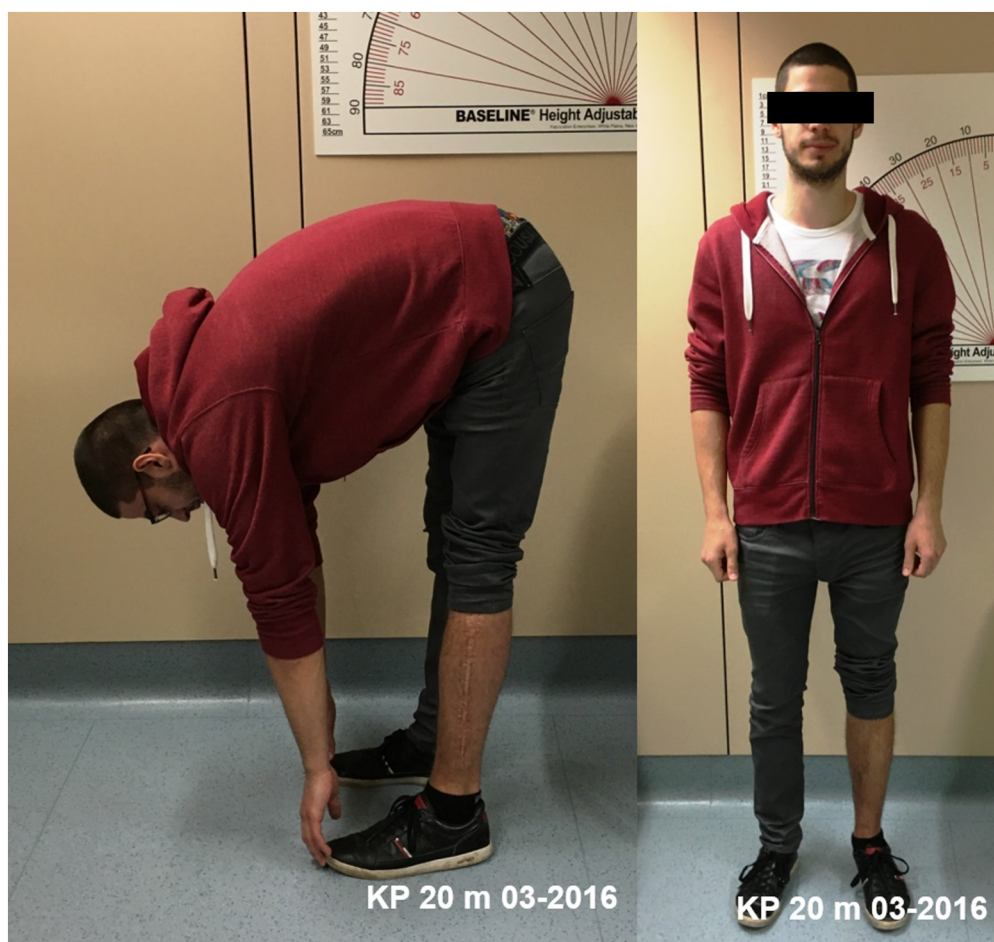
Fig. 2. Clinical findings 5 months after the periimplant fracture shows good functional result.

bearing. Equal external rotation was evident. (Figs. 2–4).

There was no hitting or stumbling of the foot and no obvious pelvic skew. Hip rotation resulted in 60° external- and 20° internal rotation. Finally the ROM in the ankle joint was 40° plantarflexion and 5° dorsiflexion. Radiologically all fractures showed significant callus formation. Clinically the same limb length was achieved as before the periimplant fracture. (Fig. 2).

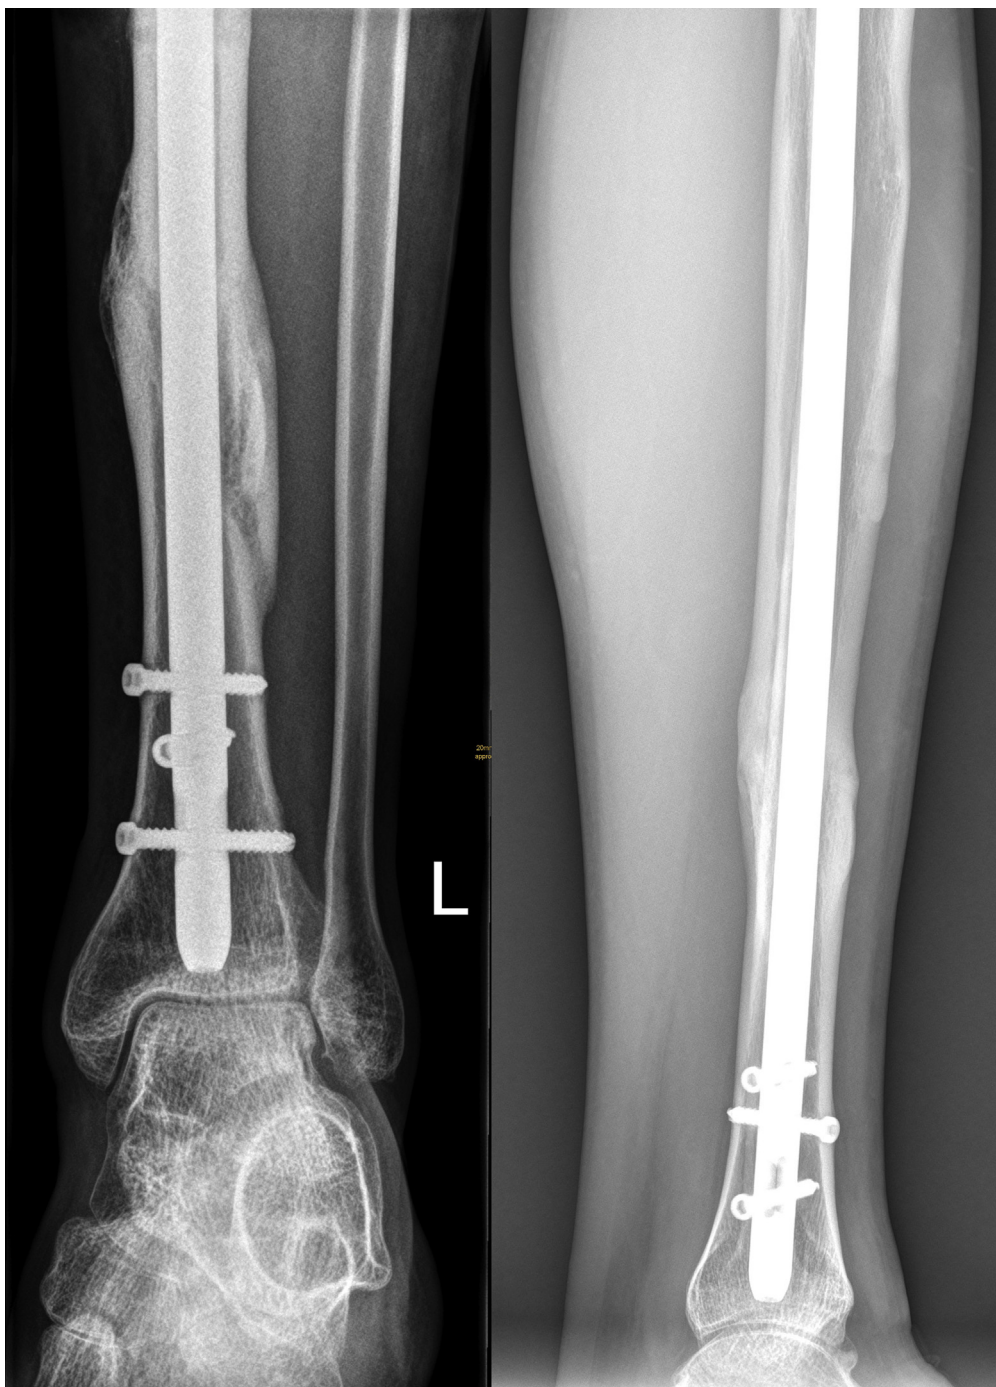
**Fig. 4.** Radiological findings 9 months after periimplant fracture and 7 months after the last surgery with solid callus formation and intact locking bolts (a.p. and lateral view).
