Application of Innovative Ropes from Textile Waste as an Anti-Erosion Measure [†]

Abstract: Using materials from recycling is a key part of decreasing present-day waste. It is optimal for recycled material to be used in environmental protection. This paper presents the application of geotextile ropes in erosion protection of a slope of a gravel pit. To protect the slope, thick ropes with a diameter of 120 mm made from wool and a mixture of recycled natural and synthetic fibers were used. After 47 months from installation, soil and rope specimens were taken from the slope parts with inclinations 1:1 and 1:1.8, and their physical and mechanical properties were determined. Direct shear tests were applied to determine the soil shear strength parameters in state at sampling and at $I_c = 0$ (unconsolidated and consolidated). Based on the obtained soil shear strength parameters, the loads on the ropes were determined, taking into account also unfavorable hydraulic conditions and compared to rope strength. It was shown that even after 47 months from installation, rope tension strength was higher as tension forces were induced in the ropes in every case. At present, whole slopes in protec

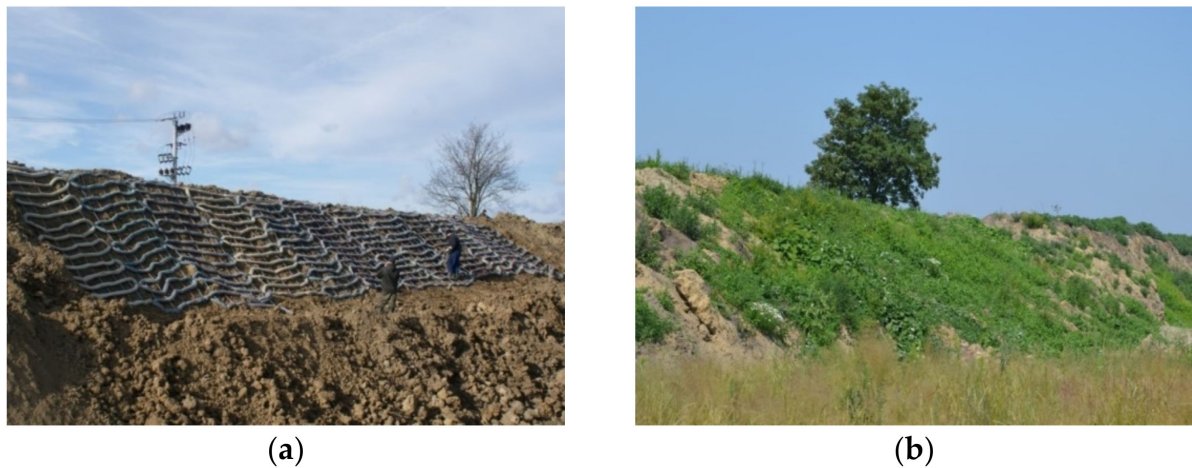
Figure 1. The effectiveness of geotextile ropes as an anti-erosion measure: (a) Slope state on 9 February 2016; (b) slope state on 23 June 2016 [17].

The ropes were meandrically arranged to form segments with widths of 1.8 m and lengths of 6 m. In order to stabilize the segments, the subsequent turns of the ropes were connected with additional links made from thick polypropylene twine. Geotextile ropes were used to secure a total area of approximately 150 m^2 in the most threatened part of the slope. The protected slope had a length of 4–6 m and an inclination from 1:1 to 1:1.8. The ropes were anchored in the crown of the slope and fastened at the surface with steel pins. Long “U-shaped” pins made from ribbed bars of diameters $\phi = 8$ mm were used. To protect a bigger section of the slope, the subsequent segments of ropes were spread alongside one another. The slope with installed ropes can be seen in the Figure 1a. The effectiveness of installed ropes can be seen in Figure 1b. As we can see in Figure 1a, there is much vegetation, and no signs of erosion exist in the protected slope part [17].

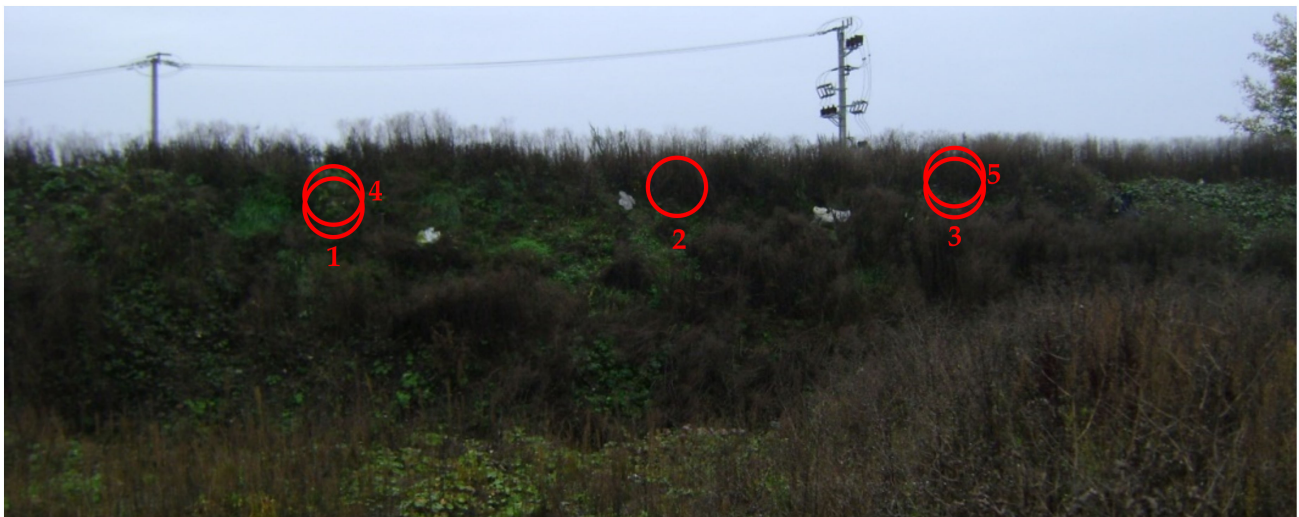
Figure 2. General view of the protected slope in Nieboczowy (numbers mark soil sample locations and state of slope on 22 October 2017; locations 4 and 5 were added on 18 January 2020).

After 20 months after the rope installation, visitation of the protected location took place on 22 October 2017, during which six soil samples were taken from three locations of the protected slope for further analyses. A general view of the protected slope can be seen in Figure 2. Numbers 1, 2, and 3 in Figure 2 mark the soil sample locations, which were chosen from the left, central, and right parts of the slope (horizontally) and in the central part (vertically). Generally, the slope is well protected and covered with rich plants [17]. After 47 months following the rope installation, a second visitation of the protected location took place on 18 January 2020 (47 months after rope installation), during which two soil samples were taken from two locations of the protected slope for further analyses. These locations are marked by the numbers 4 (0.5 m above location 1) and 5 (0.5 m above location 3) in Figure 2. A closer view of location 4 is provided in Figure 3.

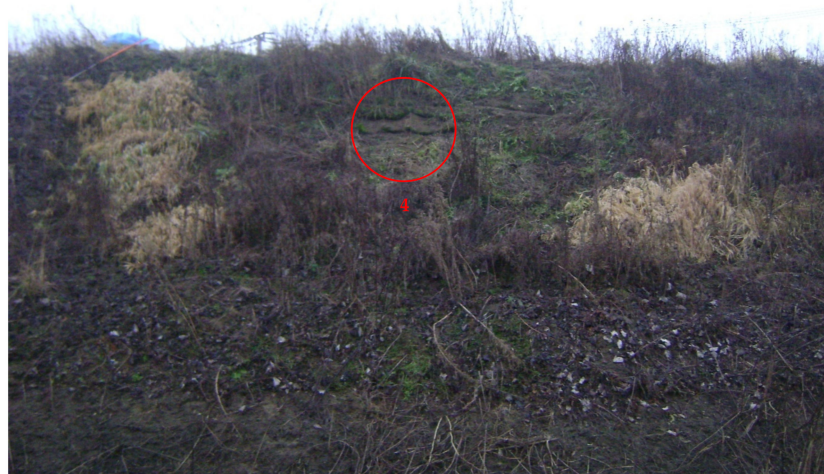
Figure 3. Closer view of location 4 of the protected slope in Nieboczowy (state of slope on 18 January 2020). In the circle: exposed recycled natural and synthetic fibers (RNSF ropes); to the right of the circle: wool rope.

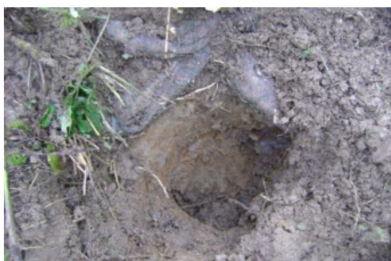
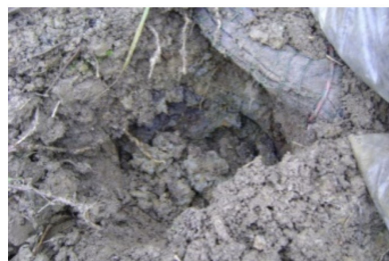
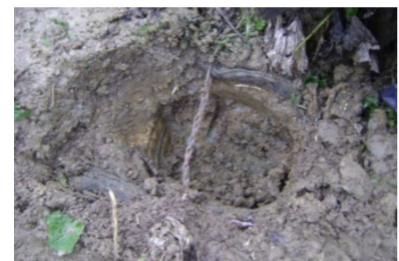
Figure 4. Sampling on 22 October 2017. Detail of the soil sample locations: (a) Location 1; (b) location 2; (c) location 3 [17].

Details of the soil sample locations 1, 2, and 3 with the installed ropes can be seen in Figure 4. It is obvious that the upper soil layer of a thickness of approximately 20 cm (cover layer) seems different to the lower layer. From this reason, two soil samples from every location were taken and analyzed. The specimens were marked based on location (numbers 1, 2, or 3 and letters “a” for the upper layer and “b” for the lower layer); for example, the specimen marked as “1a” was taken from location 1 from the upper layer [17].

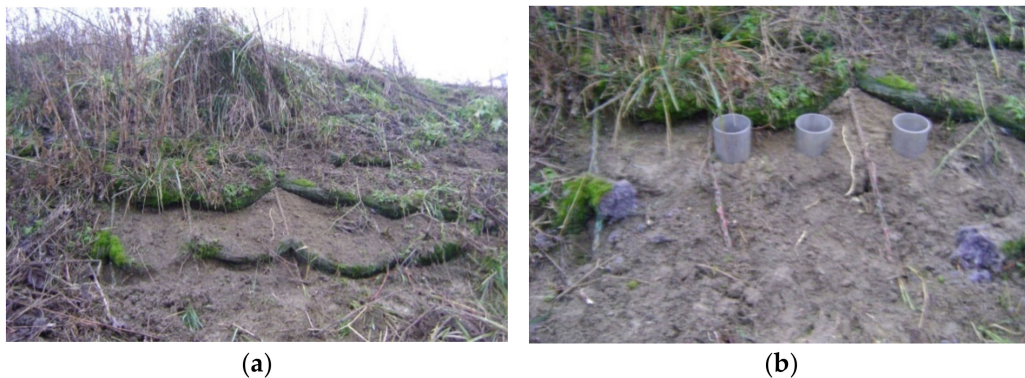
Figure 5. Sampling on 18 January 2020 at location 4. (a) The lower rope with three sections (left section, LS; center section, CS; right section, RS). (b) The sample cylinders and the cut-off rope for the rope tension strength determination and scanning electron microscopy (SEM).

In order to determine the more precise soil load on the ropes for comparison to the rope tension strength, unlike the previous sampling, soil specimens from the upper layer in locations 4 and 5 were taken as undisturbed. Sampling (soil and rope) at location 4 on 18 January 2020 can be seen in Figure 5. The ropes at location 5 were completely buried in the soil, similarly to locations 1, 2, and 3.

Approximately 27 months later (on 18 January 2020), the grain size distribution diagrams changed. At critical location 4 (approximately 0.5 m from location 1; see Figure 5), where the slope had a general inclination of 1:1 with a step caused by exposed rope; the change was significant, the soil now being classified as CS (sandy clay) with a decreased amount of clayey and silty fraction and an increased amount of sandy and gravelly fraction (compare the thin and thick red dashed lines in Figure 9 and the data for samples 1a and

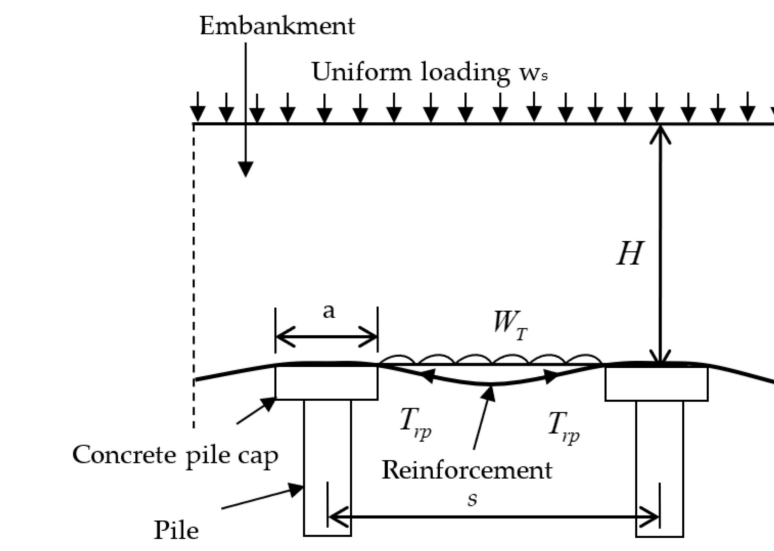
Figure 6. Parameters used in the calculation of T_{rp} [26].

In Figure 6 [26] are the parameters used in the calculation of the tension force T_{rp} per run meter, generated in reinforcement from vertical loading. For extensible reinforcement, the tension force T_{rp} per run meter, generated in reinforcement from vertical loading W_T , is:

where (see Figure 6) T_{rp} is the tension force in the reinforcement (kN), W_T is the vertical loading acting on the reinforcement between two adjacent piles caps (kN), s is the distance between the adjacent pile (m) (in our case, the distance between links made from thick polypropylene twine; values of s were obtained by measurement), a is the size of the pile cap (m) (in our case, we propose 0.05 cm), and ε is the strain in the reinforcement (-), which were calculated based on the real rope length and distances s .

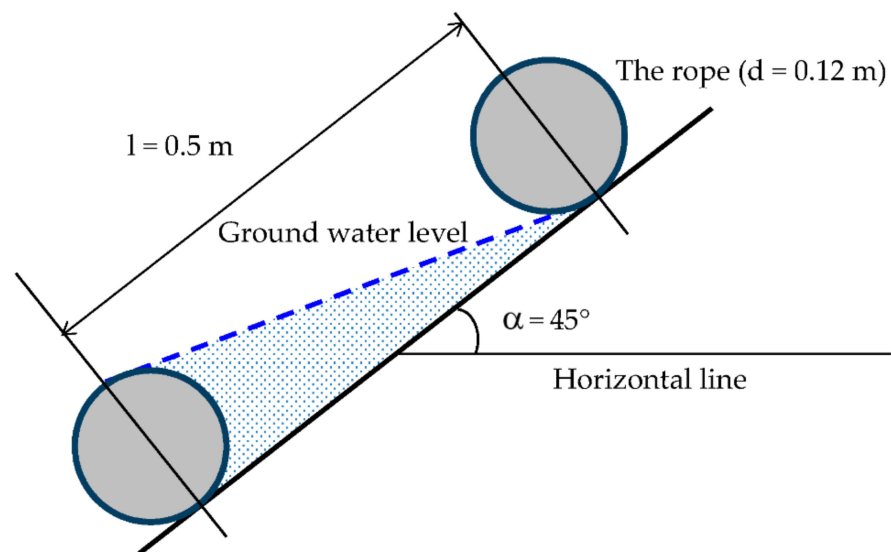
Figure 7. Schema for the calculation of the load acting on the rope at location 4.

The load W_T acting on the rope at location 4 was calculated as the difference between active force (the tangent component of the soil weight, the force from flowing water, and the soil pressure at rest) and passive force (friction and cohesion force on slide surface) using well-known formulas in geotechnical engineering (see Figure 7).

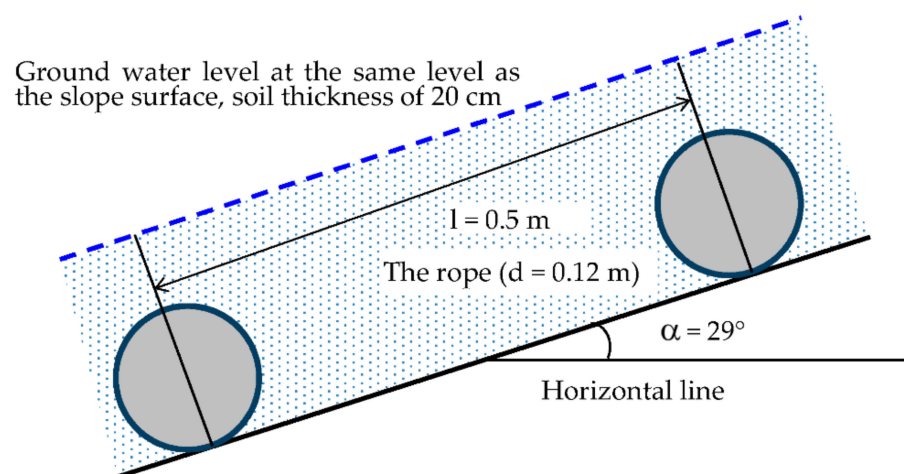
Figure 8. Schema for calculation of load acting on rope at location No. 5 (ropes are buried in soil).

The load W_T acting on rope at location 5 was calculated as the difference between the active force: The tangent component of the soil weight, the force from flowing water, and the passive force (friction and cohesion force on slide surface) using well-known formulas in geotechnical engineering (see Figure 8).

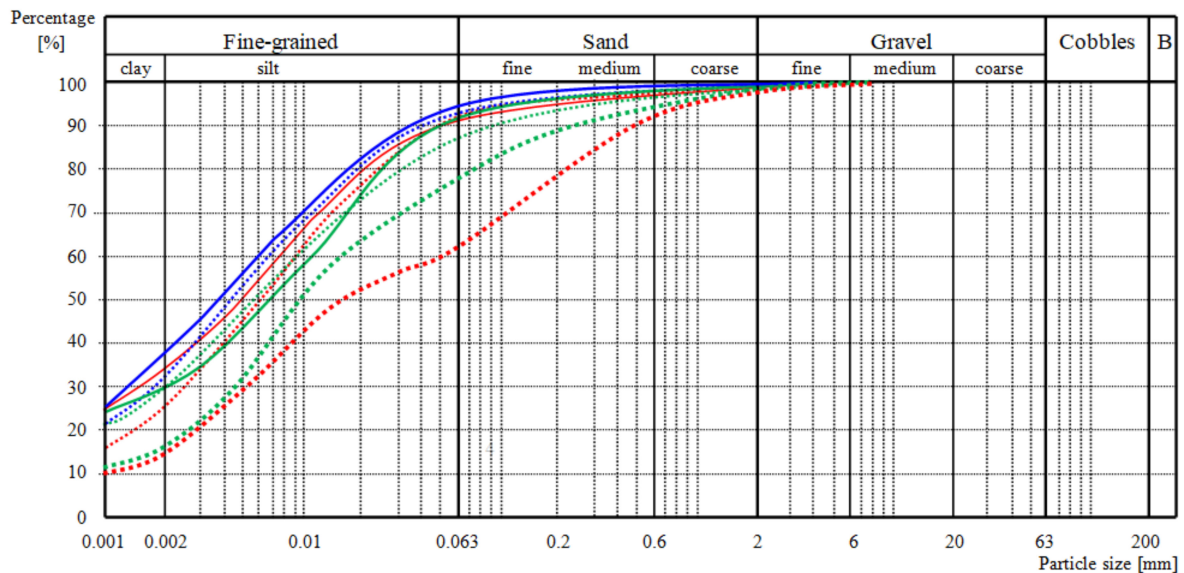
Figure 9. Grain size distribution diagram of the soils. Upper six curves (six samples taken on 22 October 2017): Thin red dashed line and solid line: Location 1, top and down sample; thin blue dashed line and solid line: Location 2, top and down sample; thin green dashed line and solid line: Location 3, top and down sample [17]. Lower two curves (two samples taken on 18 January 2020): The lowest thick red dashed line: Location 4, top sample, approximately 0.5 m from location 1; the lowest thick green dashed line: Location 5, top sample, approximately 0.5 m from location 3).

Grain size distribution diagrams of the soils in the protected section can be seen in Figure 9. The soil classifications and properties are given in Table 1. The grain size distribution diagram of the soils taken from three places on 22 October 2017 are close to one another and the classifications of the soils are very similar (CH—clay of high plasticity and CI—clay of intermediate plasticity—even the distance between locations 1 and 3 was approximately 14.5 m. Only sample number 3b (location 3, lower layer) was classified as CI. However, its liquid limit ($w_L = 48.9\%$) was very close to 50%, which is the limit value between CI and CH (see Table 1). For this reason, we can also propose that soils at locations 4 and 5, which were located only approximately 0.5 m above locations 1 and 3, can be classified as soils at locations 1 and 3. The large amount of silty fraction in the soils (from

4a in Table 1). There was also a change in the grain size distribution diagram of the soil from location 5, but it was not so significant (compare the thin and thick green dashed lines in Figure 9 and the data for samples 3a and 5a in Table 1). The amount of clayey fraction also decreased and the amount of sandy and gravelly fraction also increased as in the first case, but in this case, the amount of silty fraction did not decrease, but rather increased a little). We propose that the smaller change in comparison to the first case (soils at locations 1 and 4) was caused by the smaller slope inclination (1:1.8) without a step; furthermore, the rope was buried in the soil (no step caused by exposed rope). The change in grain size distribution and likely also further factors, such as alternate freezing and thawing and vegetation, also caused changes in W_L and W_p (compare data in Table 1) and the soil mechanical properties.

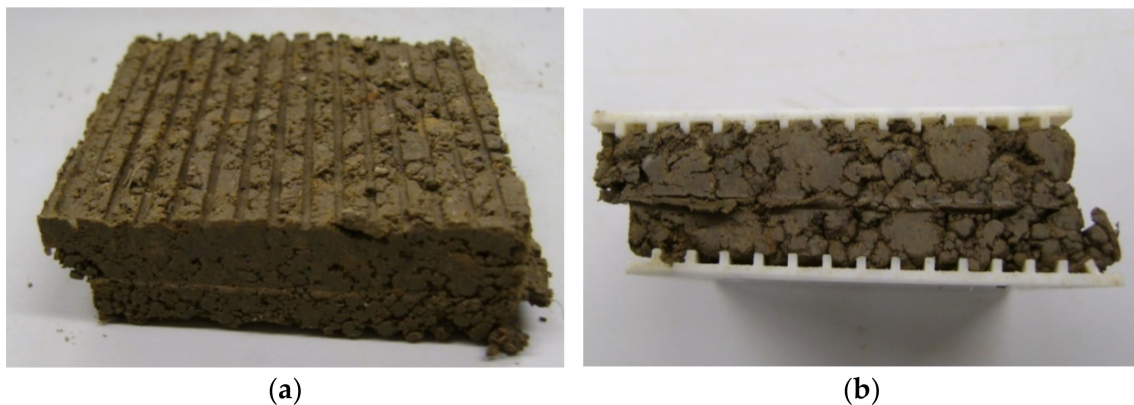
Figure 10. Soil samples after shearing (state of sampling day). (a) Sample from location 4, after shearing at a normal stress of 100 kPa; (b) sample from location 5, after shearing at a normal stress of 50 kPa.

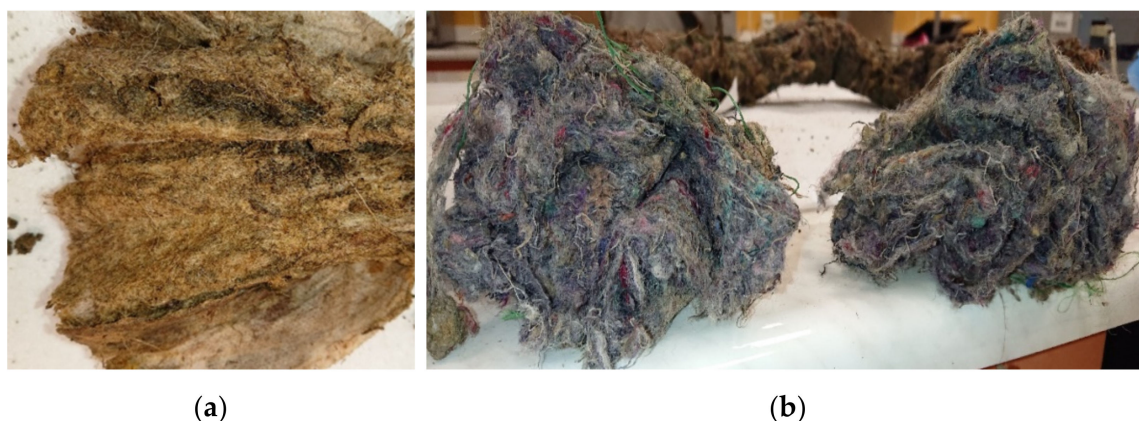
Figure 11. View of the ropes 47 months after installation. (a) Wool rope; (b) recycled natural and synthetic fiber (RNSF) ropes (left: From location 4; right: From location 5).

Figure 11 presents ropes after 47 months from installation. For ropes manufactured from wool, the symptoms of advanced biological damage are clearly visible. The observed changes of the natural original wool color into yellow and brown stains are the result of a far-reaching wool keratin biodegradation. In contrast to wool, for the RNSF ropes no visible signs are observed. For both parts of the ropes (outer and inner layer) the color of the nonwoven is unchanged and no other changes are visible.

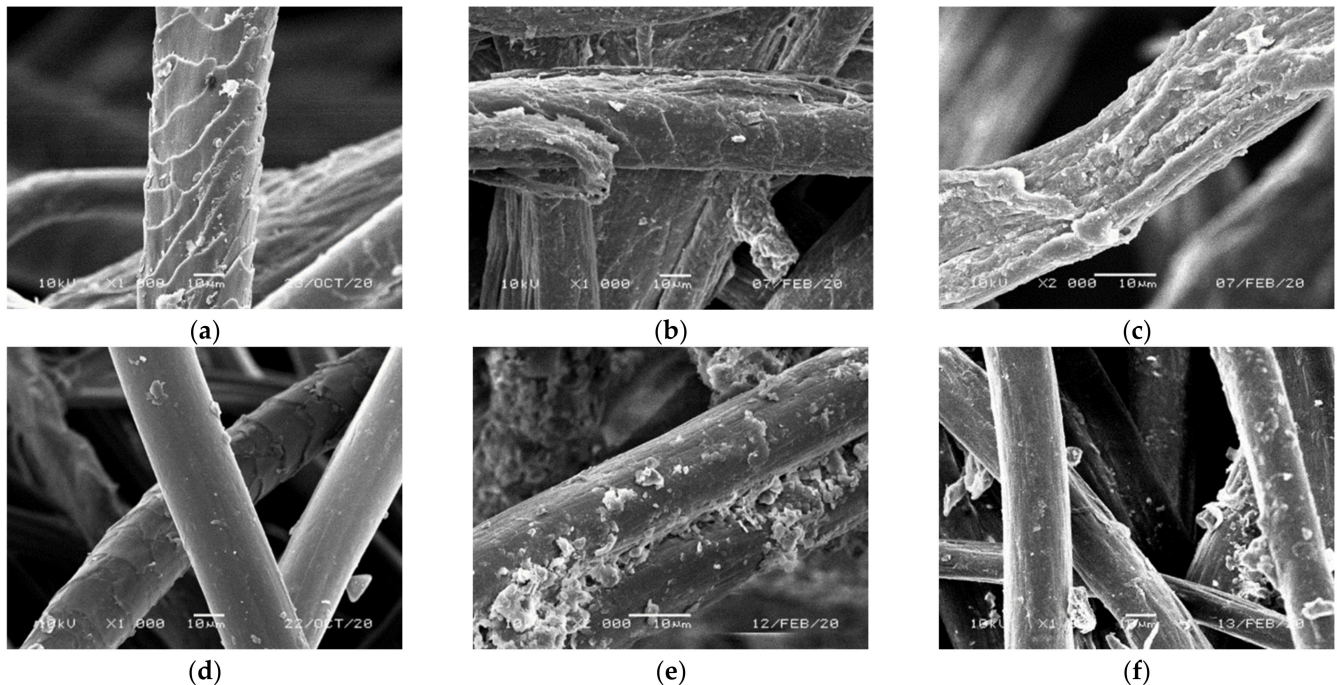
Figure 12. Changes in the morphology of the fibers of the rope depending on the material type. (a) Original wool fiber; (b) wool fiber from the wool rope surface 47 months after installation; (c) wool fiber from the wool rope core 47 months after installation; (d) original recycled natural and synthetic fibers; (e) recycled natural and synthetic fiber from the RNSF rope surface 47 months after installation; (f) recycled natural and synthetic fiber from the RNSF rope core 47 months after installation.

On the SEM images of wool (Figure 12a–c), biodegradation occurring during the exploitation of ropes is confirmed. In the initial step of the process, cuticle cells, forming on

the fiber surface characteristic scales, are firstly destroyed (Figure 12a,b). After 47 months of placement in soil, the cuticle cells are completely destroyed and further biodegradation causes the gradual destruction of the deeper placed cortical cells. The destruction leads to fibrils separation, which is followed by the disintegration of the fiber structure (Figure 12c).

For RNSF ropes taken 47 months after installation on the slope no significant signs of biodegradation are observed on the SEM images (Figure 12d–f). For fibers taken from the cover layer of the ropes, significant amount of soil particles attached to the fiber surface is visible (Figure 12e). In addition, slight mechanical damage of the fiber surface resulting from a movement of soil particles is observed. Similarly, on the fibers taken from rope core, some subtle changes of the mechanical origin are noticeable (Figure 12f).
