# Influence of a Lighting Column in the Working Width of a W-Beam Barrier on TB51 Crash Test

**Abstract:** Road equipment, such as, e.g., road safety barriers and lighting columns, are subject to certification according to the EN1317 standard to be allowed for use on European roads. In engineering practice, due to the terrain conditions, there are cases where other road equipment is installed within the working width of road safety barriers. Such situations are not considered during the certification process. Hence, the aim of this study is to analyze the effect of a lighting column installed within the working width of the barrier on the results of the TB51 crash test. The full-scale crash test and numerical simulation of this event were conducted. In the full-scale crash test, as well as in the simulation, the lighting column prevented the barrier's post from properly disconnecting from the guardrail, which resulted in the barrier failing to restrain and redirect the 13-t bus. The simulation was quantitatively compared to the experiment, where the correlation coefficient of ASI curves equaled 84%. The THIV curves differed significantly between the experiment and the simulation,

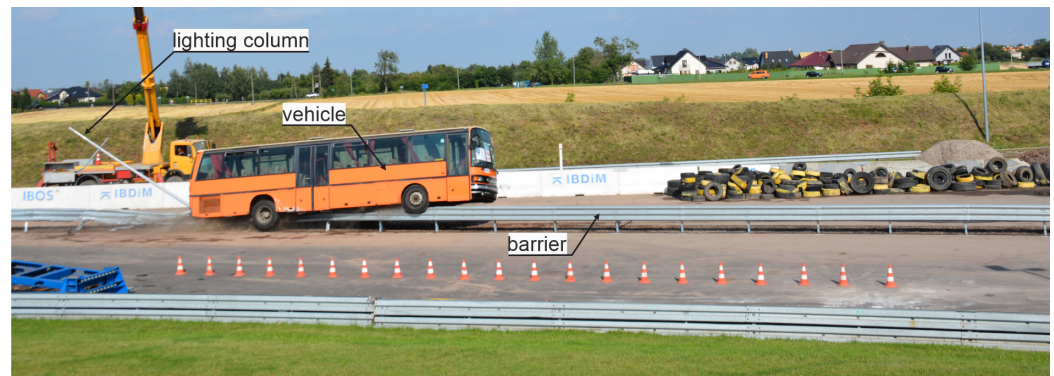
**Figure 1.** Exemplary view of the bus during the analyzed crash test.

This study analyzes the effect of the installation of a lighting column in the working width of a W-beam RSB on the results of the TB51 crash test, as in Figure 1. This research is important as it will shed light onto the mechanisms and interactions that occur in the barrier–column–vehicle system during an accident. This will allow the verification of whether two road safety devices that are safe separately will also work together to achieve an appropriate level of safety. The TB51 crash test was selected as it involves a 13-tonne bus, which can inflict serious damage to the barrier during the impact. Moreover, this particular impact can have extremely tragic consequences, as there may be many fatalities and seriously injured persons. The W-beam barrier was chosen as it is one of the most frequently used types of barriers on roads in the EU. That barrier successfully passed full-scale crash tests according to EN 1317 [14]; hence, it has appropriate certificates for use on European roads. Similarly, the lighting column was positively tested in accordance with the EN 12767 standard [32]. However, the tests for both systems were conducted separately. Hence, the research aimed to evaluate the safety of the combination of those two road safety systems: the W-beam barrier and the lighting column. The other objectives of this study were as follows:

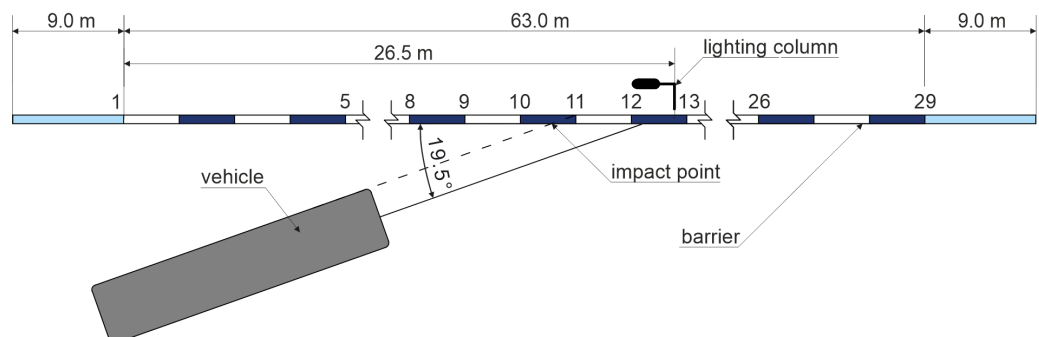
**Figure 2.** Scheme of the test setup.

The full-scale crash test was conducted on 10 August 2017 at the testing grounds of the Research Institute for Protective Systems (IBOS) [33]. The experiment was carried out by the Research Institute for Roads and Bridges (IBDiM) [34]. This institute is certified by the Polish Center for Accreditation to, among others, perform crash tests according to the EN1317 standard [14]. The setup of the test is presented in Figure 2. The total length of the system was 81 m, where there was 63 m of straight section and 9 m at each end of the barrier.

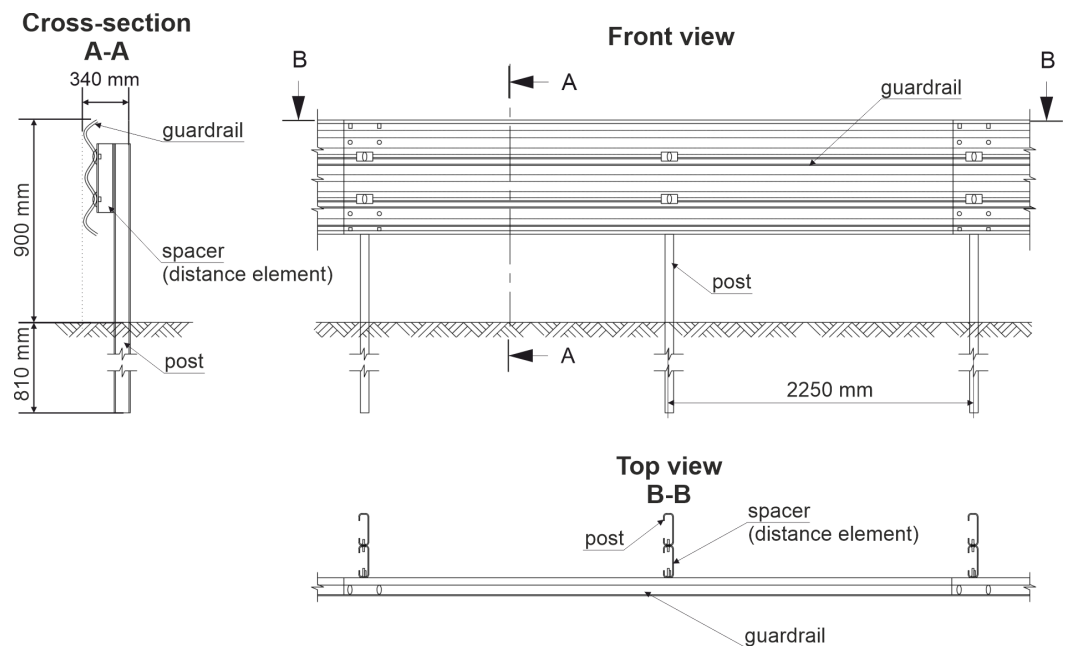
**Figure 3.** Technical drawing of the analyzed H2/W4/A road safety barrier.

A segment of the barrier is presented in Figure 3. The system consisted primarily of three main parts, that is a guardrail, posts, and spacers. The length of the guardrail section was 4.82 m. The total width of the barrier was 0.34 m. The height of the system equaled 0.90 m from the level of the ground. The posts were spaced every 2.25 m. Their total length was 1.71 m, where 0.81 m was anchored in the ground. The soil on the test site contained

broken aggregate 0–31.5 mm. Its compaction factor was equal to 1.00, and the bearing factor was in the range of 65 to 90%.

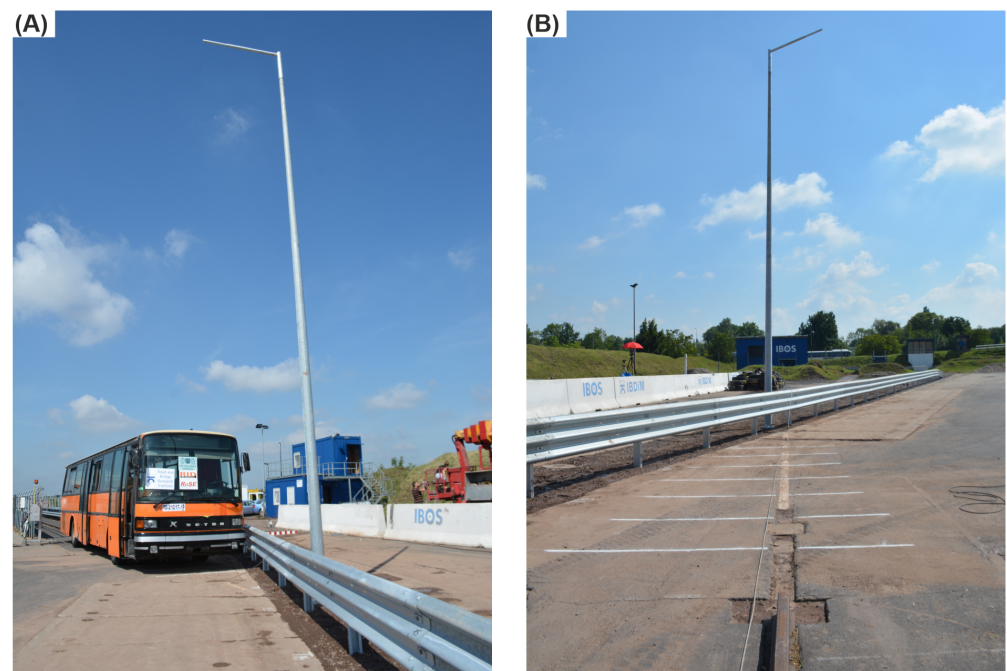
**Figure 4.** Test site before the collision, with (A) a view of the run-up track with the bus and the impact point and (B) a view of the impact point from the point of view of the run-up track.

The analyzed crash test also considered the lighting column in the working width of the barrier. This column was the 100HE3 class according to the EN 12767 standard [32]. Without a foundation, the column was 10 m long and weighted 87 kg. It was mounted 1.75 m behind the 12th post of the barrier (see Figure 4), and its axis was distanced at 0.60 m from the face of the system. The foundation was made of a 150 × 30 × 30 cm reinforced concrete cube, weighing approximately 225 kg.

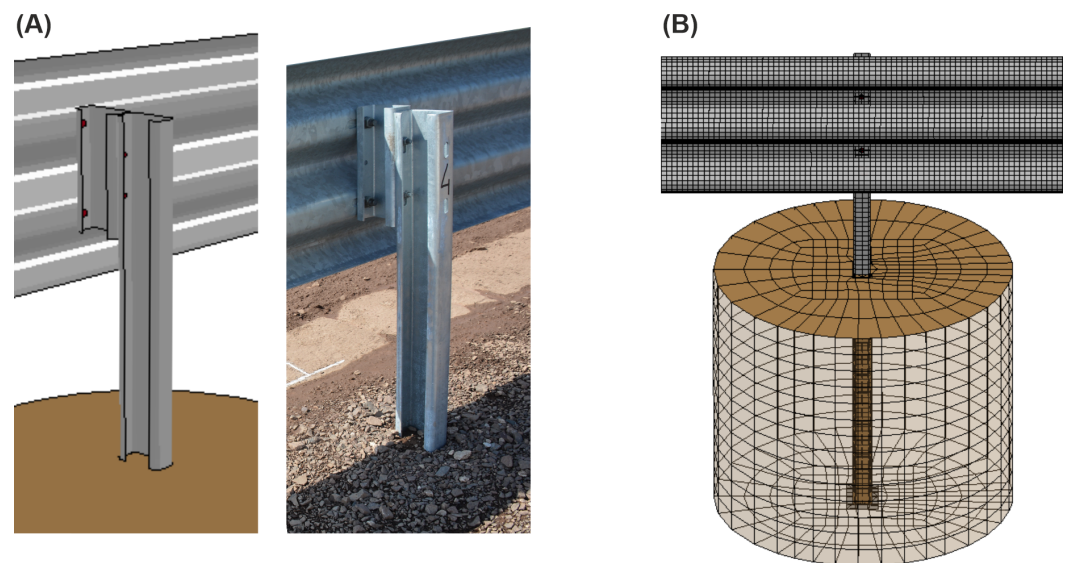
**Figure 5.** (A) Comparison between the actual post of the road safety barrier and the corresponding numerical model; (B) detail of FE discretization of a guardrail, a post, and the ground.

The model of RSB consisted of 271,018 nodes and 259,336 mainly quadrilateral FEs. The comparison between the selected part of the numerical model and the actual barrier is shown in Figure 5A. In Figure 5B, there is a view on the detail of the finite element discretization of the surroundings of the barrier's post. Figure 6A,B show the numerical simulation setup and include descriptions of the objects involved. In Figure 6C, there is also a discretization detail of the barrier's segment.

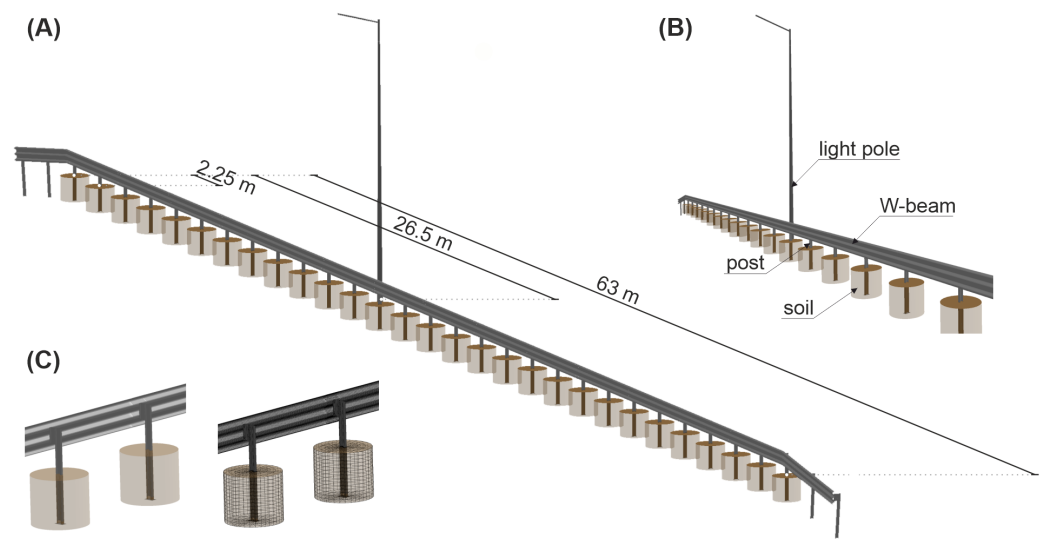
**Figure 6.** General views of the road safety barrier and the lighting pole with (A) specific dimensions, (B) a description of specific elements, and (C) a discretization detail of the barrier's segment.

The lighting column model was created based on the column used in the experiment. The column in the test setup is shown in Figure 6A,B. The numerical model consisted of 3715 nodes comprising 3706 FEs. The elements of the column were modeled using four-node reduced integration shell elements. They had assigned a constitutive model of a piecewise linear plastic material law with material characteristics corresponding to S235 steel. The size of the elements was in the range from 20 to 50 mm, depending on the height. The mass and geometry were assigned according to the report from the experiment.

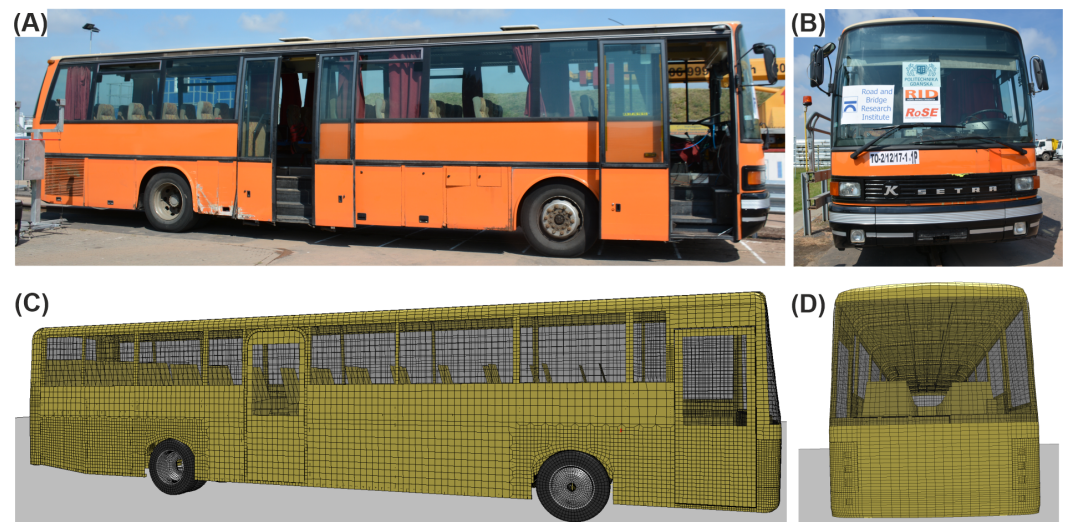
**Figure 7.** Comparison between the bus used in the experiment and the corresponding numerical model, with (A) a side view of the bus, (B) a front view of the bus, and (C) a side view and (D) a front view of the numerical model.

The bus model used in this study was developed by The Norwegian Public Road Administration [40]. The model of the bus was modeled mainly using fully integrated 4-node shell elements and selectively reduced solids. Most parts of the bus used the piecewise linear plasticity material law; the tires had the Mooney–Rivlin hyper-elastic constitutive relation assigned. Figure 7 shows the comparison between the bus used in the full-scale crash test and the bus from the simulations. In Figure 7A,B, there is a side view and a front view of the bus used in the experiment, respectively. The corresponding views for the bus from the simulations are in Figure 7C,D. A summary of the vehicle parameters, along with the requirements for the TB51 crash test vehicle, for both the simulation and the experiment, is presented in Table 1. As seen, all requirements were met for both vehicles.

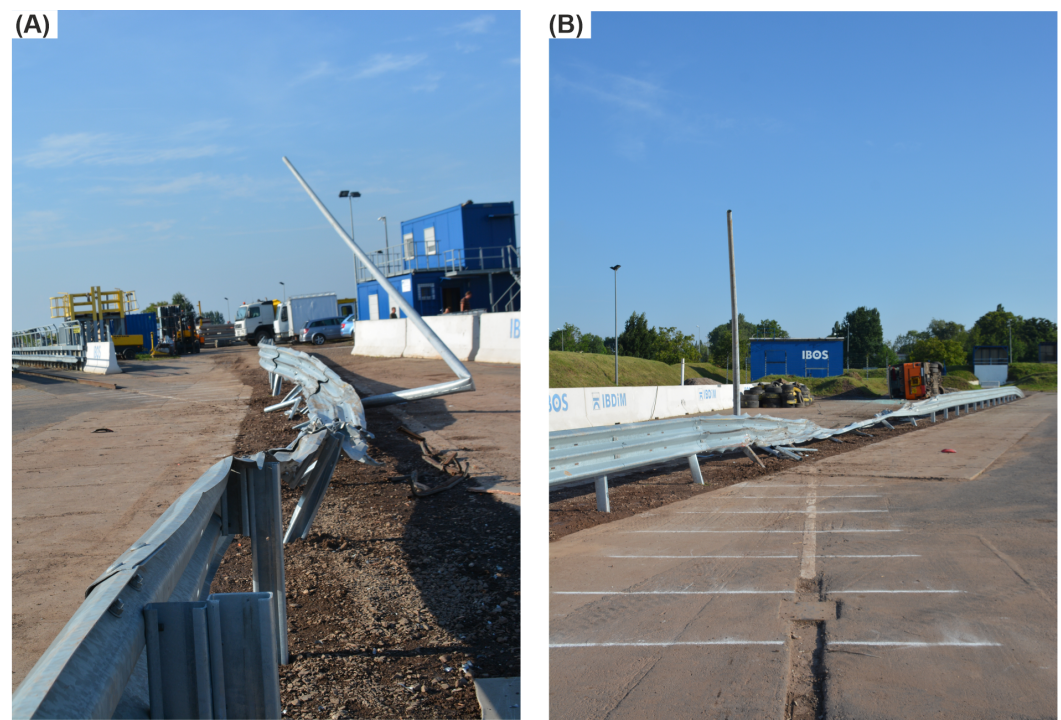
**Figure 8.** Test site after the collision with (A) a view from behind the barrier on the vehicle approach track and (B) a view from the approach track on the impact point.

The impact speed of the bus in the full-scale crash test was 73.2 km/h, and the angle equaled  $19.5^\circ$ , thus generating the vehicle's kinetic energy of 298.7 kJ. During the experiment, the vehicle hit the barrier 10 cm before the post No. 11 and remained in contact with the guardrail. After passing the post No. 14, the bus ran over the barrier and rode along the barrier's top up to the post No. 16. After reaching this post, the bus left the barrier on the side opposite to the in-run. At the height of the Post 29, the vehicle overturned to its left side, which can be seen in Figure 8B. In addition, damage to the protective system and the lighting column is presented in Figure 8A.

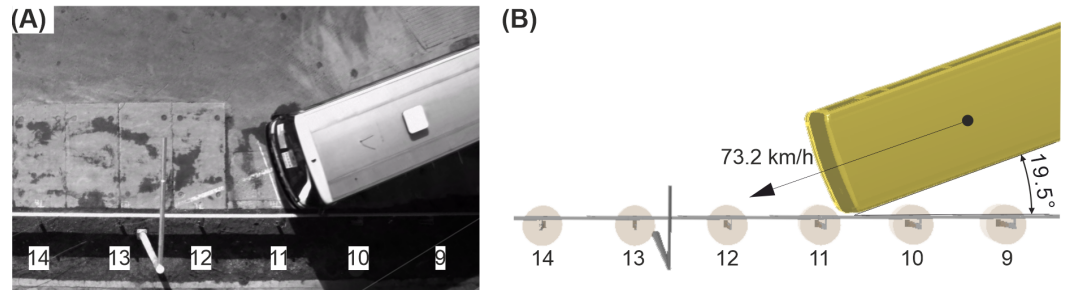
Figure 9. Impact conditions of the vehicle in (A) the full-scale crash test and in (B) the simulation.

The numerical simulation had the same impact conditions as in the experiment, i.e., the same velocity and the same impact angle. To impact location was also chosen as

in the experiment; hence, the bus in the simulation hit the barrier 10 cm before Post 11. A comparison of the impact conditions between the experiment and the simulation is also presented in Figure 9.

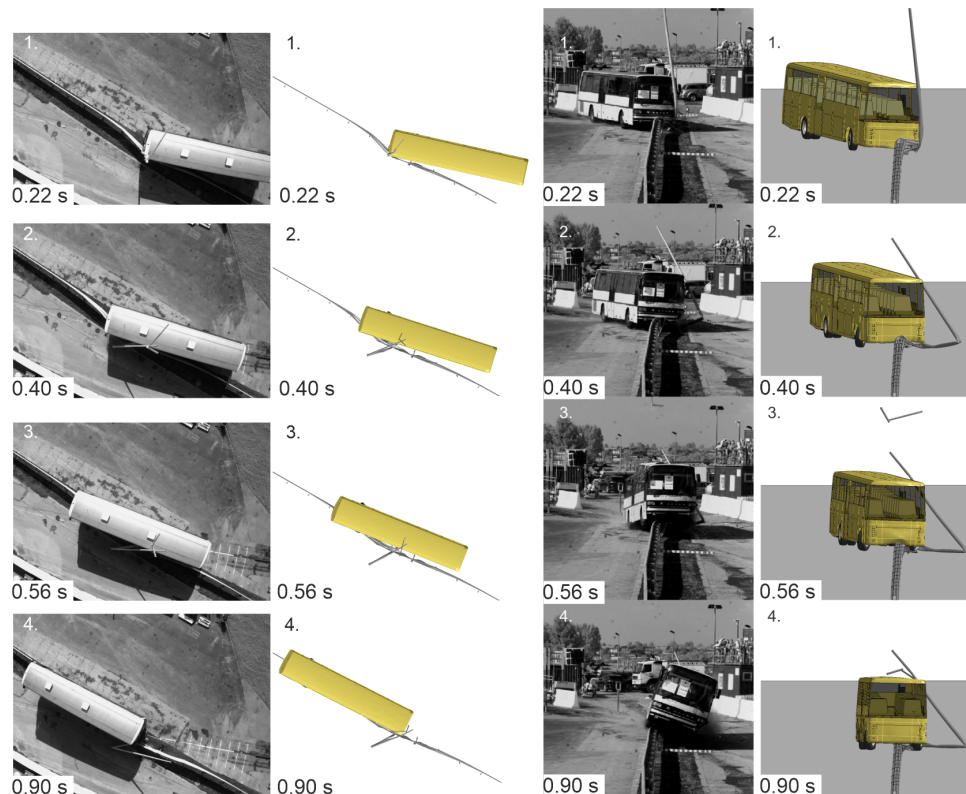
Figure 10. Vehicle trajectories of the full-scale crash test and the numerical simulation.

The results of the numerical simulation were compared with the corresponding experiment. A visual representation of the vehicle trajectories for both cases is presented in Figure 10. During the initial phase, the bus in the simulation and the experiment followed a similar path. Differences were observed in the latter parts of the test. The vehicle in the experiment hit the barrier and swung to its other side, as in Figure 10(2). As seen, the left side of the vehicle crossed the face of the barrier, and eventually, the whole bus followed and fully crossed over to the other side of the protective system (see Figure 10(4)). The wheels on the right side of the bus then caught the barrier, resulting in the bus rollover. A difference in the vehicle course was observed in the simulation where the center of the vehicle’s chassis did not cross the face of the barrier. Hence, as a consequence, the vehicle hung on the barrier, as seen in Figure 10(3). The simulation ended with the bus’s undercarriage hanging on the protective barrier, as in Figure 10(4). Nevertheless, in both, the experiment and the simulation, the analyzed road safety barrier did not stop the vehicle from crossing over the traffic lane.

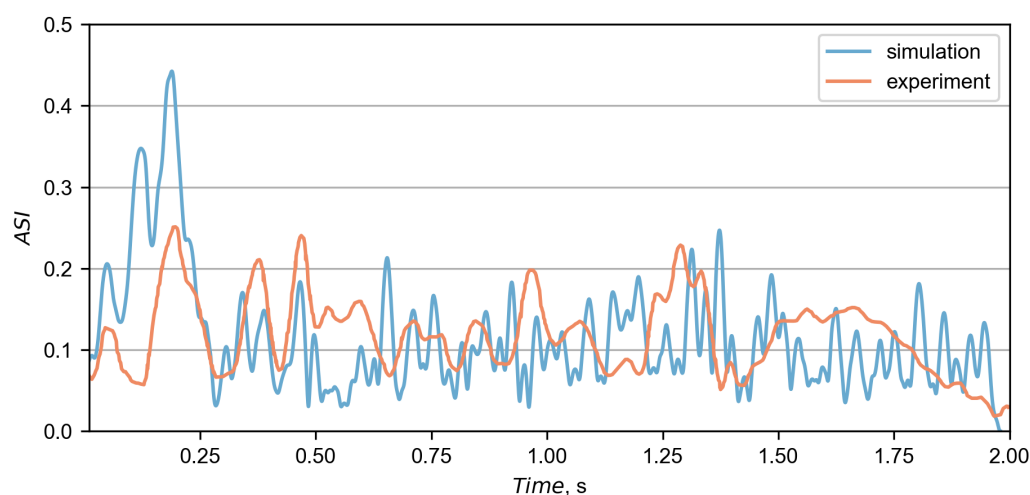
**Figure 11.** The comparison between the ASI calculated at the driver seat in the simulation and the experiment.

The calculated ASI curves were based on accelerations from the driver seat and are presented in Figure 11. The similarity between the curves was calculated based on the MPC and ANOVA metrics, as proposed in the technical report [41]. Residuals of ASI curves with their corresponding distributions are presented in Figure 12. A summary of the metrics is in Table 2, where all criteria were fulfilled, indicating a good overall correlation between curves. The maximum ASI in the experiment was 0.25 and occurred 0.196 s after the initial impact. In the simulation, the maximum ASI was higher and occurred 0.44 s after the initial impact.

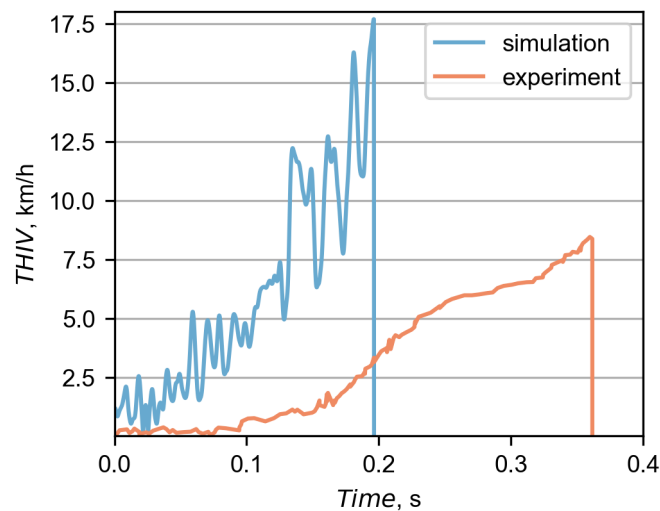
Figure 13. The comparison between the THIV calculated at the driver seat in the simulation and the experiment.

In Figure 13, there is a comparison between the experimental and the simulation THIV curves. For both cases, the THIV was based on accelerations from the driver seat. However, as seen in Figure 13, there are significant differences between those curves. Discrepancies are mainly due to the different rate at which the vehicle changed its direction after hitting the barrier. This is because the THIV index directly depends on the yaw velocity. In both cases, the barrier initiated the redirection of the bus. However, in the simulation, the redirection occurred faster and was more abrupt. In the experiment, the bus maintained its initial moving direction for longer. Additionally, the discrepancy may be due to the fact that in the simulation, the bus hanged on the barrier, and in the experiment, the bus completely ran over to the other side of the barrier.

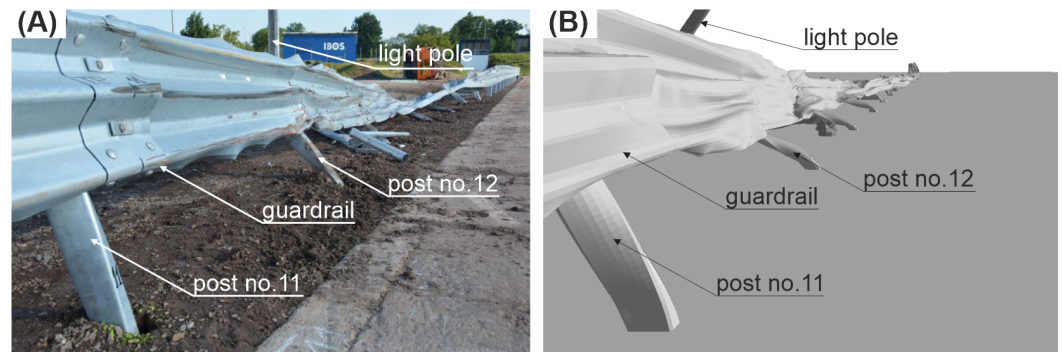
**Figure 14.** View of the damaged barrier. (A) Experiment; (B) simulation.

As a result of the impact in the full-scale crash test, the system was damaged between Posts 11 and 19. For the simulation, the damage was between Posts 10 and 25. The guardrail was locally torn in the experiment at Posts 12, 15, 16, and 18. For the simulation, the guardrail was severely damaged at Posts 12, 15, 18, 19, and 20. In the full-scale

crash test, Posts 11, 12, and 17 were bent, the posts between 13 to 16 were bent to the ground, and the posts from 1 to 11 were only twisted. For the simulation case, Posts 10, 11, 12, and 24 were bent, Posts 13 to 23 were bent to the ground, and the posts from 1 to 9 and No. 25 were only twisted. The lighting column for both the experiment and the simulation was damaged near the foundation and was broken at one third of its height.

A view of the damage of the system can be seen in Figure 14.

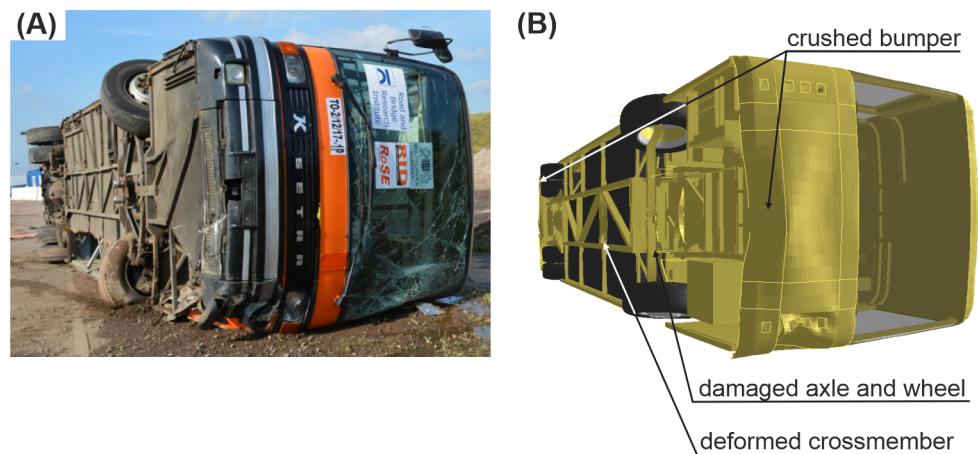
**Figure 15.** View of the damaged vehicle. (A) Experiment; (B) simulation.

In the experiment, the rear window of the vehicle was broken, the front windshield was severely cracked, and the front bumper was crushed. Moreover, the left-front wheel of the vehicle was broken. The left side of the vehicle was damaged due to the contact with the guardrail. In the simulation, the left side of the vehicle was also damaged. Additionally, the front and rear bumpers were crushed due to the impact. Moreover, the cross-member of the chassis frame was damaged and the front axle was bent near the left-front wheel.

A comparison of vehicle's damage between the full-scale crash test and simulation is presented in Figure 15.

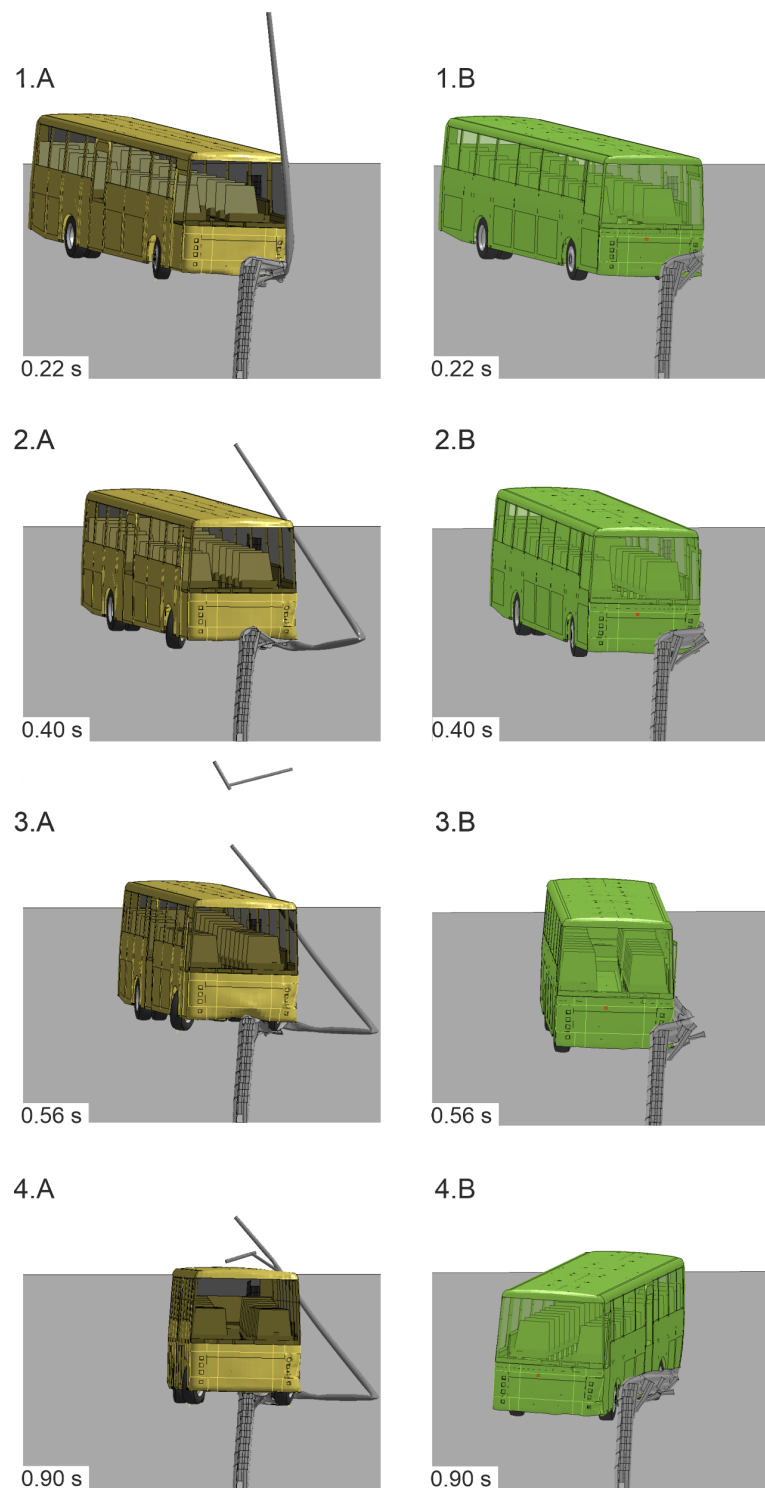
**Figure 16.** Vehicle trajectories of numerical simulations of (A) the barrier without an obstacle (Case No. 1) and (B) the barrier with a lighting column within its working width (Case No. 2).

Numerical simulations considered two cases, where Case No. 1 had the lighting column installed within the working width of the H2/W4/A W-beam RSB and Case No. 2 considered the barrier itself, without any obstacles. All of the modeling details were the same in both simulations, i.e., the model of the vehicle and the model of the barrier remained unchanged. Both cases had the same impact conditions, i.e., the impact speed of 70.6 km/h, the impact angle of 20.3°, and the impact location of 10 cm before Post No. 11. The course of the vehicles' trajectories in both simulations is presented in Figure 16.

The trajectory of the vehicle in Case No. 1 was described in Section 3. In simulation Case No. 2, 0.08 s after the impact, the barrier guardrail flattened on the left-front side of the vehicle body and the vehicle began to slide and redirect along the guardrail. At 0.14 s after the impact, Spacer No. 12 was detached from the guardrail, and then, two more spacers (Nos. 13 and 14) also detached from the guardrail consequently. At 0.54 s after the impact, the rear of the bus hit the guardrail at the height of Post No. 10 (see Figure 16(3.B)). The rear of the vehicle was also caught by the barrier, and the guardrail properly redirected the vehicle; at 1.30 s after the impact,

Time Intervals, s	Comparison between Simulations	
	Case No 1	Case No 2
0.0 *–0.13	Similar Course	
0.14–0.25	The guardrail made contact with the lighting column, which prevented the connection between the post and the guardrail from breaking (see Figures 16(1.A) and 20A).	Post No. 12 was detached from the guardrail (see Figures 16(1.B) and 20B).

0.26–0.39	Post No. 13 did not detach from the guardrail, and the system was pressed to the ground by the vehicle chassis (see Figure 16(2.A)).	Another post (No. 13) was detached from the guardrail. The guardrail flattened against the vehicle body and began to redirect the vehicle (see Figure 16(2.B)).

0.40–0.63	After sliding underneath the vehicle chassis, the guardrail was shaped into a flat surface parallel to the ground, which acted as a ramp, which allowed the vehicle to run over the barrier (see Figure 16(3.A)).	Post No. 14 disconnected from the guardrail, and the guardrail continued to effectively redirect the vehicle (see Figure 16(3.B)).

0.63–0.85	The left-front wheel of the vehicle crossed to the other side of the barrier, and the vehicle chassis landed on the top of the guardrail. The system underneath the bus almost completely laid down on the ground (see Figures 16(4.A) and 19A).	The bus was moving parallel to the line of the barrier. Post No. 12, 13, and 14 were disconnected from the system (see Figures 16(4.B) and 19B).

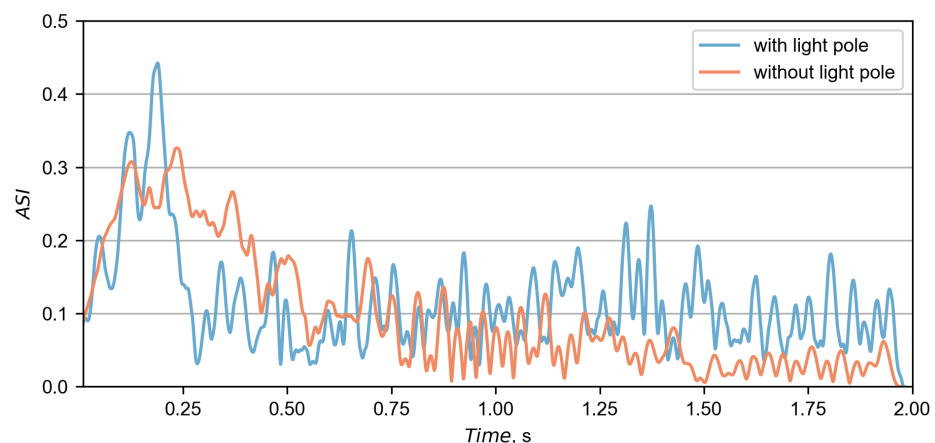
**Figure 17.** The comparison between the ASI calculated at the driver seat in both simulations.

The results of the ASI and THIV for both simulations were calculated based on accelerations from the driver seat. Their corresponding curves are presented in Figures 17 and 18. In Case No. 2, the maximum ASI equaled 0.33 and was 25% lower than in Case No. 1. The time of the maximum ASI in Case No. 2 was at 0.235 s after the impact, which was 0.046 s later than in Case No. 1. The maximum THIV in Case No. 2 was 16.06 km/h at the time of 0.196 s, which is 9% less and 0.006 s earlier, compared to the other case.

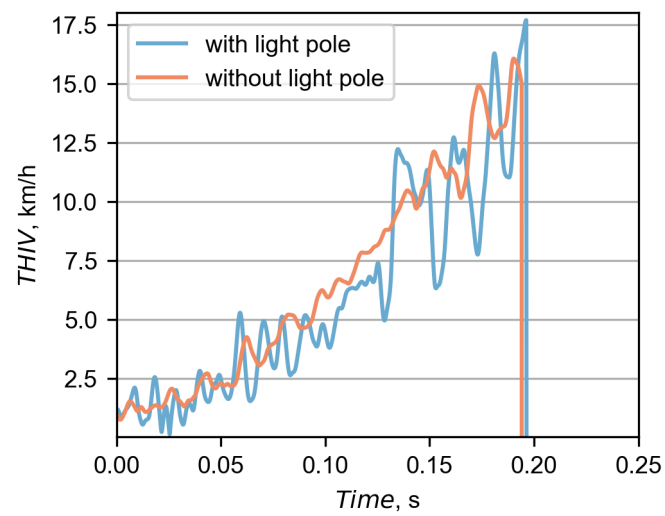
**Figure 18.** The comparison between the THIV calculated at the driver seat in both simulations.

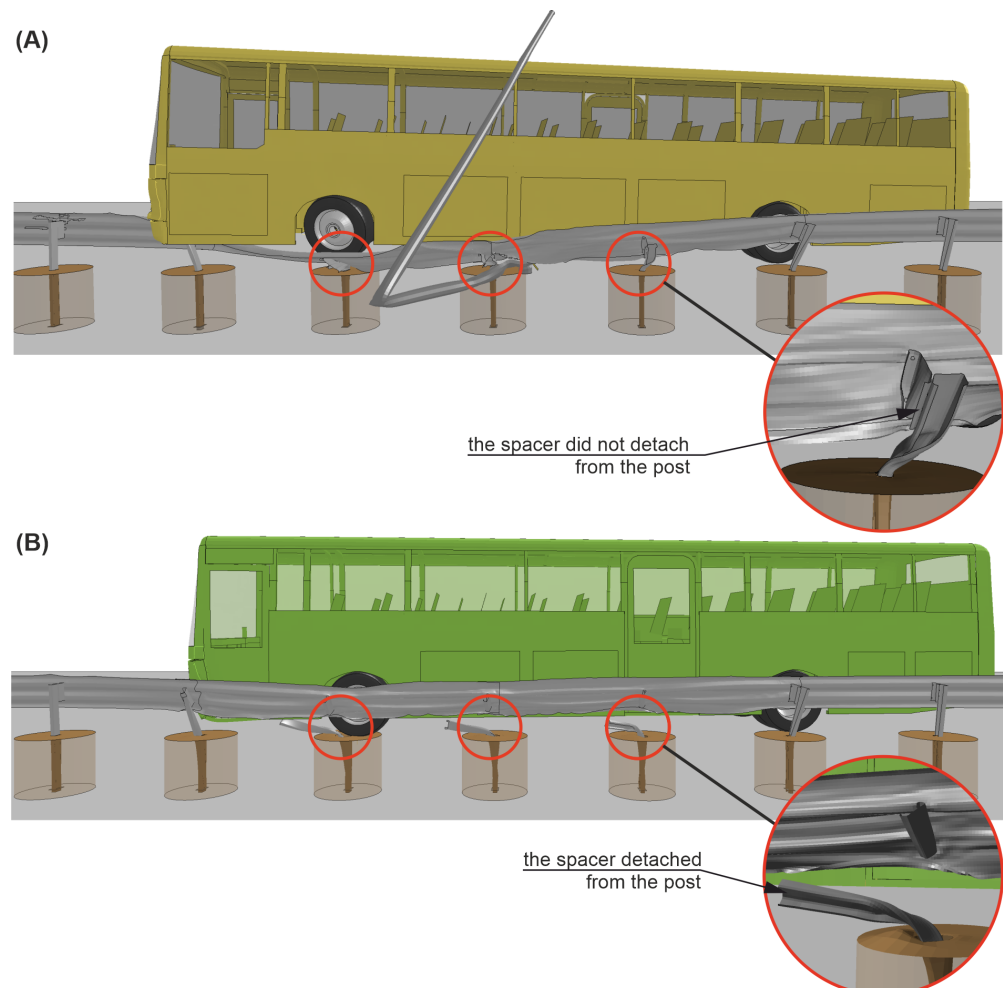
**Figure 19.** Side views of the H2/W4/B road safety barrier during simulations (time = 0.5 s) for (A) Case No. 1 and (B) Case No. 2. Note that the surface and soil cylinders are set transparent for clarity.

In Figures 19 and 20, there is a comparison between Case No. 1 and Case No. 2 at crucial moments in the simulation. It was observed that Post Nos. 11, 12, and 13 in Case No. 1 (see Figure 19A) did not detach from the guardrail, in contrast to the ones in Case No. 2 (see Figure 19B). This difference seems to be crucial from the point of view of the correct operation of the system. The experiment additionally confirmed the simulation results, where also no detachment of the posts from the system was observed. The comparison of the damaged barrier in the experiment and corresponding simulation is presented in Figure 21.
