Case report

Polyethylene liner dissociation with the Pinnacle acetabular component: should we be concerned?

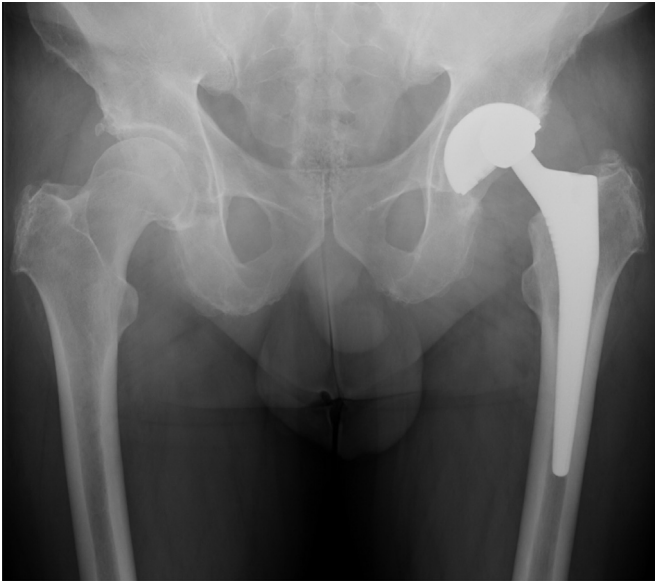
Figure 1. Internal subluxation of femoral head within the socket.

There may be further patients who have some instability of the liner but do not develop frank dissociation. Three patients in our series had some prodromal symptoms of pain or subluxation in the months preceding the actual dissociation. This diagnosis needs to be considered. However, radiological diagnosis is difficult in such patients. One had a radiograph taken due to a subjective feeling of subluxation which showed a congruent hip joint. Computed tomogram (CT) is a well-recognized tool in assessment of polyethylene wear and component alignment in hip arthroplasty [21]. We are unaware of any cases where a CT has been used to detect polyethylene dissociation; however, a thin-slice metal suppression CT may detect subtle changes not evident on plain radiographs.

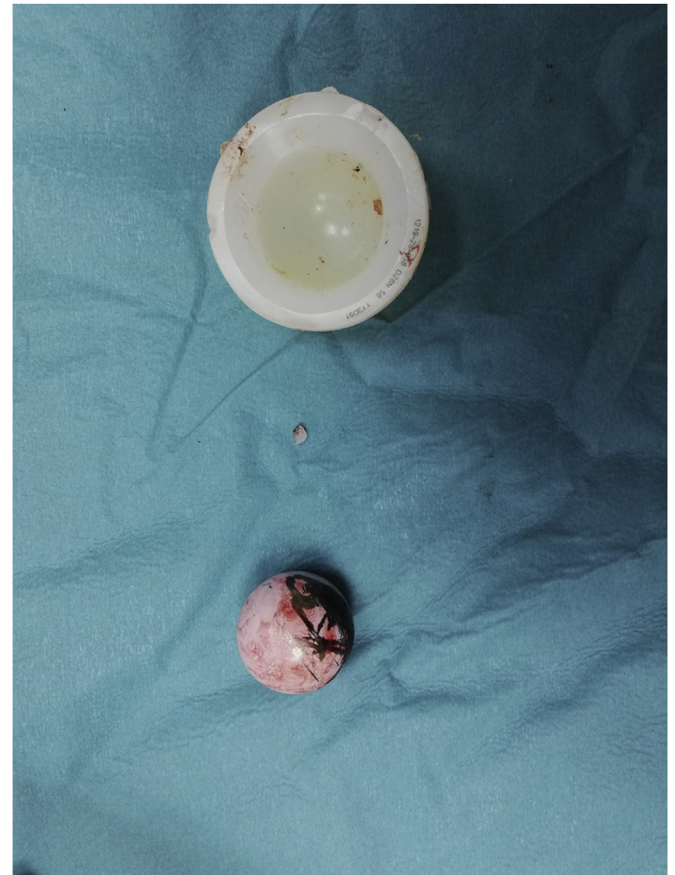
At the revision, all acetabular components were well fixed and the liner clearly loose. Typically, the superior 3 tabs had sheared off (Fig. 2). In 5 hips, acetabular and femoral components were well positioned. In one hip, there was posterior impingement of the femoral neck on the polyethylene secondary to excessive anteversion of the femoral component. The acetabular shell was retained, a new liner inserted, and the femoral component revised. One acetabular component had signs of pitting due to the metal head articulating against it. It was retained because of the age of the patient who died 3 years later due to an unrelated medical illness. All acetabular components were retained and a new polyethylene liner inserted after checking the locking mechanism integrity in 5 cups. In one patient, a new liner was cemented into the metal shell because of concerns about the competency of locking mechanism. The femoral head was exchanged in all cases. No further complications have been recorded in revised patients at their most recent follow-up.

Figure 2. Retrieved polyethylene insert and head showing fractured tabs and deformed shape.

such as the Duraloc [6]. A taperloc mechanism was introduced in the Pinnacle component to accept both polyethylene and ceramic or metal bearings with 6 tabs to resist rotation. The liner was also changed from conventional polyethylene to a highly cross-linked polyethylene (Marathon) irradiated to 50 kGys, which improved wear characteristics but at the expense of mechanical strength [15,16]. The effect these changes has is a reduced pull-out strength of the liner [17].

It is not clear why there are multiple reports of dissociation with the Pinnacle acetabular component and not with other contemporary systems. This suggests a problem with the locking mechanism which may be less forgiving than other systems. The Pinnacle system allows for the use of neutral, lipped, lateralized, and a 10° face changing liner option. Liner dissociation may be more common in neutral and face changing liners compared with lipped ones. In Yun’s
