Effect of head size and rotation on taper corrosion in a hip simulator

**C. M. Wight,
C. M. Whyne,
E. R. Bogoch,
R. Zdero,
R. M. Chapman,
D. W. van Citters,
W. R. Walsh,
E. Schemitsch**

Cite this article: *Bone Jt Open* 2021;2-11:1004–1016.

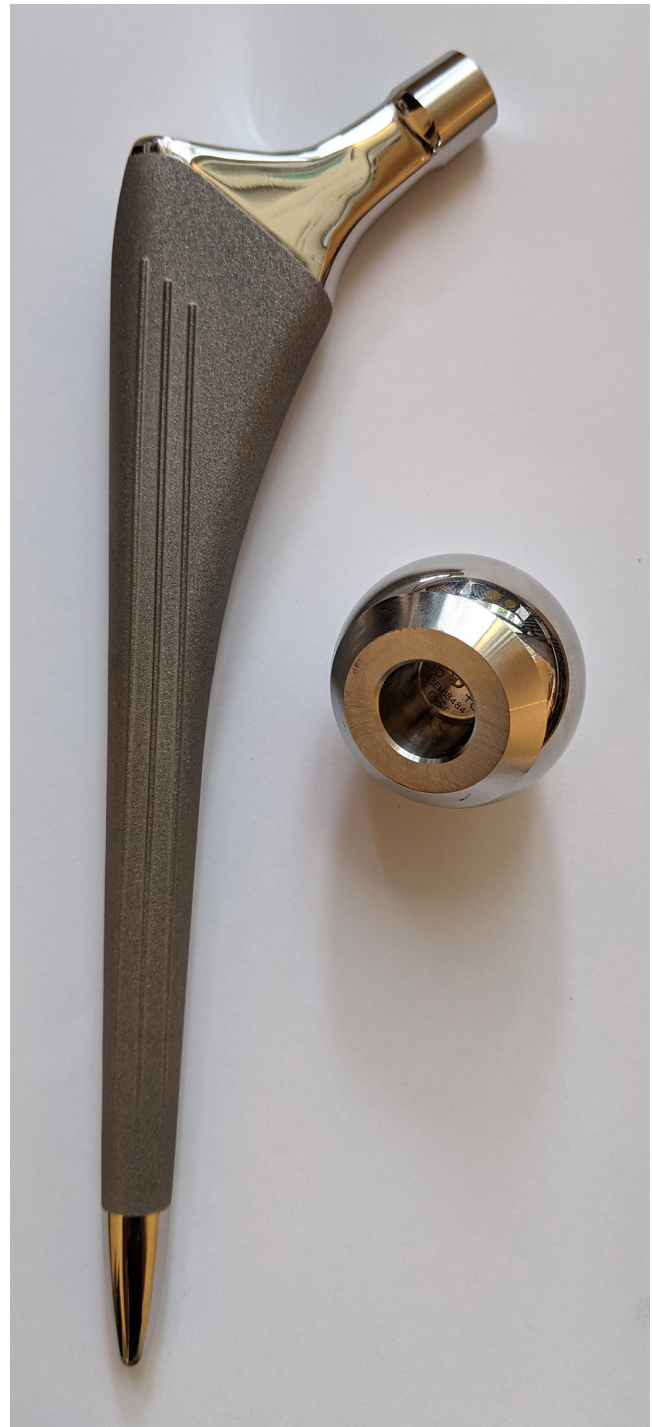
Fig. 2

Synergy Stem and CoCr femoral head test samples (Smith & Nephew, UK).

Materials. Femoral test samples were implant grade final products (Synergy Stem; Smith & Nephew, UK; Figure 2). Femoral heads were Co-Cr-Mo alloy (CoCr), with either 28 mm or 36 mm diameter, and all neutral offset (0 mm) to ensure no taper coverage or offset differences. Femoral neck samples were prepared from Ti-6Al-4V alloy femoral stems. Stems were cut 15 mm below the resection level, and two tapped holes were added to the sectioned surface to allow test apparatus connection. Femoral neck

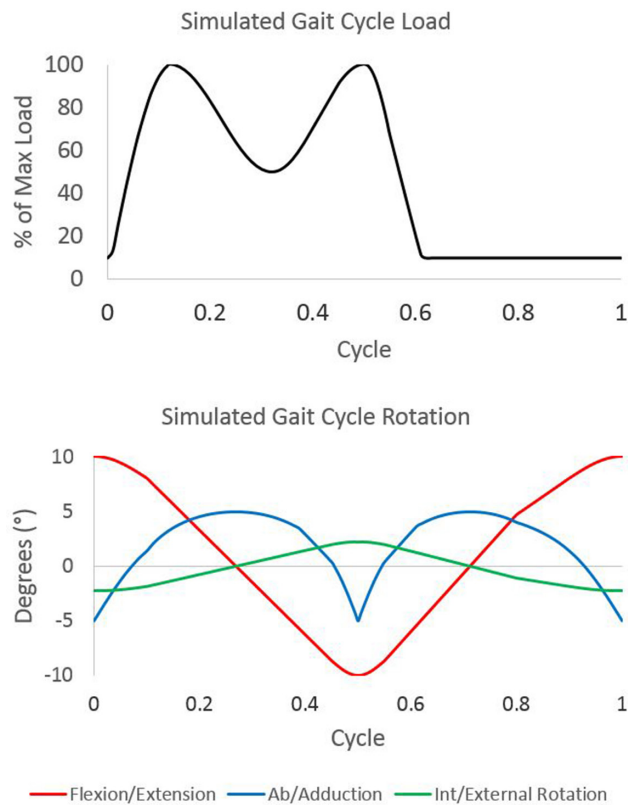
Fig. 4

Simulated gait cycle load and rotation.

and SD 2° internal/external rotation (Figure 4). The peak load increments rose from 100 N steps from 100N to 1,100N, to 200 N steps from 1,100 N to 3,300 N, while maintaining a 0.1 minimum to maximum load ratio. Cyclic loading was continued at each increment for three minutes, then OCP and corrosion current were measured before proceeding to the next load. After measurements were taken at 3,300 N compression with joint movement, joint movement was discontinued and OCP and corrosion current were measured after three minutes of cyclic compression only.

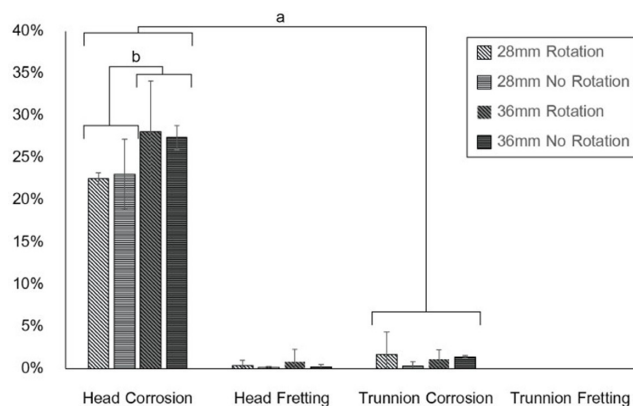
Fig. 11

Area percentage of corrosion and fretting damage after wear cycling. a) Significantly greater corrosion damage on head tapers than stem trunnions ($p < 0.001$), and b) significantly greater corrosion damage area for 36 mm over 28 mm heads ($p = 0.05$).

Figure 11 presents the fretting and corrosion damage areas for head and stem tapers after wear cycling. Corrosion damage area was significantly greater for 36 mm heads (28% (SD 4%) vs 23 (SD 4%); $p = 0.050$, ANOVA). Fretting levels were low and no significant difference between head sizes was observed. Significantly greater

areas of head tapers were corroded than stems (25% (SD 4%) vs 1% (SD 1%); $p < 0.001$, ANOVA).
