**TECHNICAL NOTE**

# Quantifying construction vibration effects on daily radiotherapy treatments

Jonathan J. Hindmarsh | Wendy L. Smith

Tom Baker Cancer Centre, Foothills  
Hospital, 1331 29th St. N.W, Calgary, AB,  
T2N 4N2

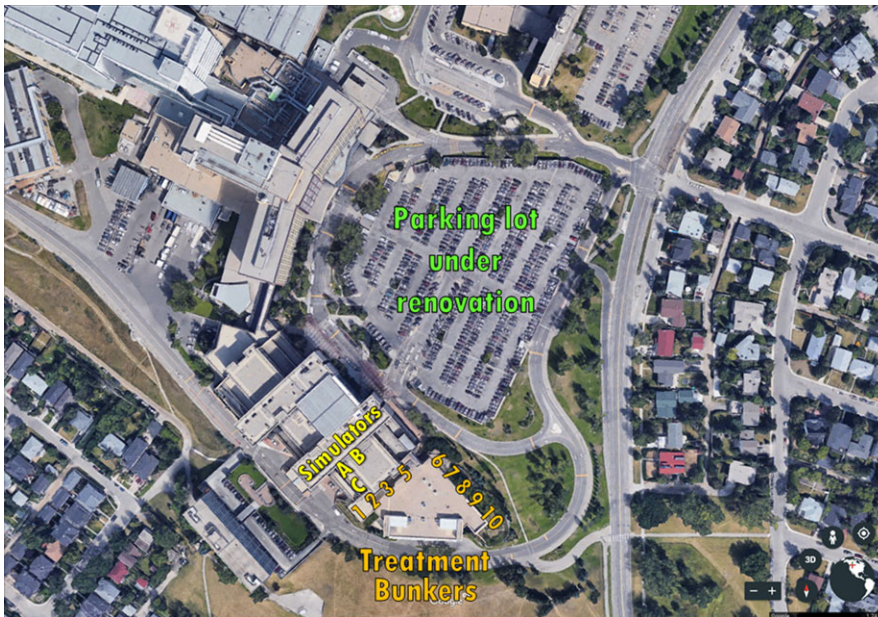
**FIG. 1.** Location of construction site relative to TBCC. Treatment vaults are labeled numerically. The stereotactic radiosurgery (SRS) vault is #3. The location of the CT and conventional simulators is also indicated.

the vibrations were ongoing. The accelerometer was installed sequentially in two locations: on the floor in the control room (InCloset) and on the floor behind the linac stand in the treatment room (InRoom), both in Vault 6, which was the vault closest to the construction at that time (Fig. 1) and where the vibrations were most strongly felt. In our short time with the equipment, we were not able to determine if the areas of apparent maximum vibration moved when the location of the construction work outside moved, so a worst-case scenario, that the maximum vibration in the vault would affect the linacs, rather than only measuring by the couch and machine base, was used.

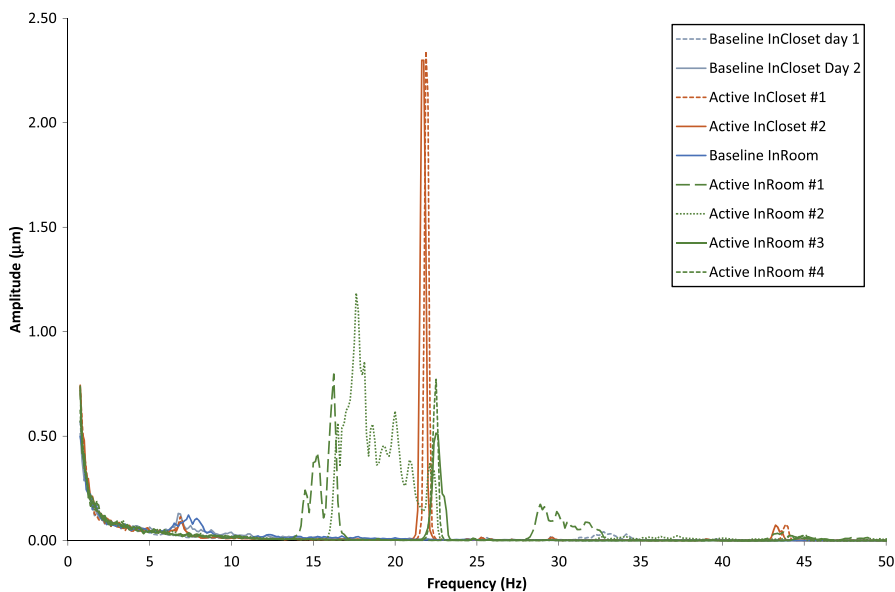
**FIG. 2.** The average zero-peak displacement over 20 individual 8-s samples as a function of frequency, measured as background (no construction activity) and under active vibrations conditions in two locations chosen based on ease of access during treatment hours and length of time with the equipment. InCloset was on the floor in the control room and InRoom was on the floor behind the linac stand. Measurements were acquired over 2 days with the same equipment running (InCloset background on day 1, InCloset and InRoom background and under active conditions on day 2) and repeated approximately every 5 min for the duration of the vibration.

Using the accelerometer provided by the external consultants and communicating with the construction site, vibrational amplitude vs frequency data were acquired in the control and treatment rooms under background conditions and during active vibratory piling conditions. Each of the data tables provided by the consultant contained the average and maximum zero to peak displacement for frequencies between 1 and 50 Hz taken from 20 individual 8-s samples. Figure 2 shows the frequency vs vibrational amplitude recorded by the accelerometer for baseline and under active vibratory piling conditions. Under active vibratory piling, resonant peaks were observed primarily between 20 and 25 Hz with average displacements over 20 samples up to  $2.35 \mu\text{m}$ . The measurements in Fig. 2 were acquired during the operation of the same piece of equipment while it was in the vibration drilling phase. This phase lasted between 15 and 45 min per casing. The InCloset measurements were acquired under steady-state conditions, and the InRoom measurements were acquired under both initial ramp up and steady-state vibratory conditions.

frequencies for the linacs and couches, which were unfortunately quite close at this site. Using the FFT data (Fig. 2) and the resonance amplitude method from the vendor specification document, the maximum total vibration under active vibratory piling of the treatment system was  $268 \mu\text{m}$  for the Varian Clinac (minimum  $38 \mu\text{m}$  of the measured points) and  $143 \mu\text{m}$  for the Varian Truebeam (minimum  $20 \mu\text{m}$ ). As the range of total vibration values above and in Fig. 2 demonstrate, there was large variation. The variation was caused by changes in the stage (ramp up or steady state) of the piling activity, the treatment head position (head up/down versus head  $90^\circ/270^\circ$ ) and the type of machine as well as the frequency of the peak amplitudes. A change of  $<1 \text{ Hz}$  in the frequency of the peak amplitude could substantially reduce the resonant amplification factor. Vibration propagation through the ground, walls, floor, and equipment is nontrivial. The location of the maximum vibration within the room appeared to move around the building as work was conducted at different locations outside, and measurements at the different locations in the building had vastly different readings. Given the limited access to the accelerometer, our goal was to determine if a reasonable approximation of the maximum motion exceeded the manufacturer's specifications, rather than to fully characterize vibratory motion within the treatment vault and console.

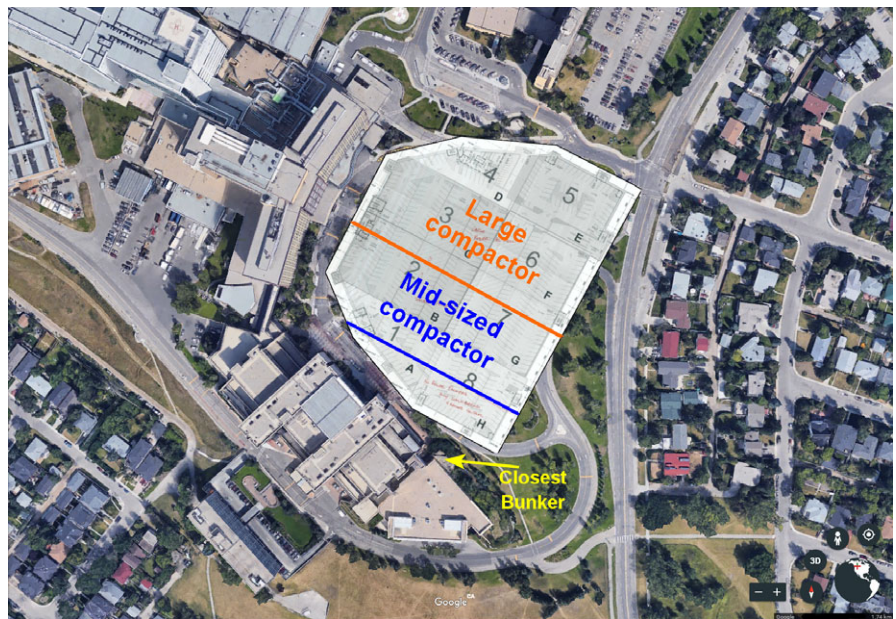
from the department until the vibrations no longer caused observable ripples in the water. The setbacks for vibratory compactors were approximately 30 m for the 500 lb compactor, 50 m for the midsized compactor, and 100 m for the 8000 lb compactor. A schematic of this is shown in Fig. 3.

**FIG. 3.** Satellite image of hospital site with parkade plans overlaid.

When vibratory compactors were identified as an issue in early 2017, this rule was used to determine acceptable operating setbacks. These tests were conducted one evening after treatments had finished. A cup of water was placed on the treatment couch of each affected treatment room. Each of the compactors was operated independently on the construction site and gradually driven further
