Trauma Case Reports

Case Report

Isolated trochlea osteochondral fracture of the distal humerus in a 6-year-old patient surgically fixed using biodegradable pins: A case study with over 3 years of follow-up

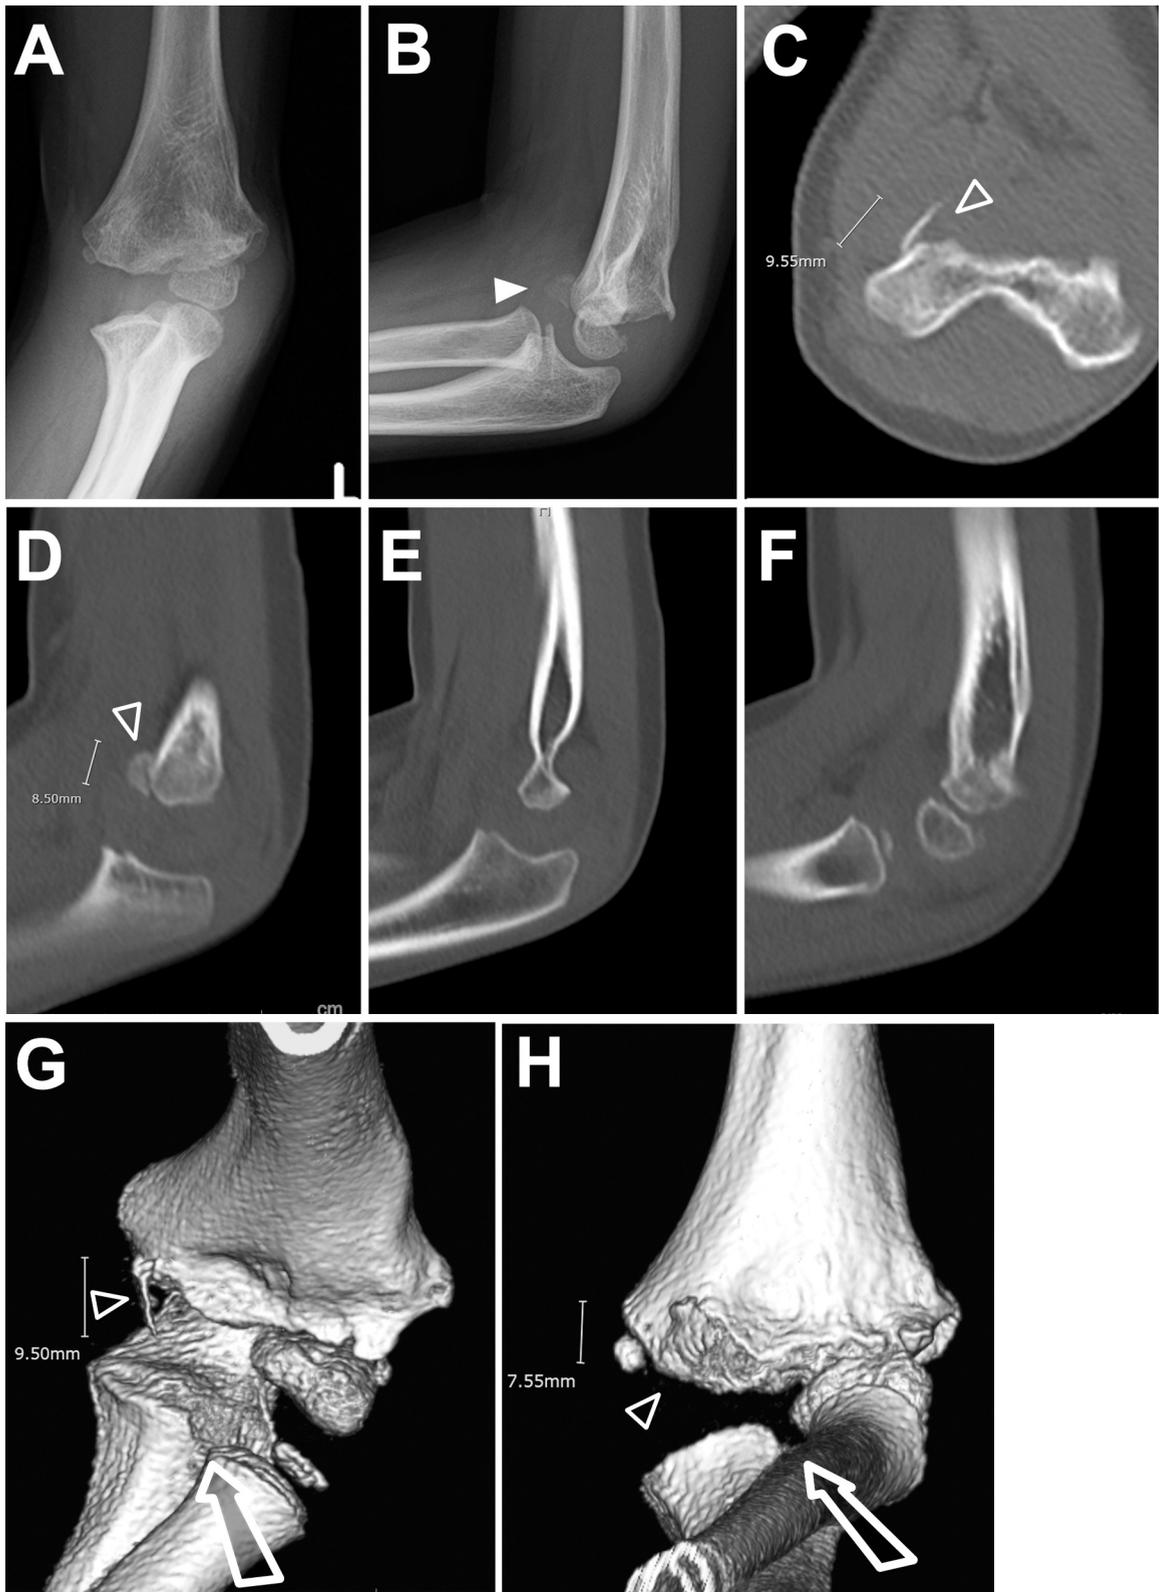
Fig. 1. Primary plain radiographs (A and B) and computed tomography (CT) images (C-H) of the involved elbow. A, Anteroposterior view. B, Lateral view, a bony fragment was observed anterior to the distal humerus (arrowhead). C, Representative axial image. D-F, Representative sagittal image at the medial section involving the bony fragment (D), at the middle section including the olecranon and coronoid fossa (E), and the lateral section

including ossification center of the capitellum and radial head (F). Note the normal congruity of the humeroulnar joint and normal position of the ossification center of the capitellum. G and H, 3D reconstructed images, a laterally opened avulsed fragment was observed (blank arrowheads in C, D, G and H). Arrows in G and H show the estimated direction of the impact that entered from the lateral side of the elbow and progressed from the coronoid process onto the sulcus of the trochlea.

On physical examination, the left elbow showed slight swelling with restriction of range of motion (ROM) and a normal peripheral neurovascular status. Plain radiographs revealed only a bony fragment anterior to the distal humerus. Computed tomography (CT) showed that the fragment was approximately 7.5×9.5 mm in size and anteromedially displaced from the superior border of the trochlea; no other bone injury was identified, with the congruity of the humeroulnar joint and the position of the ossification center of the capitellum being found to be normal (Fig. 1). For a further evaluation, ultrasonography confirmed that the fragment had continuity with the cartilaginous trochlea, which exhibited instability on elbow motion (Fig. 2A), and it had a border at the middle portion of the trochlea in the coronal plane (Fig. 2B). The diagnosis was isolated trochlea osteochondral fracture with intraarticular instability, based on the fact that the fracture consisted of an avulsed bone fracture and surrounding cartilaginous tissue of the trochlea, with the fracture

The direction of fracture displacement on primary CT (Fig. 1) in our present patient supported the mechanism of the injury proposed in previous reports [4,5,7,8]. The laterally opened avulsed fragment depicted the trace of the impact, which entered from the lateral side of the elbow and progressed from the longitudinal ridge of the coronoid process onto the sulcus of the trochlea (Fig. 1G and H). Then, the resultant load split the surface of the anteromedial portion of the trochlea, shearing off the osteochondral segment medially and proximally. An association between isolated trochlea fracture and prior elbow fracture was suggested in a previous report [4,5]. Yano et al. reported the case of a 7-year-old boy with isolated trochlea fracture caused by falling with an extended elbow, and proposed the influence of varus deformity resulting from prior lateral condyle fracture to transfer the varus and axial force from the radiocapitellar joint to the ulnohumeral joint at injury [5]. In our patient, in accordance with the abovementioned injury mechanism, residual varus alignment may have enhanced the topical stress at the origin of fracture, where the remaining uneven articular surface due to prior lateral condyle fracture could add vulnerability to stress.

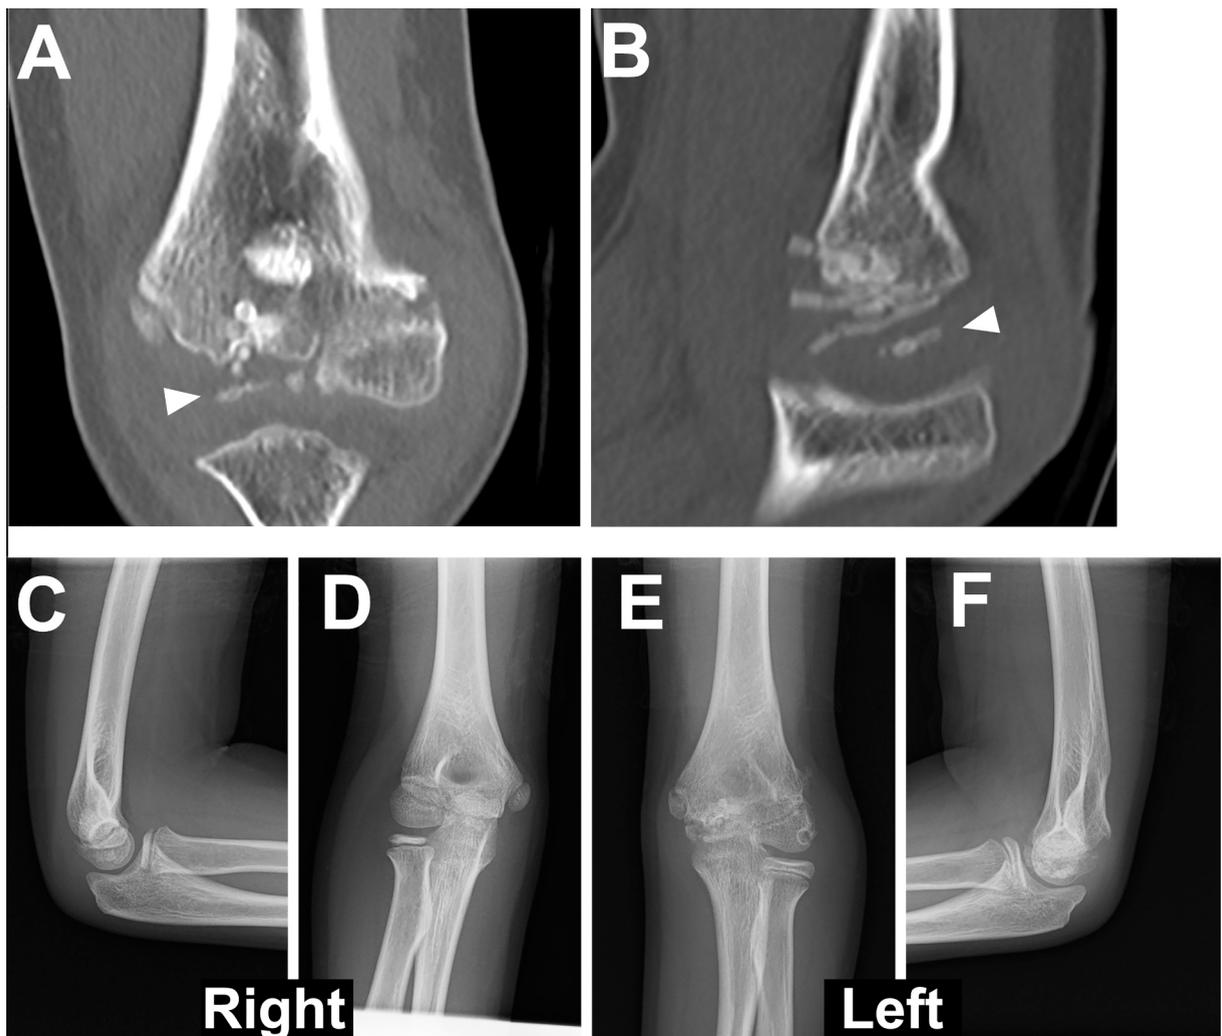
Fig. 4. Representative CT images obtained 29 months after surgery (A and B) and plain radiographs obtained 43 months after surgery (C, D, E and F); A, Coronal image. A sclerotic rim around the most proximal pin and hollow area around the 2nd proximal pin were observed. B, Sagittal image. An ossification center appeared in the trochlea (arrowheads in A and B). C and D, Lateral and anteroposterior (A-P) views of the contralateral elbow. E and F, A-P and lateral views of the involved elbow. A slight difference in the radiographic carrying angle was observed.

Four days after the injury, the patient underwent surgery. Under general anesthesia, the elbow joint was exposed via a medial approach. The fracture fragment was identified on the antero-medial surface of the trochlea with anterior displacement with a stepped-off longitudinal fracture line at its lateral and distal borders and the formation of hinges without a visible fracture line at the proximal and medial border (Fig. 3A–C). Since it was difficult to directly observe the lateral fracture border, a hook was used to probe the border, confirming the instability of the fragment (Fig. 3A). To obtain accurate reduction, the medial hinged line of the fragment was initially cut to facilitate mobility (Fig. 3D). After reduction, the fragment was fixed by inserting threaded biodegradable pins (diameter 2.0 mm, $n = 3$; diameter 1.5 mm, $n = 1$) made of forged composites of unsintered hydroxyapatite/ poly-L-lactide (F-u-HA/PLLA) (Osteotrans Plus, Takiron Co. Ltd., Hyogo, Japan) into the proximal side of the fragment to obtain adequate stability (Fig. 3E, F). Each pin was buried so that it would not protrude from the articular surface. Postoperatively, the arm was immobilized for 20 days. Reduction of the bony fragment was maintained on postoperative radiographic assessments. CT at 29 months after surgery demonstrated that the shape of biodegradable pins became obscure and collapsed, meanwhile a sclerotic rim surrounding the most proximal pin, and a hollow feature around the 2nd proximal pin was observed. A new ossification center appeared in the trochlea (Fig. 4A, B).

At the most recent visit, at 43 months after surgery, he had no complaints regarding the involved elbow and could participate in sports activities. The physiological valgus of the involved elbow decreased to 0° ; the physiological valgus of the contralateral elbow was 10° . The elbow ROM reached $10\text{--}150^\circ$ in extension and flexion, and 90° and 75° in supination and pronation, respectively. Radiographically, biodegradable pins were vaguely visible, and the ossification center in the trochlea was developing. The radiographic carrying angle of the involved and contralateral elbow was 171° and 167° , respectively (Fig. 4C–F), however the angle of the involved elbow did not change from that (170°) of 3 months before the trochlea fracture during follow-up for prior lateral condyle fracture. No complications requiring additional treatment occurred postoperatively.
