Case report

Trunnion Failure in Revision Total Knee Arthroplasty

Samir Chihab, MD^{*}, Bryan M. Grommersch, Greg A. Erens, MD, George N. Guild III, MD

Department of Orthopaedics, Emory University School of Medicine, Atlanta, GA, USA

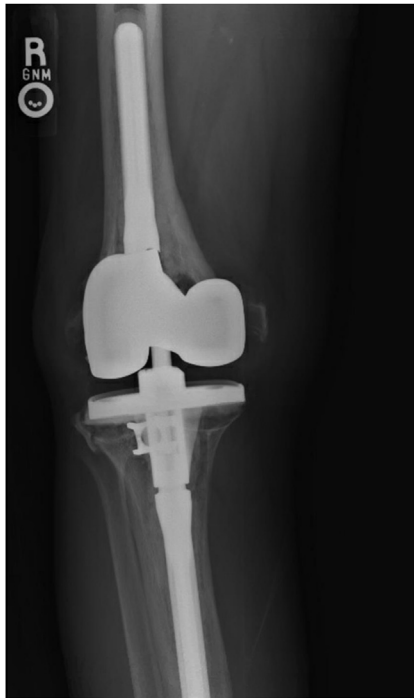
Figure 1. An anteroposterior radiograph of the right knee showing the broken stem.

outside facility. Unfortunately, his postoperative course was complicated by infection requiring two-stage revision. Over 10 years later, the patient developed worsening right knee pain and instability. His radiographs revealed gross mechanical failure at the junction of the femoral component and stem (Fig. 1). The infection workup was negative. He underwent rTKA because of mechanical failure of a posterior stabilized legacy constrained condylar knee (LCKK) prosthesis (ZimmerBiomet, Warsaw, IN).

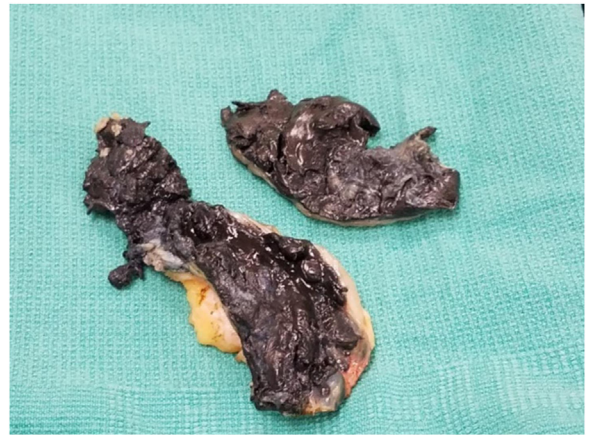
Figure 3. Thickened and stained synovium resected from the right knee.

Informed consent for the procedure and publication was obtained and documented. Upon entry into the knee, it was noted that the patient had thickened black-stained synovium (Figs. 2 and 3). The joint fluid appeared relatively normal. The LPS liner did not show any signs of excessive or focal wear. As revealed on the pre-operative radiographs, the femoral component was grossly broken at the femoral stem-condyle junction. Because the broken femoral stem remained lodged within the femoral canal, osteotomes followed by a trephine were used. The femoral component was easily extracted, and the tibial plate was noted to be solidly fixed. The decision was made to keep the tibial base plate to avoid more proximal bone loss. The femoral component was revised to a posterior stabilized LCKK with a small cone while the tibial component remained in place (Fig. 4). Unfortunately, the initial revision was performed at an outside institution in 2008, and documentation of the implant sizes was not available. The implants used for the revision reported herein were femur size D with 13 × 100 cemented femoral stem and a porous tantalum cone size small 30 mm in height, as well as a 20-mm LCKK polyethylene liner. At 21-month follow-up, the patient had experienced no postoperative complications and demonstrated an active range of motion of 0–110° with excellent strength and stability.

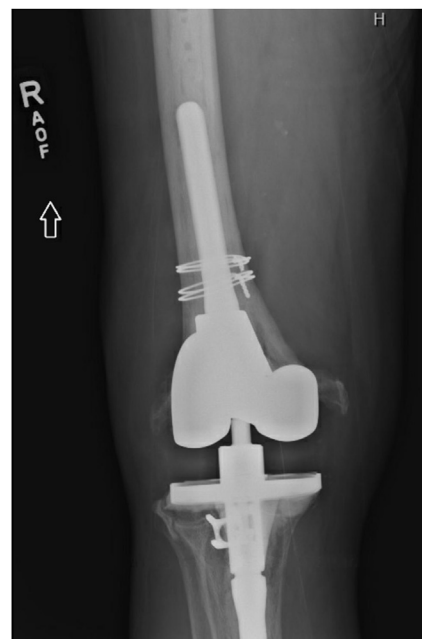
Figure 4. Postoperative anteroposterior radiograph of the right knee.
