Case report

Catastrophic Failures of the Tibial Post in a Bicruciate Substituting Total Knee Prosthesis

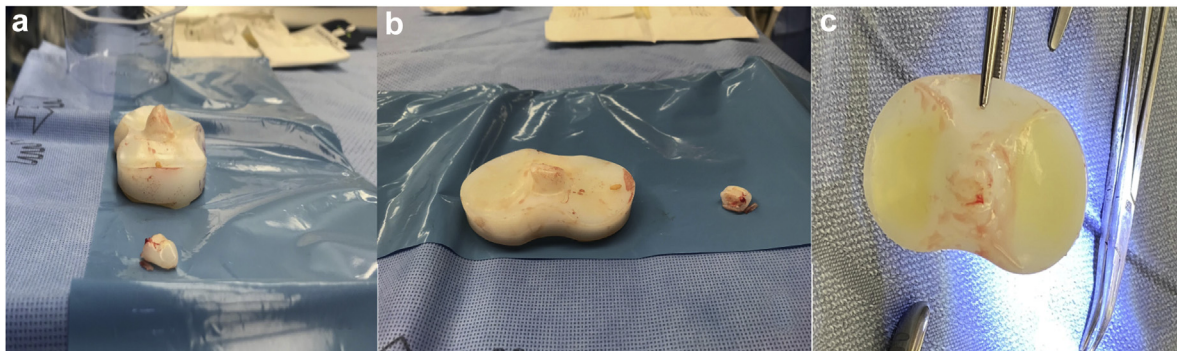
Figure 3. Intraoperative images from a revision BCS TKA displaying a 14-mm Journey 1 BCS explanted tibia polyethylene with a fractured tibial post and recovered post fragment (a, b, c).

posterior location of the tibial post. Similarly, Grieco et al. found that between 30 and 90 degrees, the JI-BCS experienced greater than 5 mm in posterior translation of the lateral condyle and approximately 3 mm in posterior translation of the medial condyle [8]. The brittleness of XLPE makes the tibial component more susceptible to failure as the kinematics of implant designs, such as the JI-BCS, put significant forces on the tibial component [9]. In the most severe tibial implant failure cases, tibial post fracture can occur, as seen at our institution, resulting from the JI-BCS design mechanics. Retrieved tibial inserts from fractured tibial posts have clinically confirmed the study by Gillis et al. and have a smooth fracture morphology adjacent to the tibial post base likely related to the poor ductility of the highly crosslinked polyethylene [10].

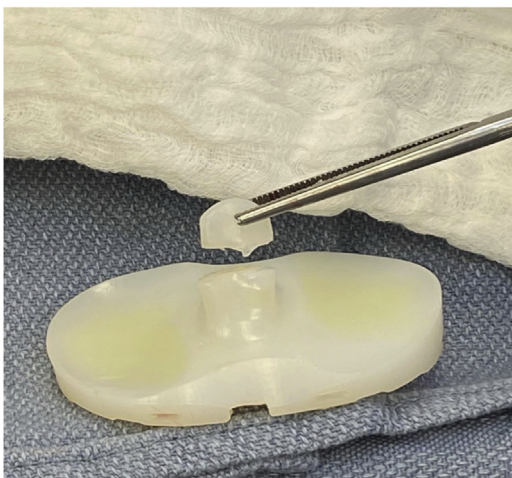
Figure 5. Intraoperative image of an explanted 9-mm Journey 1 BCS tibial polyethylene with a fracture of the tibial post and oxidation of the medial and lateral tibial compartments.

Three weeks after the presentation in the office, a revision arthroplasty was performed. Before the surgery and after induction of anesthesia, a physical examination was performed. No firm endpoint was appreciated on a posterior drawer test when slight anterior force was applied to the femur. Intraoperatively, the tibial PE showed signs of oxidation and wear on both medial and lateral sides in addition to a one-centimeter defect of the tip of the tibial post (Fig. 5). The 1 cm missing tip of the post was found in the lateral gutter and removed. The 9-mm tibial PE was removed and reimplanted with an 11-mm size and found to be stable in all planes. The femoral and tibial components were evaluated and deemed acceptable with an appropriate amount of external rotation to the tibia and femur and no significant coronal or sagittal plane malalignment. The patella tracked midline and did not show any significant amount of wear.
