Comparing two intraoral porcelain repair systems for shear bond strength in repaired cohesive and adhesive fractures, for porcelain-fused-to-metal restorations: An *in vitro* study

Aim: The objective of research was to evaluate the shear bond strength of two commercially available intraoral porcelain repair systems, Clearfil repair system (Kuraray) and P and R repair system (Shofu) for repairing cohesive and adhesive fracture in metal-ceramic restorations.

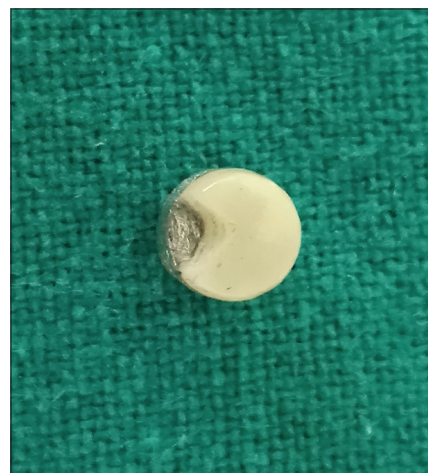
Figure 2: Adhesive fractures

Adhesive fracture [Figure 2] and cohesive fractures [Figure 3] were created in 80 test samples (40 each, respectively).

Adhesive fractures were created in 40 test samples with the help of diamond fissure bur of 2 mm diameter (GWZ 856-018 Great White diamond bur SS white) in one-fourth of the total area of the disc sample and defect was created until the metal was exposed. Whereas cohesive fractures were created in 40 test samples to expose the body ceramic by marking depth orientation grooves (1.6 mm) and reducing them to leave a uniform thickness of 0.2 mm ceramic over the metal disc.

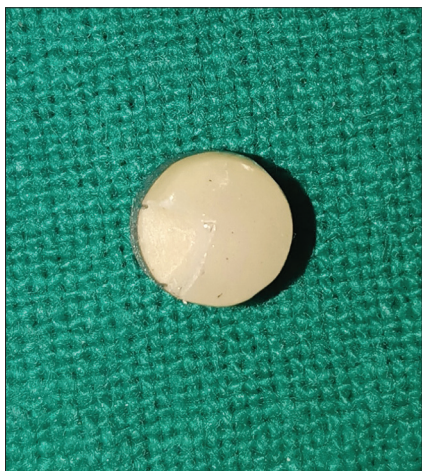
Figure 3: Cohesive fractures

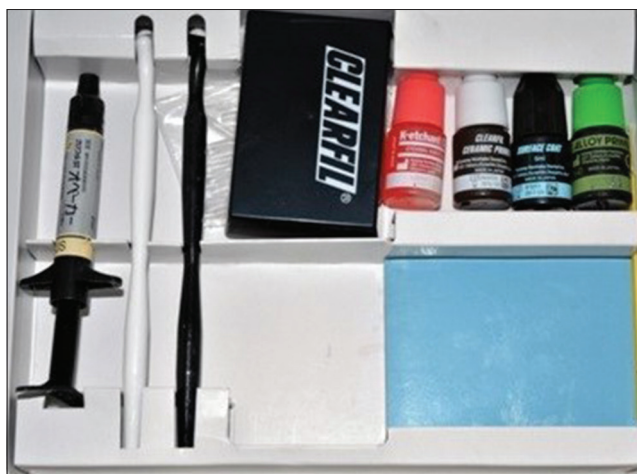
Figure 4: Clearfil repair kit

The fractured surface of exposed metal and porcelain was roughened with a diamond point, and the sharpened areas were beveled. A layer of K etchant gel was applied for 5–10 s, thoroughly rinsed with water and dried with oil-free air. Then, a thin layer of alloy primer was applied over exposed metal surface and allowed to dry for 5 s. Thereafter, thin layer of ceramic primer was applied over exposed ceramic surface and allowed to dry. Now 0.5 mm thick layer of Clearfil ST opaque [Figure 4] was applied over the treated surface and cured for 30–40 s. The composite was placed in increments to build the fractured portion, and each increment was light-cured for 30–40 s. After the fractured portion was built, it was finished properly, and thin layer of surface coat was applied over it and light-cured for 30–40 s. The same procedure was repeated for 40 samples (20 samples with adhesive defects and 20 samples with cohesive defects).

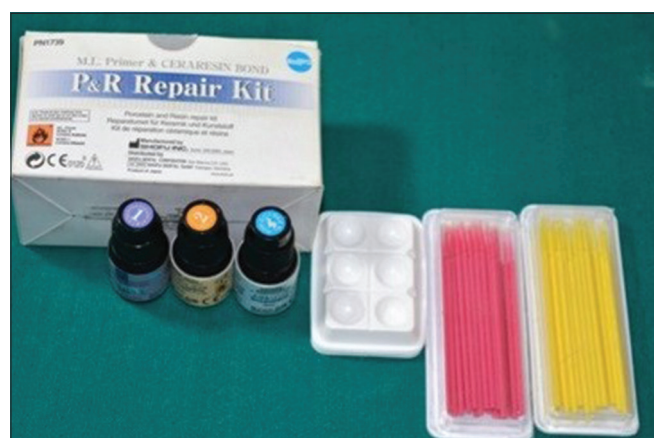
Figure 5: P and R Shofu repair kit

The exposed metal and porcelain surface was roughened and cleaned with diamond point. It was followed by the application of M. L primer [Figure 5] which was left for 10 s. Then the opaque paste was applied on the exposed metal surface and light-cured for 30–40 s, after it was cured, Cera Resin Bond 1 was applied, left for 10 s and followed by Cera Resin Bond 2 application which was again left for 10 s. Then the application was light-cured for 10 s.

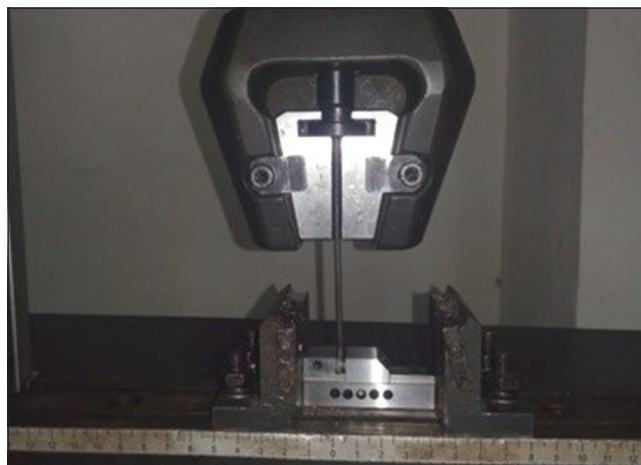
Figure 6: Testing of samples with universal testing machine machine

The shear bond strength test of 10 control group samples was done using Universal Testing Machine (UTM) (WDW-5E, Serial-20070802, Times Shijin Group) with a 10-kN load cell and 0.5 mm/min crosshead speed. A chisel load applicator was used to direct a parallel shearing force as close as possible to the ceramic metal substrate interface of samples. Shear bond strength for each sample was calculated using the formula ultimate force/area of the force application. The shear bond strength values were recorded in MPa.

To test the bond strength of metal and porcelain with repaired porcelain, repaired samples were fractured using UTM (WDW-5E, Serial–20070802, Times Shijin Group) [Figure 6] and the resulting shear bond strength was calculated.
