Case report

An unusual presentation of catastrophic failure of hip arthroplasty with a thigh mass

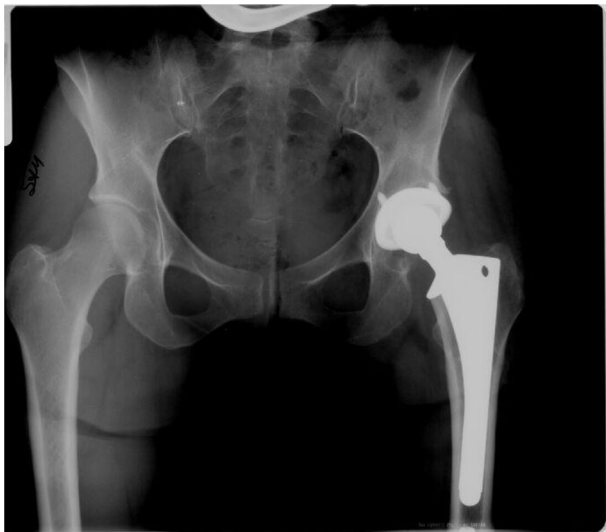
Figure 1. Anteroposterior radiograph of original left total hip arthroplasty in the immediate postoperative period.

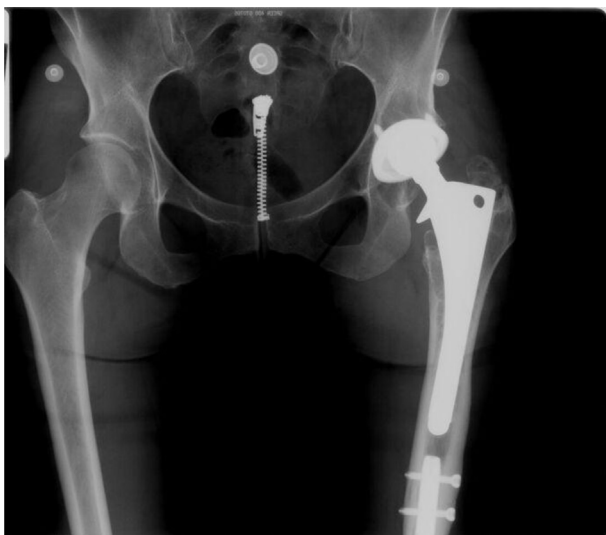
Figure 2. Anteroposterior radiograph of original left total hip arthroplasty with impending polyethylene wear-through (12 years from surgery).

Patient had excellent clinical results with her hip replacement, until she was seen in 2009 for left hip pain. Radiographs revealed polyethylene wear with impending wear-through; however, no surgical treatment was offered at that time (Fig. 2). She had no further follow-up until 2014, when she returned with a 3-month history of left hip pain and a progressively enlarging painful anterior thigh mass. She denied any infectious signs and symptoms. As a result of the pain, she was dependent on a walker for ambulation. Furthermore, she was unable to work and severely limited even with activities of daily living. Radiographs revealed left total hip prosthesis with complete wear-through of the femoral head through the polyethylene liner and the acetabular component (Fig. 3). Infectious workup resulted negative (normal C-reactive protein and estimated sedimentation rate). She underwent a computed tomography (CT)-guided hip aspiration. CT scan of the hip confirmed the acetabular protrusion of the femoral head and an anterior thigh fluid-filled mass (Fig. 4). Fluid aspiration was noted to be “dark/motor oil” in color and consistency. Samples from the hip joint and mass aspiration were negative for infectious etiology.

In 2009, the patient was noted to have polyethylene wear with impending wear-through. Often times, arthroplasty surgeons are faced with the decision to perform polyethylene exchange vs complete acetabular revision in asymptomatic patients. There is certainly no consensus in literature. One major concern for isolated polyethylene exchange is postoperative instability and dislocation [21–24]. In contrast, O'Brien et al [25] showed no dislocations with isolated polyethylene exchange. It is worth mentioning that usually patients spend less hospital days and decreased blood loss with polyethylene exchange alone [26]. Discussion with patients is important in discussing the risks and benefits of the 2 procedures. In our practice, we elect to proceed with polyethylene exchange alone when possible if significant wear is identified during surveillance postoperative imaging. Certainly, modular exchange or component revision should be offered earlier to avoid this sort of catastrophic progression of wear.

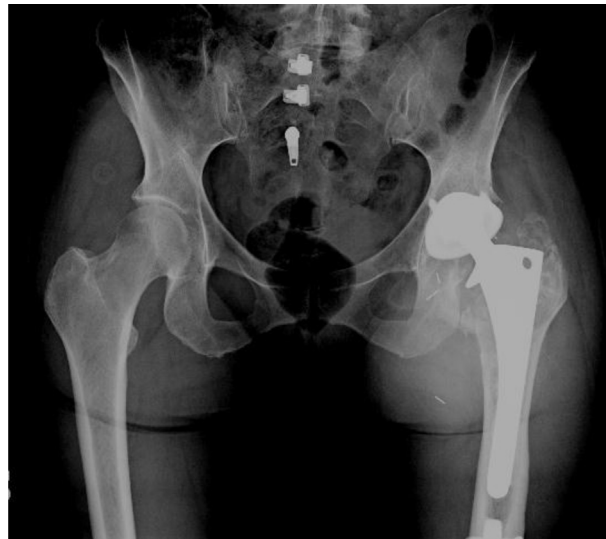
Figure 3. Anteroposterior radiograph of left total hip arthroplasty with complete wear of the polyethylene liner and the acetabular socket. The femoral head is mostly contained within the socket (17 years from surgery).
