## Case Report

# Recurrent Catastrophic Ceramic Femoral Head Failure in Total Hip Arthroplasty

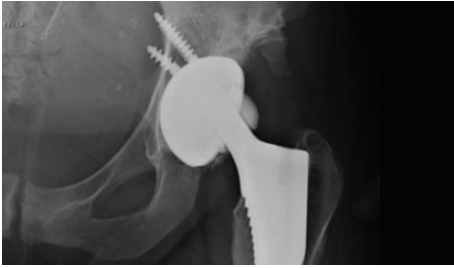
FIGURE 1: Radiograph demonstrating subtle fragmentation at the inferior head/neck junction.

Approximately twenty months after her primary hip replacement, the patient noticed that her hip began to squeak intermittently. A few months later, she was participating in moderate, low impact exercise when she experienced discomfort and a grinding sensation arising from her hip. Two days later, whilst turning over in bed, she felt significant pain and the sensation of the hip dislocating. The patient was admitted to hospital after X-rays demonstrated fragmentation of the ceramic femoral head (Figure 1). An urgent operative exploration of the hip was performed, revealing a fractured femoral head and a deeply scratched acetabular ceramic liner. The scratched liner was explanted, the fractured head fragments were removed (Figure 2),

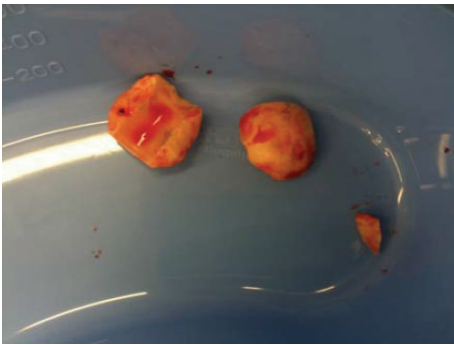
FIGURE 2: Ceramic head fragments removed at first revision.

and a thorough lavage and debridement of the operative field was performed to oust the ceramic debris. The stem and cup were well fixed and hence left in situ. The liner was renewed with a 28 mm internal diameter “ceramic insert for metallic cup” (DePuy International Ltd., Leeds, England) and a BioloX Delta Articuleze ceramic 28 mm diameter, +1.5 neck length, 12/14 tapered cone head (DePuy Orthopaedics Inc., Warsaw, IN, USA) was applied to the trunnion of the stem as before. As with the primary procedure, the patient made an uneventful postoperative recovery. Whilst the patient’s hip functioned well after the revision procedure, at subsequent outpatient based clinical reviews, the patient noted that her hip continued to squeak intermittently.

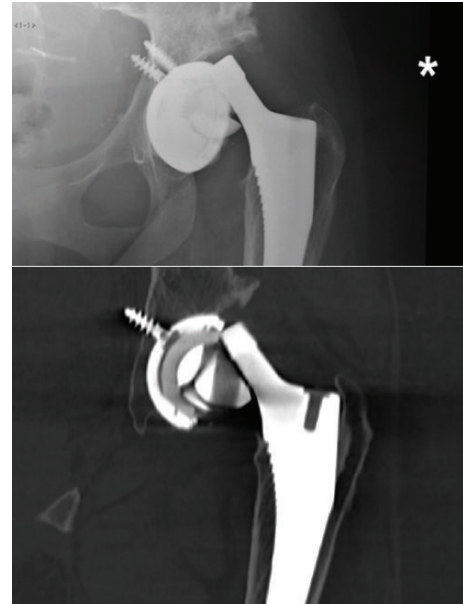
Six years following her revision procedure, the patient was again taking part in moderate, low impact exercise, when she felt a severe pain in her hip, with the sensation of the hip dislocating. Subsequent emergent radiographic investigations demonstrated a fractured ceramic head (Figure 3). After communication with the regional tertiary referral centre (where the index procedure had been performed), the patient was taken to theatre. Here, the ceramic liner was explanted together with the ceramic head fragments (Figure 4). The original metal acetabular shell was explanted and replaced with a 54 mm Delta TT cup (Lima Corporate Spa, Via Nazionale, Udine, Italy). The cup fixation was supplemented with two 6.5 mm screws. A large (36 mm) BioloX delta ceramic liner was utilized (Lima Corporate Spa, Udine, Italy). The trunnion of the well-fixed femoral component was noted to be damaged. A metallic Bio-Ball trunnion sleeve (12/14, -3.0 mm) was positioned over the scratched trunnion, and a 36 mm Bio-Ball delta ceramic head was inserted into the trunnion sleeve (Bio-Ball; Merete, Berlin, Germany).

FIGURE 3: Plain radiograph and CT scan demonstrating fragmentation and dislocation of the ceramic head.

Stripe wear is a phenomenon that describes a localized crescent-shaped surface discoloration on the ceramic head. This was demonstrated on the head fragments excised at the second revision procedure and a reciprocal discoloration was apparent on the superior aspect of explanted ceramic liner (Figure 3). One theory concerning the aetiology of stripe wear is the development of high contact stresses at the articulating surfaces as a result of an abducted cup position. Another reported theory is that of microseparation of the bearing surfaces during the gait cycle. Large separations of the articulating surfaces may result in high-impact loads and the risk of considerable damage to the ceramic [8]. Perhaps this could be in keeping with our patient developing symptoms whilst performing moderate exercise.

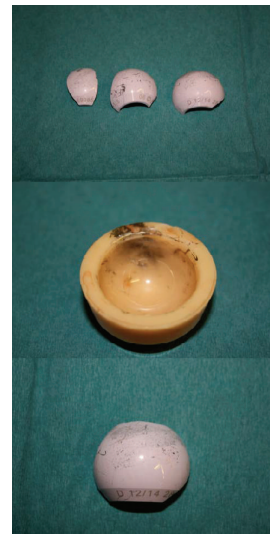
FIGURE 4: The ceramic components removed at the second revision procedure.

The head bore is a tapered hole created in a modular femoral head into which the Morse taper of the femoral component is inserted. The distance between the corner of the bore and the external surface of the ceramic head is less in short-neck tapers when compared with medium or long-neck tapers. In our case report, the ceramic head had a neck length of  $+1.5$  mm in both the index and revision procedures. This observation may suggest that the risk of ceramic head fracture is increased when short-neck taper components are utilized. This theory is reinforced by a multicentre retrospective study of 312 patients who underwent ceramic-on-ceramic total hip arthroplasty [9]. In this cohort, 5 patients suffered ceramic head fractures, with all 5 individuals having a short-neck ceramic head in situ. Of interest, the pattern of head fracture demonstrated in our case (Figure 3) is identical to that in the study by Koo et al., involving the thinnest circumferential portion of the head, adjacent to the proximal edge of the head bore, with vertical cracks extending from the circular crack to the lower edge of the head component.

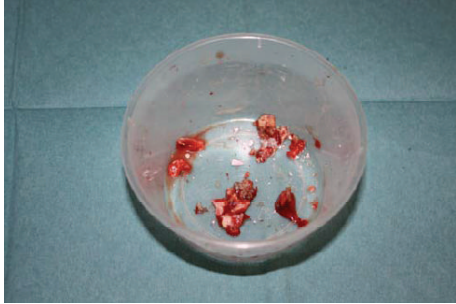
FIGURE 5: Ceramic debris excised from the soft tissues.

A thorough lavage and debridement of the operative field was performed in an attempt to remove all of the ceramic debris (Figure 5). The immediate postoperative recovery was uneventful, and the patient was discharged home at day 7 postoperatively (Figure 6). At the time of writing, 5 months after the second revision procedure, the patient was walking independently, with good hip function and with no further squeaking emanating from the hip joint.

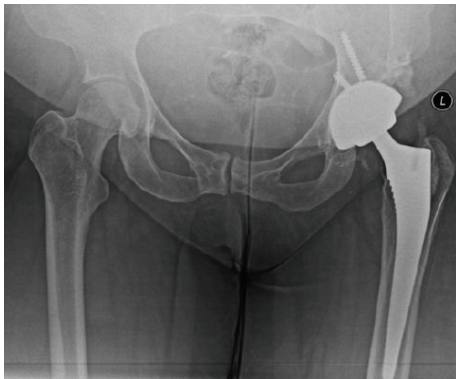
FIGURE 6: Acetabular component revised to a less abducted position. Ceramic bearings changed and trunnion sleeve utilized.

revision, however, despite the cup remaining well fixed, it was explanted, and a new cup was inserted in a more closed position compared with the primary component. Perhaps revising the cup after the first ceramic fracture would have prevented the second failure. In contrast to this theory, however, no link has been established between a high cup inclination angle and ceramic head fracture and, therefore, it is debatable as to whether adjusting the cup position at the first revision procedure would have prevented the second ceramic head fracture.
