CASE REPORT

Coronary artery perforation after bioresorbable scaffold implantation treated with a new generation covered stent—OCT insights

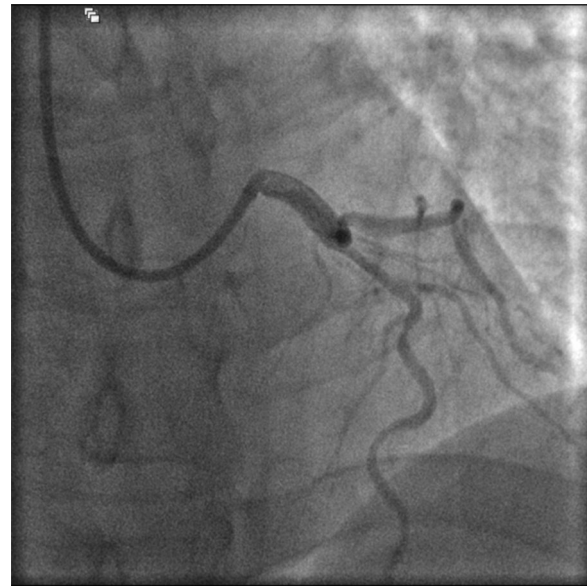
Fig. 1 Proximal LAD stenosis involving bifurcation with first diagonal branch (Medina-1, 1, 0) with FFR of 0.64. Given the patient's young age and suitable target lesion characteristics, it was felt an Absorb BVS was preferred over a permanent metallic implant

The target lesion in the proximal LAD was a long segment and involved the bifurcation with the first diagonal branch (Medina 1, 1, 0) (Fig. 1). In the context of his young age and suitable target lesion characteristics including the lesion length and the mild degree of calcification, an Absorb bioabsorbable vascular scaffold (BVS) (Abbott Vascular, Santa Clara, CA, USA) was therefore selected, avoiding a permanent metallic implant and preserving future revascularisation options. Following right trans-radial access, the LAD and first diagonal branches were wired employing an angiographic-guided, provisional bifurcation PCI strategy using an EBU 4.0 guide catheter (Medtronic, Minneapolis, USA). The mid LAD was pre-dilated with a 3.0 mm Hiryu (Terumo Medical, Tokyo, Japan) non-compliant monorail balloon and given full balloon expansion was achieved, the target lesion was then covered with a 3.5 × 28 mm Absorb BVS implanted at 14 atm (deployed across the diagonal side-branch, protected by a jailed-wire). Although the target lesion

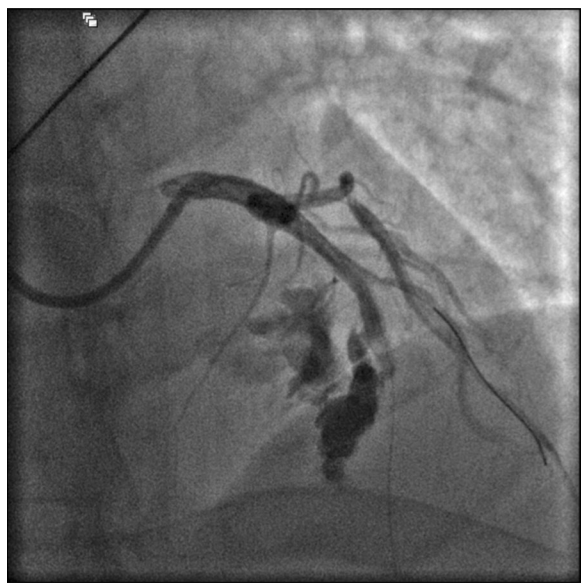
Fig. 2 Large Ellis type III coronary perforation at distal edge of the BVS with no flow to distal LAD beyond the rupture. Prolonged balloon inflation immediately proximal to the site of perforation combined with fluid and vasopressor support achieved haemodynamic stability

Following post-dilation of the distal segment of the scaffold, widespread ST elevation and profound hypotension ensued. Angiography revealed a large, Ellis type III coronary perforation at the distal edge of the scaffold with no flow to the distal LAD beyond the rupture (Fig. 2), associated with a large pericardial effusion confirmed on bedside TTE. Prompt intravenous fluid and vasopressor support were administered and stability was initially re-established with a prolonged balloon inflation within the Absorb BVS immediately proximal to the site of perforation, permitting urgent insertion of a pericardial drain (Merit Medical, South Jordan, Utah, USA). 400 ml of blood was aspirated, with resolution of the hypotension, but despite this the chest pain and ST

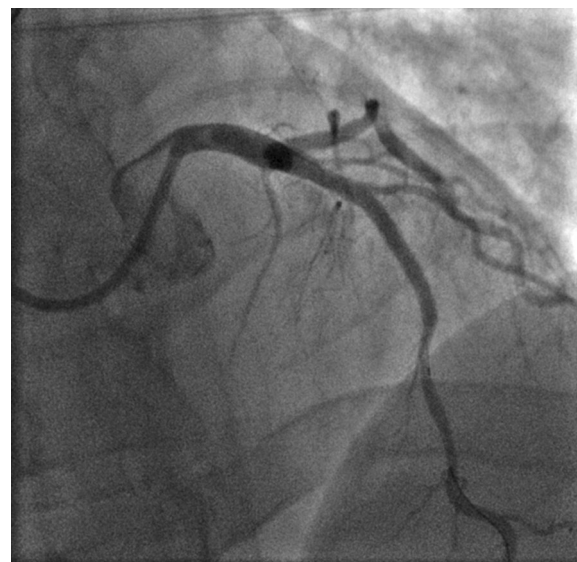
Fig. 3 A 3.0 × 21 mm BeGraft covered stent deployed across the perforation distal to the diagonal side-branch at 14 atm, with approximately 10 mm of overlap between the Absorb BVS and the covered stent. Subsequent angiography demonstrated normal LAD flow and resolution of the perforation

elevation persisted. As angiography during transient balloon deflation showed a large and persistent perforation, a 3.0 × 21 mm BeGraft covered stent (Bentley Innomed, Hechingen, Germany) was passed via the same right radial guide access and deployed across the perforation (distal to the diagonal side-branch) at 14 atm, with approximately 10 mm of overlap between the Absorb BVS and the covered stent. This lower profile device passed easily and smoothly through the Absorb BVS with no hold up. Covered stent implantation restored normal LAD flow angiographically and abolished the perforation (Fig. 3). The patient's chest pain rapidly resolved and correspondingly the ST segments became isoelectric. Heparin reversal was not performed and cardiopulmonary resuscitation was not required at any stage as despite initial profound hypotension, the patient remained conscious throughout the procedure. Haemodynamic stability was subsequently maintained and there was no re-accumulation of the pericardial effusion post-PCI. Sinus rhythm was maintained throughout with no arrhythmias noted during the event.

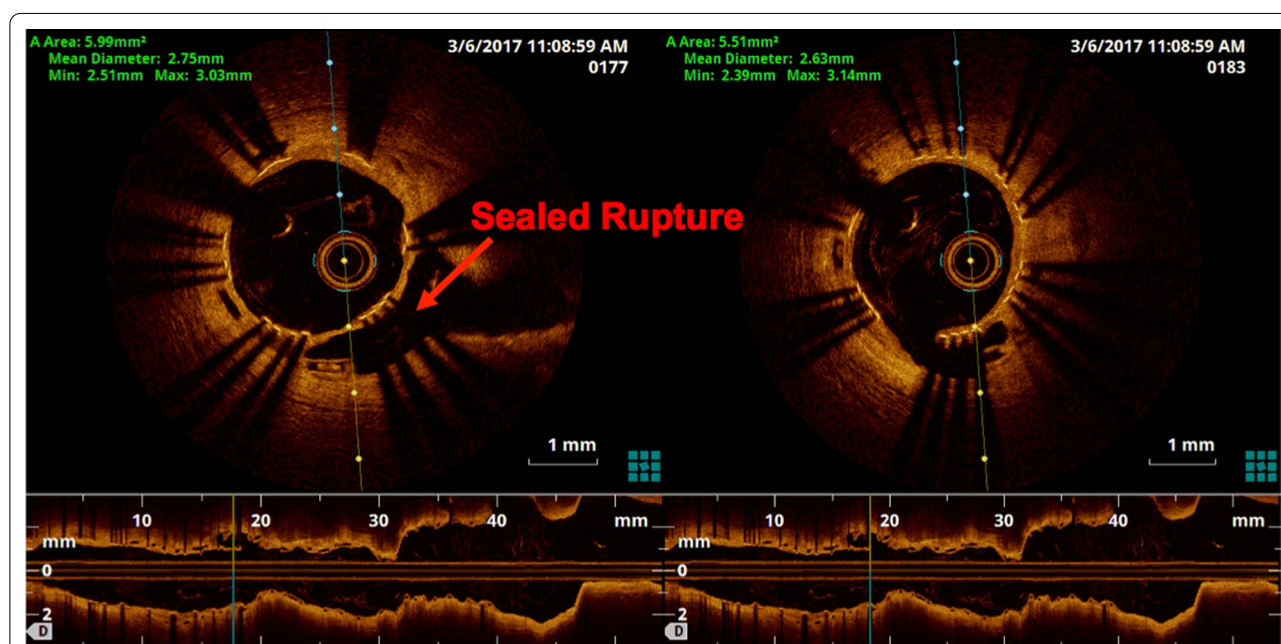
Fig. 4 OCT demonstrating very short segment of malapposition of BeGraft in Absorb BVS at proximal overlap margin

was a short segment of malapposition between the two devices at the proximal overlap margin adjacent to the area of sealed rupture and perforation (Fig. 4, Additional file 1: Fig. S5). There was otherwise good expansion and apposition of the BeGraft within the remaining distal overlap segment with the Absorb BVS but incomplete strut coverage (Fig. 5, Additional file 2: Fig. S7). There was evidence of neo-intimal hyperplasia and mild in-stent restenosis in the distal (non-overlap) portion of the BeGraft covered stent. Given these findings, no further intervention was performed.

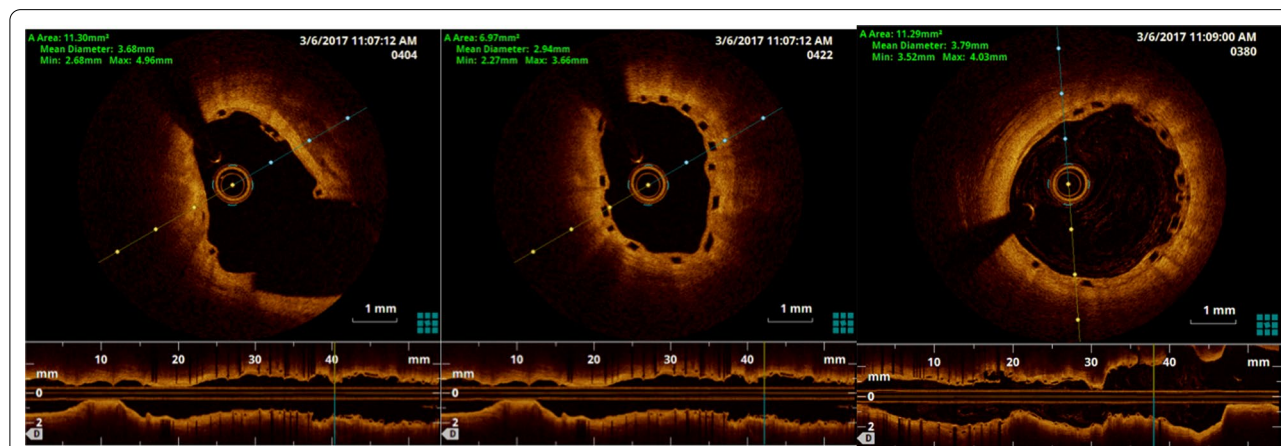
Fig. 5 OCT demonstrating Absorb BVS well expanded proximal to BeGraft overlap
