Migration of a double J stent into the inferior vena cava

A case report

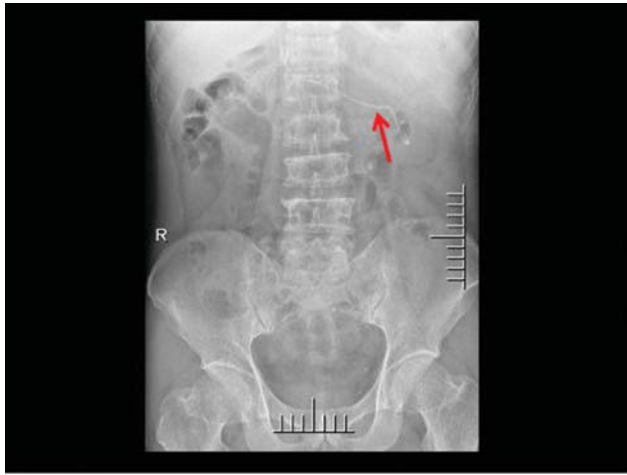
Figure 1. KUB x-ray film revealed an abnormal pathway of the double J stent that probably entered into the inferior vena cava. The red arrow shows the position of the double J stent. KUB=kidney ureters and bladder.

A 53-year-old male patient with a history of long-standing left renal calculi underwent left-side pyelolithotomy with postoperative placement of a DJS at a county hospital on April 2016. However, the stent placement was not performed under fluoroscopy guidance and postoperative imaging examinations were not performed to confirm the DJS position. The patient was advised for stent removal after 5 months. Surprisingly, kidney, ureters, and bladder (KUB) x-ray film showed that the DJS was not in the right location and appeared to enter into the IVC (Fig. 1).

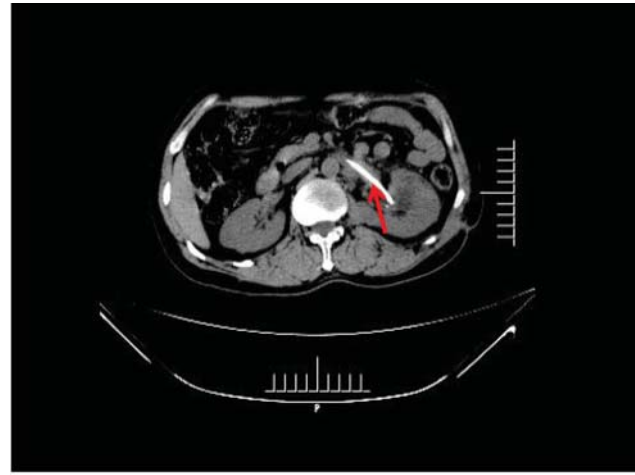
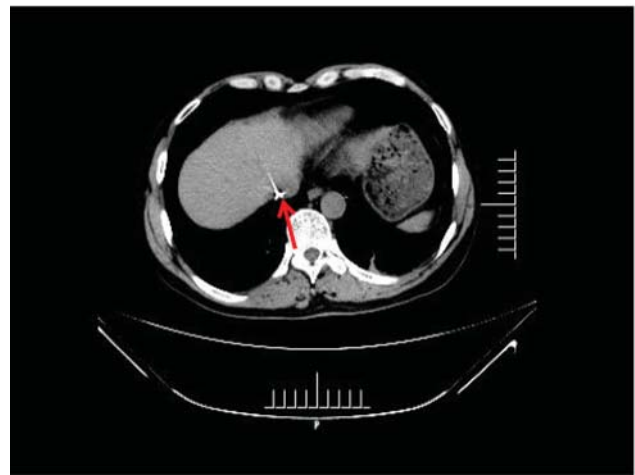
Figure 2. CTU scan confirmed that the double J stent was in the inferior vena cava (red arrow). CTU=computed tomography urography.

was positive with a growth of *Enterococcus faecalis*. Color Doppler flow imaging (CDFI) showed the formation of small mural thrombus in the IVC. Therefore, the patient was assigned to treatments with anticoagulants and antibiotics. The next-day computed tomography urography (CTU) was performed to assure the position of the stent. In combination of left-side hydronephrosis, migration of the DJS into the IVC was seen at the level of the left renal vein. The proximal coil was in the IVC and the distal coil was in the left renal pelvis (Fig. 2). Then, we performed percutaneous nephroscope under C-arm guidance by using 18G puncture needles and 20 Fr working sheaths. The distal coil of the DJS was visualized and removed successfully under nephroscope without any complications. A new DJS was placed and its location was confirmed by radiologic imaging (Fig. 3). After the operation, the patient was transferred to intensive care unit (ICU) and treated with continued anticoagulants and antibiotics. Fifteen days after the operation, CDFI showed there was no thrombus in the IVC. The patient was discharged 16 days after the operation with symptom free and the follow-up was uneventful.

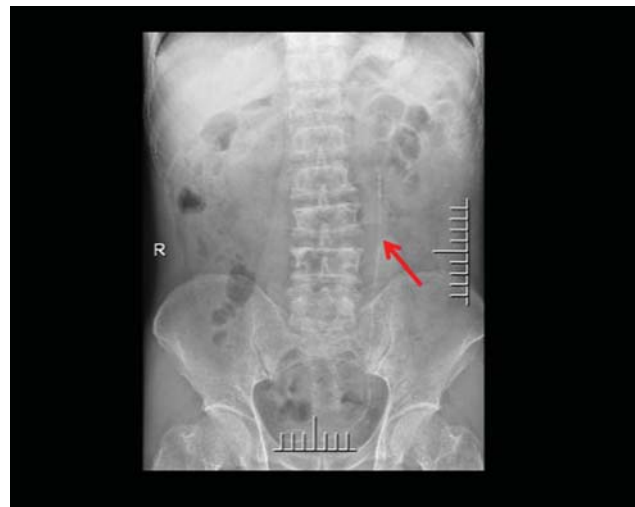
Figure 3. KUB x-ray film showed a new double J stent was placed into the left ureter (red arrow). KUB=kidney ureters and bladder.
