Bilateral periprosthetic tibial stress fracture after total knee arthroplasty: A case report

INTRODUCTION: Periprosthetic fractures around the knee after total knee arthroplasty can be seen in the femur, tibia and patella. The tibial fractures are rare cases. Our case with bilateral tibial stress fracture developed after total knee arthroplasty (TKA) is the first of its kind in the literature.

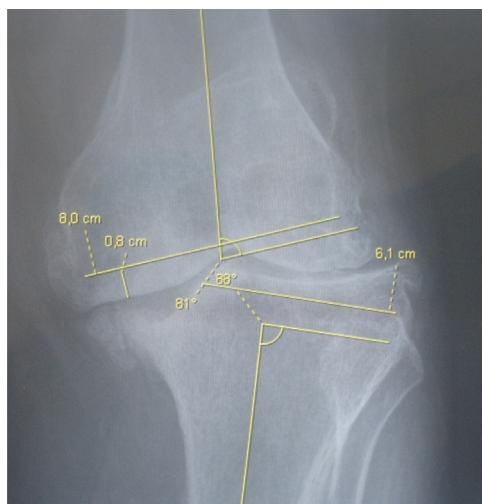
75-year-old male patient with bilateral knee osteoarthritis had not benefited from conservative treatment methods previously applied. Kellgren-Lawrence stage 4 gonarthrosis was detected in his radiographies and TKA was decided to be applied (Fig. 1, Fig. 2). Hypertension, under controlled with treatment, was only present in the case and he was assessed in ASA risk group 2.

Fig. 1. Preoperative planning.

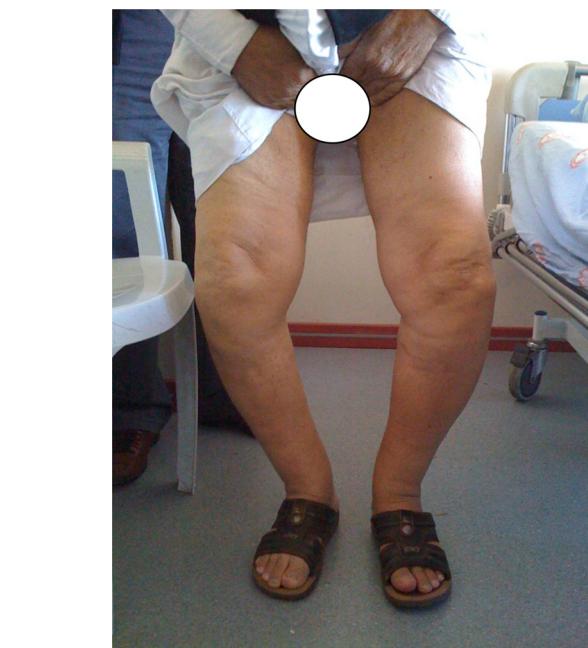
Fig. 2. Preoperative clinical view of the patient.

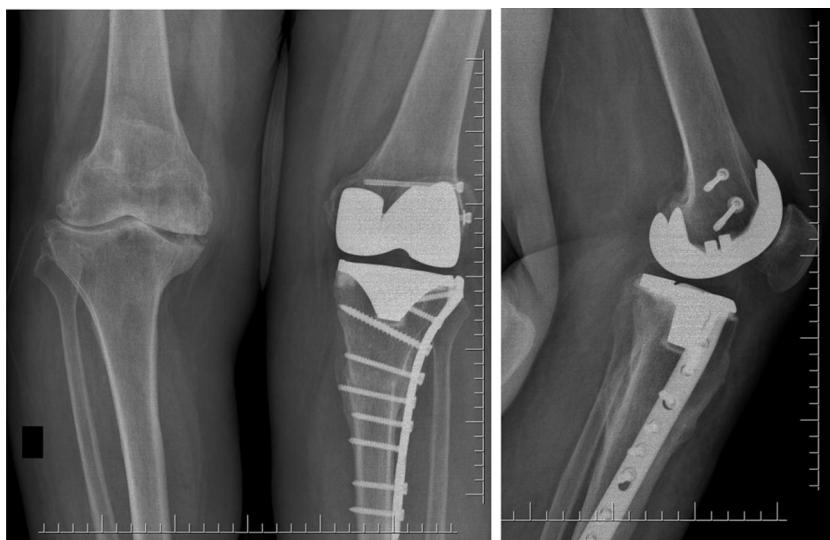
the tibia in the second month postoperatively, Felix [2] (Table 1) fracture type 3A periprosthetic tibial fracture was identified in the upper end of the tibia and osteosynthesis was implemented with locked tibia proximal plate-screw. Bone union in 12 weeks was observed in his follow-ups (Fig. 3).

Fig. 3. ORIF of the periprosthetic stress fracture of the left knee and severe osteoarthritis of the right knee.

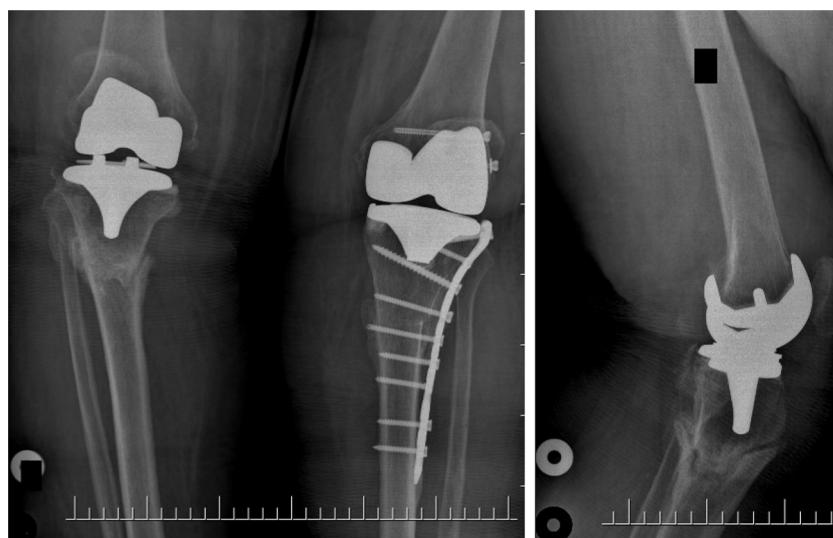
After 15 months of his first TKA operation, another TKA was applied to the right knee of the patient under spinal anesthesia. In the radiographic examination of the patient who presented with complaint of pain postoperatively in the second tibial proximal, as in the first operation, Felix [2] Type 3A periprosthetic tibial fracture was detected (Fig. 4). Osteosynthesis with locking plate-screw

Fig. 4. Periprosthetic stress fracture of the right knee.

Felix et al. have developed a classification system after examining 102 periprosthetic tibial fracture after TKA cases [2]. This classification includes four types and three subgroups (Table 1). Our patient's right and left periprosthetic tibial fractures [2] were assessed as Type 3A according to the classification system. Prostheses were evaluated as stable on both sides and internal fixation was performed with open reduction and anatomical locking plaque. Bone union in 12 weeks was observed on both sides in follow-ups.

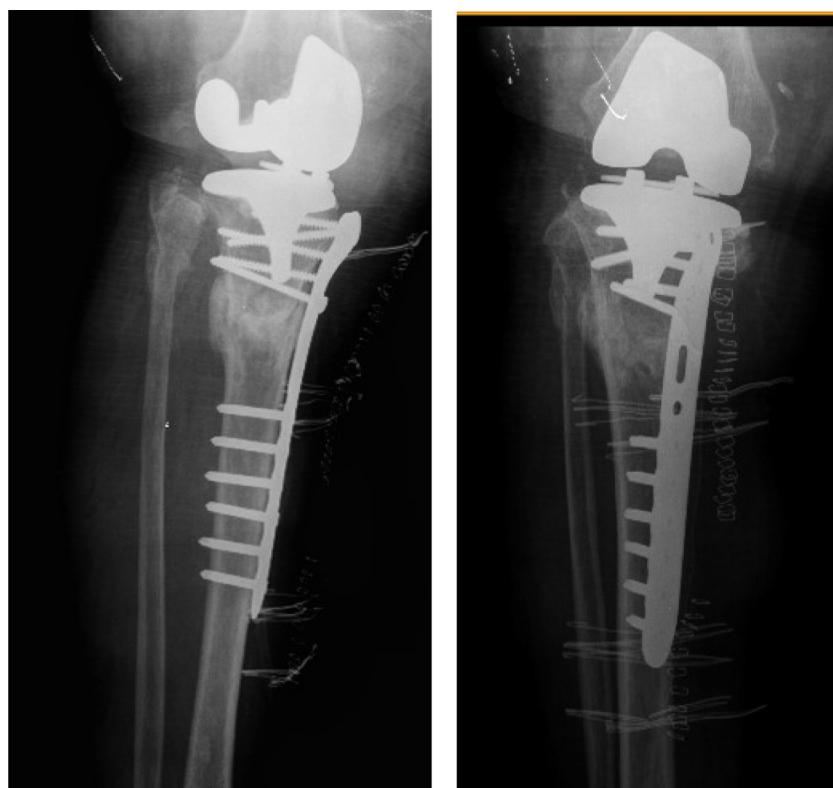
was applied and union in 12 weeks was observed in his follow-up (Fig. 5).

Fig. 5. ORIF of the periprosthetic stress fracture of the right knee.
