Removal of bent intramedullary nail

Two case reports

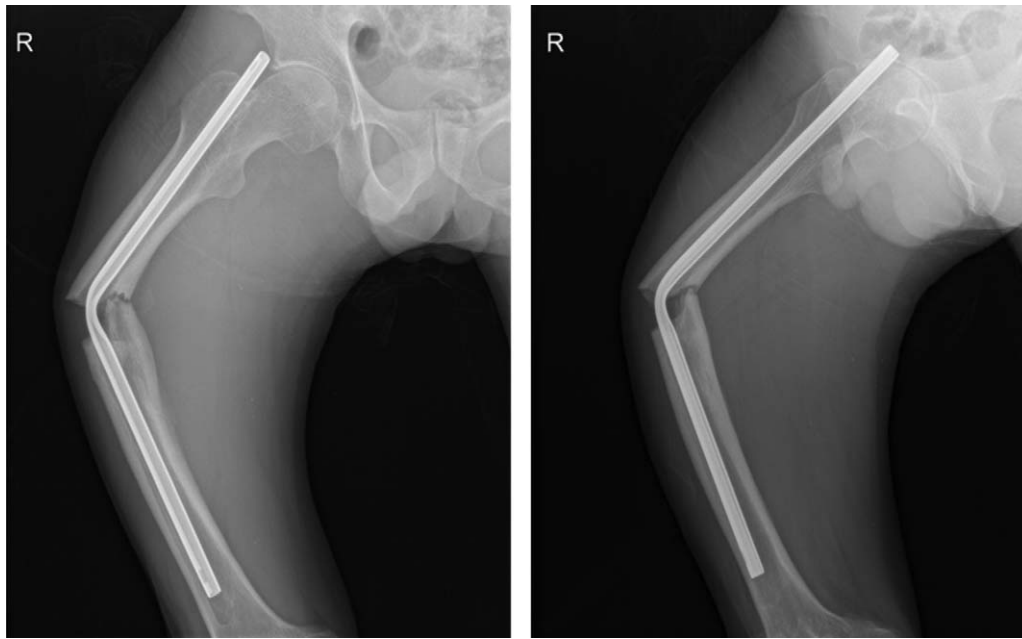
Figure 1. Radiographs showing a refracture of the right femoral shaft and a bent IM nail with 60.1° varus deformity.

and lateral radiographs obtained in the emergency room revealed a refracture of the right femoral shaft and a bent IM nail (Fig. 1). The initial varus deformity of the nail was 60.1° in the coronal plane. We tried closed manual reduction of the fracture and bent nail with analgesics in the emergency room. After reduction, the

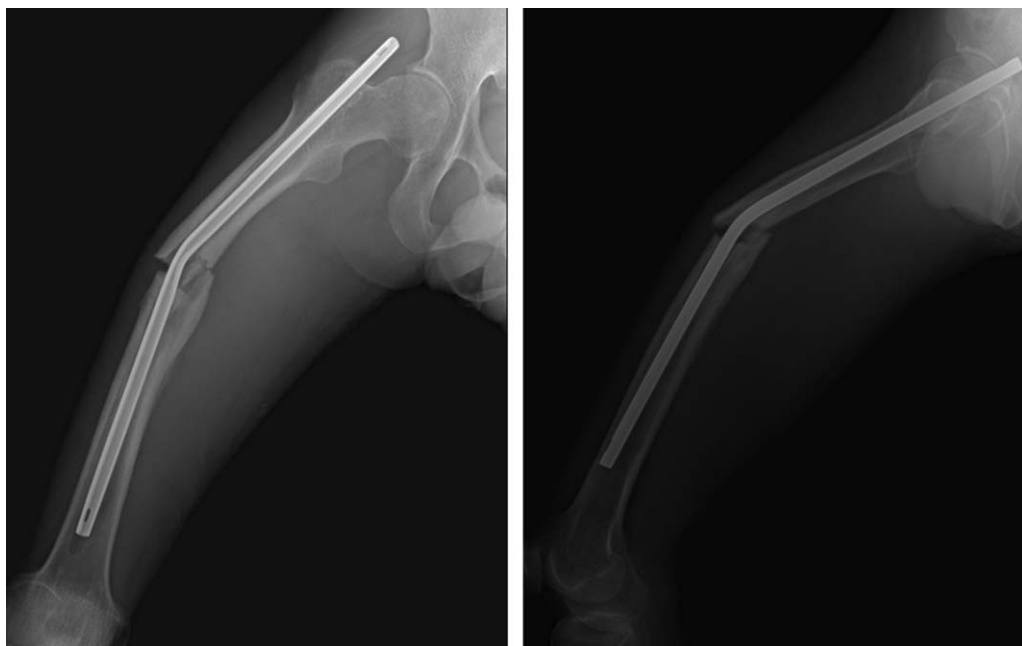
Figure 2. After initial reduction at emergency room, the varus deformity was decreased into 26.0°.

varus deformity was decreased to 26.0° in the coronal plane (Fig. 2).

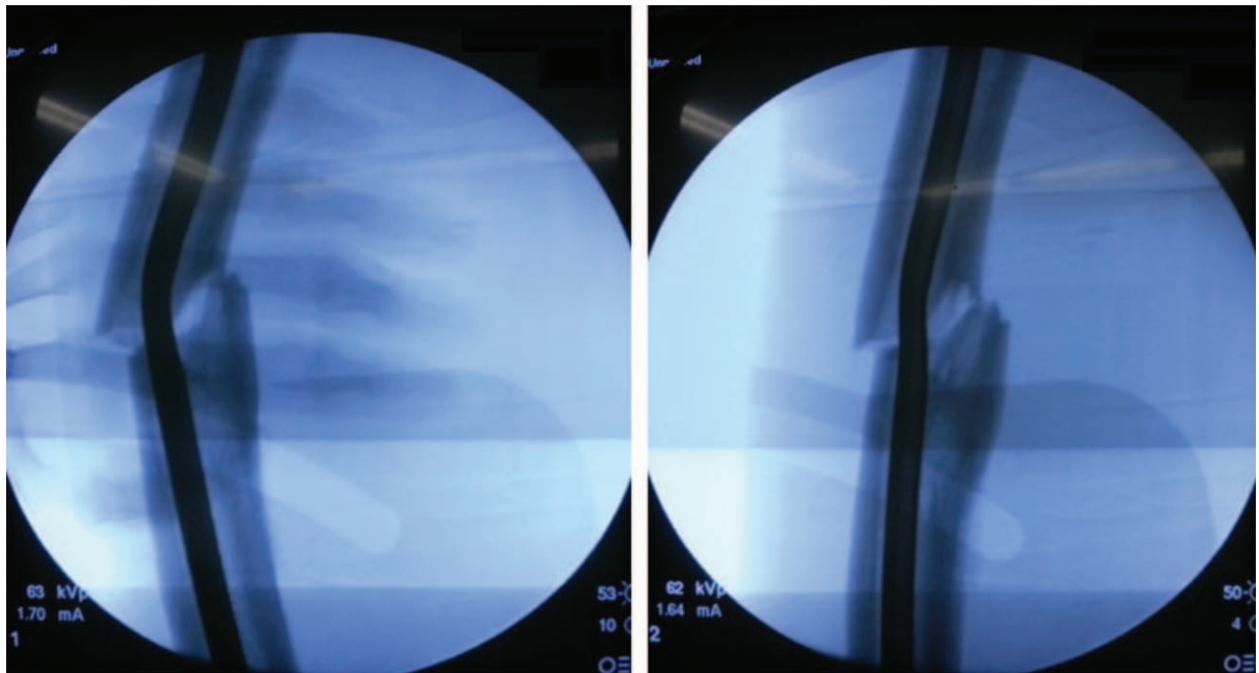
Figure 3. Fluoroscopic images showing a bent nail (A) and much corrected nail after closed manipulation (B).

After the nail was straightened (Fig. 3), the entry site of the nail at the greater trochanter was exposed through a 5 cm skin incision. The nail was extracted smoothly by the standard method and in one piece. After nail extraction, the reaming of the intramedullary canal was performed to a diameter of 13 mm. A new IM nail (12 mm × 380 mm) was inserted through the previous insertion site and fixed with locking screws (Fig. 4). There were no postoperative complications and the patient was mobilized with

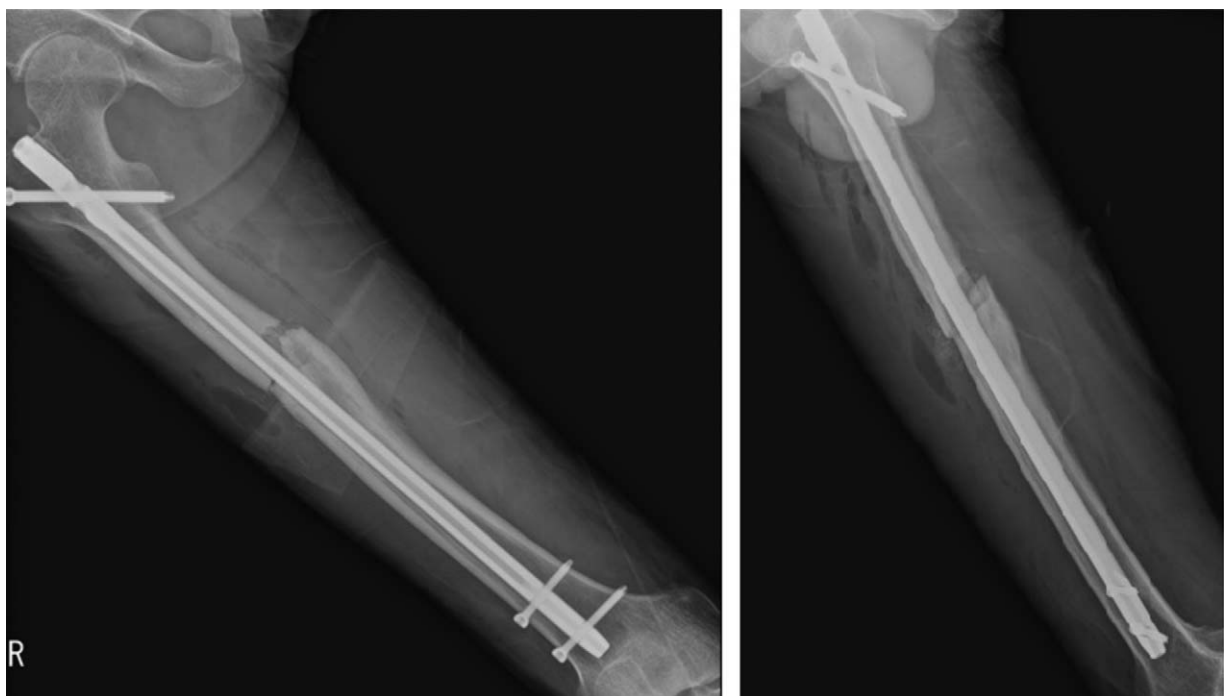
Figure 4. Radiographs after exchanging nailing using a new nail.

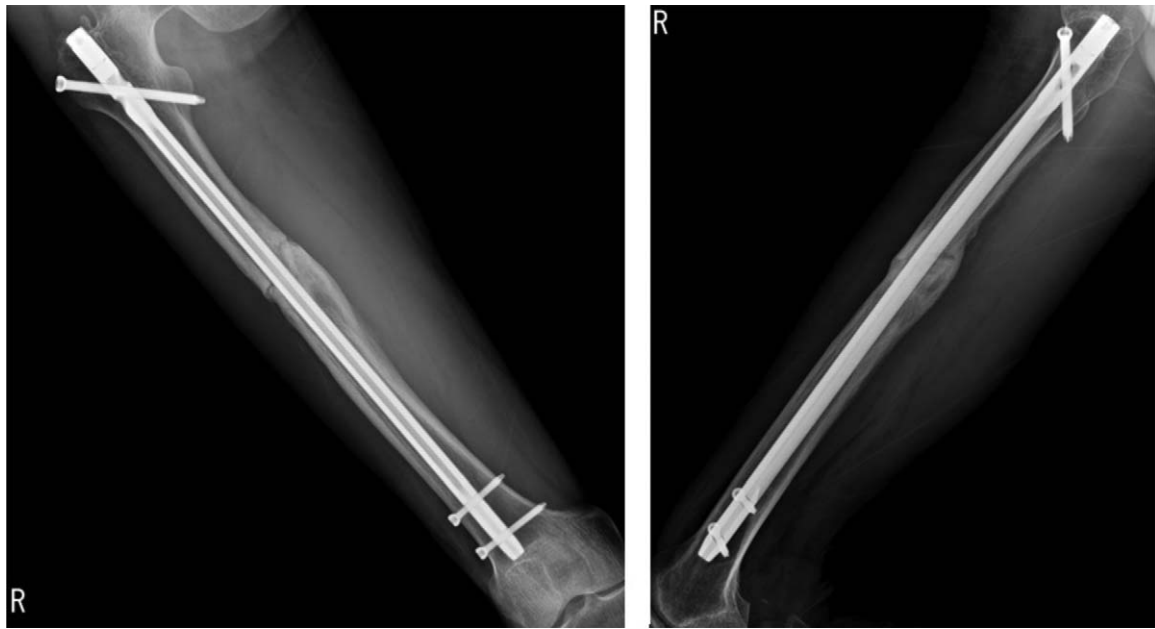
Figure 5. Radiographs showing the complete healing of the femoral shaft fracture.

partial-weight bearing assisted with a crutch on postoperative day two. One year after surgery, the fracture union was complete and the patient was pain-free (Fig. 5). The range of motion in the hip and knee were normal.

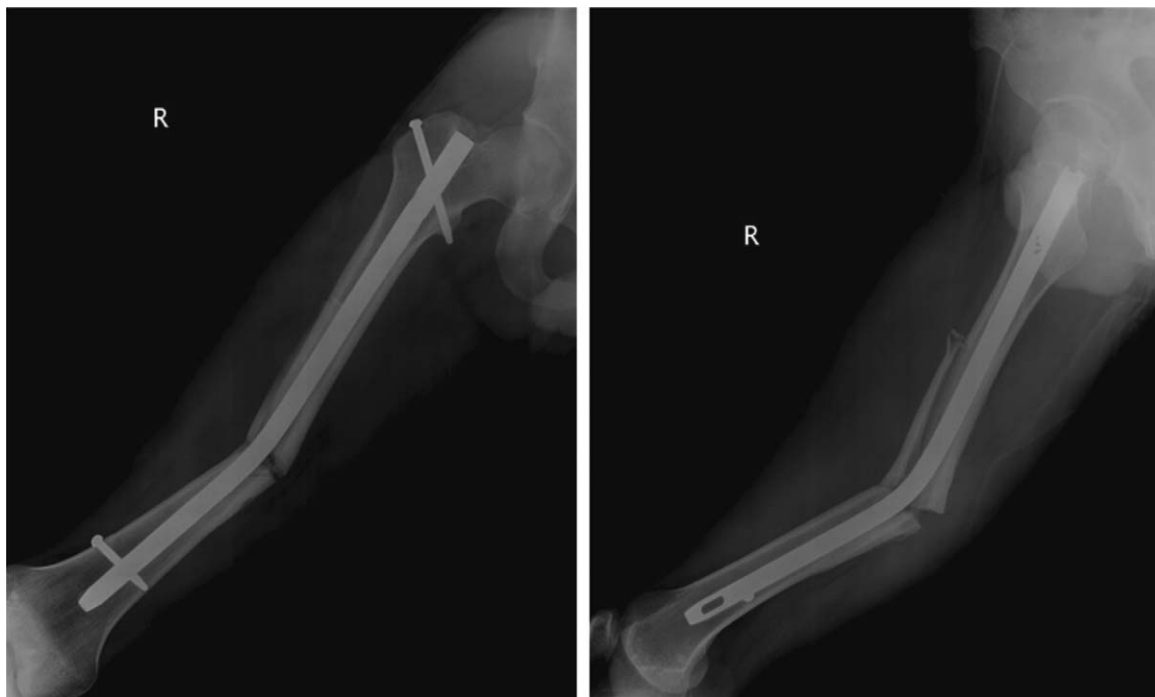
Figure 6. Radiographs showing bent IM nail with an apex-posterior angulation of 34.8° in the sagittal plane.

nail at our centre three years before, presented again after falling down the stairs. The incident had resulted in a refracture of the femoral shaft with posterolateral bending of the nail. The valgus deformity of the nail was 16.1° in the coronal plane with an apex-posterior angulation of 34.8° in the sagittal plane (Fig. 6). Removal of the nail and internal fixation were indicated.

The patient was placed in the left lateral decubitus position under general anesthesia. Initially, a closed manipulation of the bent nail was attempted under C-arm image intensifier control, but no difference in the valgus deformity was achieved. Intraoperatively, the skin was incised for a length of 15 cm above the bent part of the nail. Using a high-speed cutting burr,

the apex part of the bent nail was progressively sectioned until the nail could be straightened. During this procedure, soft tissues were protected and permanently irrigated while any metal debris was carefully removed with the suction. Afterwards, the nail was extracted through the original incision at the hip. However, in the process of extracting the nail, the comminution of the fracture site was extended and had to be fixed with a cerclage wire. Then the femoral canal was reamed to 13 mm and a new nail (13 mm × 360 mm) was inserted (Fig. 7). No complications occurred postoperatively. Six months after surgery, the fracture union was complete with sufficient callus formation around the fracture site (Fig. 8).

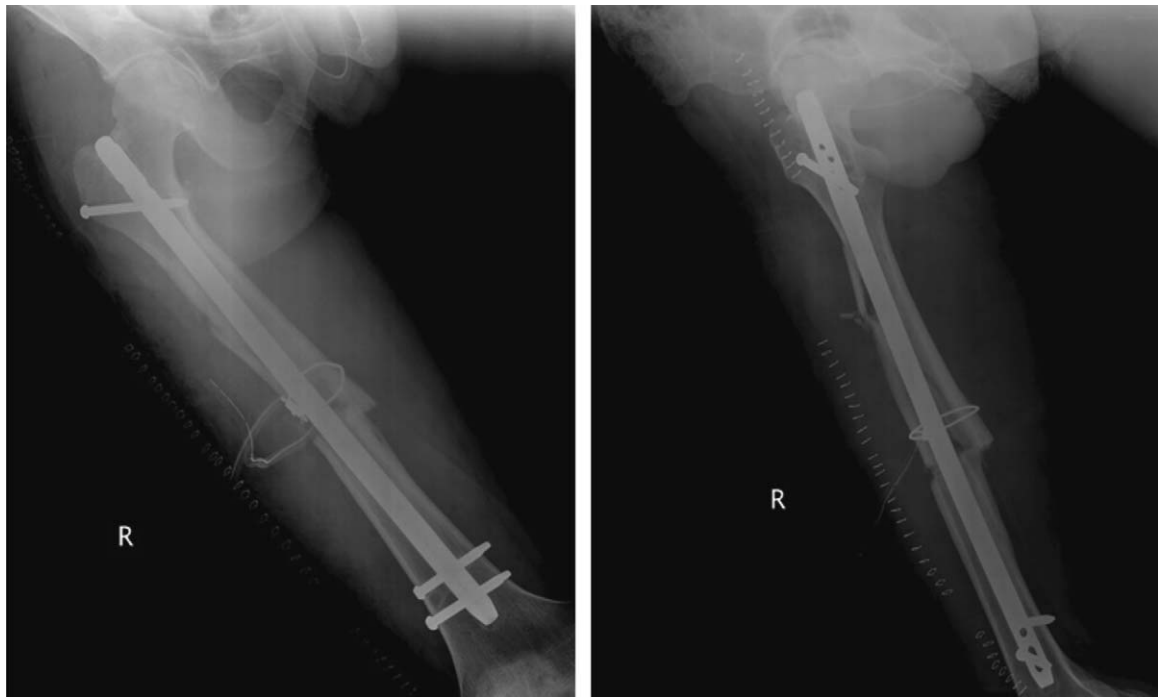
Figure 7. Radiographs after exchanging nailing using a new nail and a cerclage wire to fix the extended comminution of the fracture.

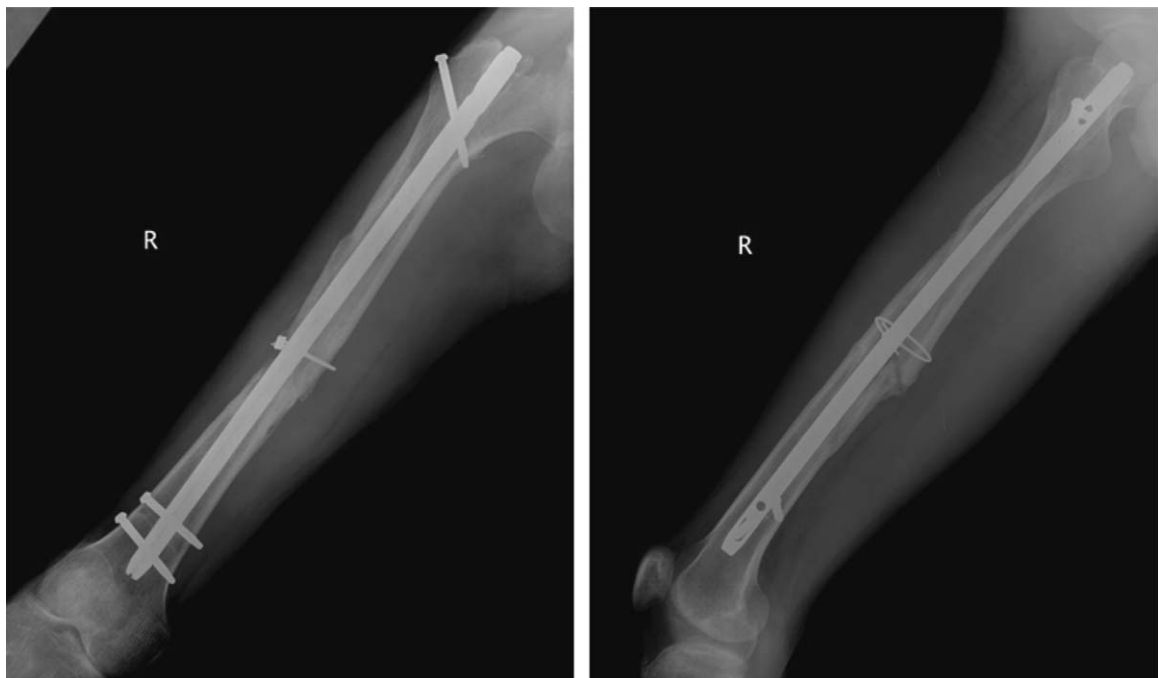
Figure 8. Radiographs showing the complete healing of the femoral shaft fracture.
