Paediatric elbow fractures and public play spaces: adherence to standards for children's playground equipment and surfacing

To cite: Smith J, Chhina H, Sidhu P, *et al*. Paediatric elbow fractures and public play spaces: adherence to standards for children's playground equipment and surfacing. *BMJ Paediatrics Open* 2021;**5**:e001125. doi:10.1136/bmjpo-2021-001125

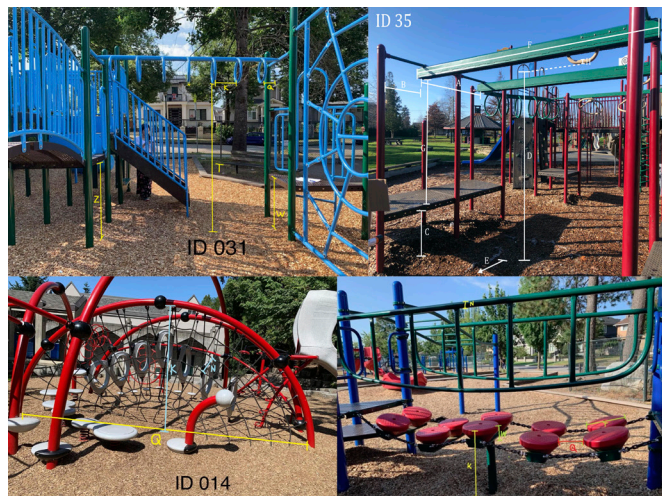
Figure 1 Examples of play structure types. Clockwise from top left: upper body structure, track ride, unclassified bridge and climbing net structure. The notations on the pictures were used by the research assistants to populate the data set in Excel.

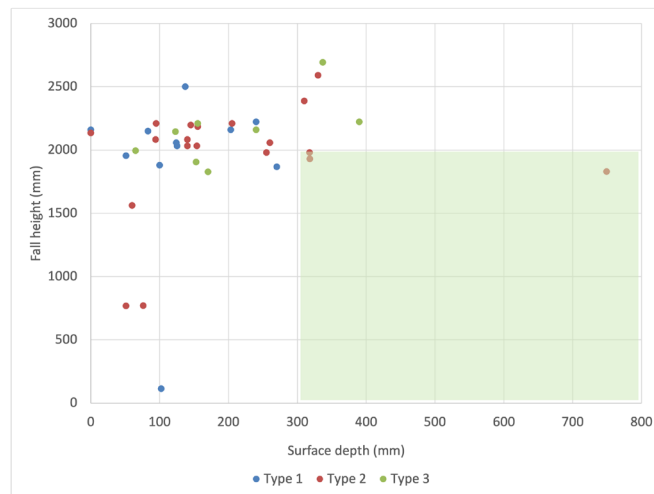
Figure 2 Injury severity by fall height and surface depth in millimetres. Fall height could not be determined in two cases and surface depth was not applicable or could not be measured precisely in seven cases; a total of nine cases were excluded from the figure. Green zone represents alignment with the Canadian Standards Association (CSA) standards, as applicable.

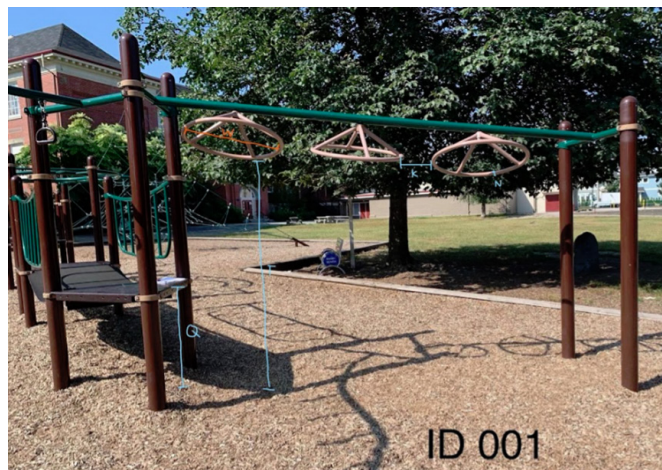
Five children were injured at five sites falling from rotating structures (figure 3). One contained a single rotating component while the other four play structures comprised multiple units. The minimum recommended CSA standard clearance between such components is 1800 mm, yet all four multiunit structures were well below this minimum, ranging from 248 to 609 mm of clearance. Two did not have a speed-limiting device. The children who were injured playing on these most often reported that they fell after knocking into another child on the adjacent rotating component.

Figure 3 Example of rotating structure.
