Case Report

Airbag-related penetrating injuries: A case series from a level 1 trauma center

^a Department of Surgery, Trauma Surgery, Hamad Medical Corporation, Doha, Qatar

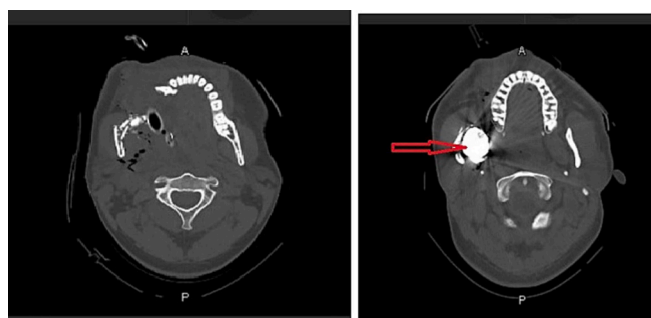
Fig. 1. CT scan for case 1 (arrow: foreign body).

A 29-year-old male restrained driver of a 13-year-old compact sedan was injured in a head-on collision. Paramedics found him lying prone outside his car, the airbag was noted to have deployed. He had a Glasgow coma scale (GCS) of 15 and was noted to have a large laceration on the right jaw. In hospital he was conscious and alert but due to the risk of a compromised airway, he was intubated electively. He had no other obvious injuries. His head computerized tomographic (CT) scan films showed a severely comminuted fracture involving the right hemi-mandible with dislocation of the right temporomandibular joint. A $2.2 \times 2.1 \times 2.1$ cm hyperdense foreign body (FB) was seen in the vicinity of the fracture fragment at the level of the right ramus. Multiple fractures of the anterior and lateral walls of the right zygoma and maxillary sinus reaching the floor of the right orbit were also noted (Fig. 1).

The patient was taken to the operating room (OR) and underwent exploration with retrieval of a round metallic FB and open reduction and internal fixation (ORIF) of the mandible. His post-operative course was uneventful, and he was discharged home 14 days after admission.

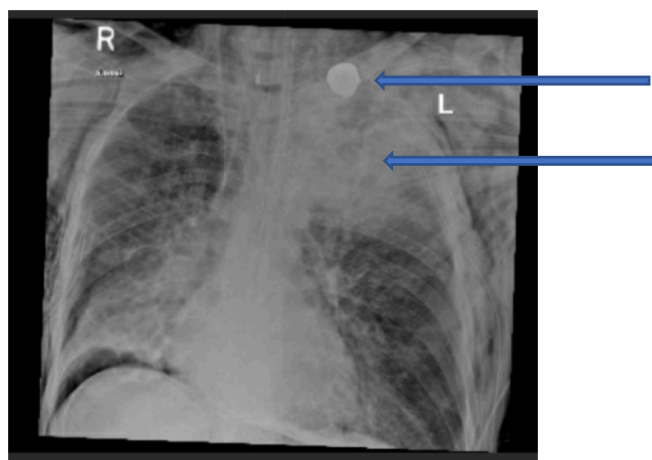
Fig. 2. Chest X-ray revealing a foreign body in the left upper chest with significant contusions for case 2 (upper arrow: foreign body; lower arrow: lung contusion).

A 43-year-old male intoxicated restrained driver of a 3-year old sedan was injured in a frontal collision with a fixed object. There was significant damage to the vehicle and the patient was entrapped. When the paramedics arrived he had a GCS of 12, was tachycardic with a systolic blood pressure (SBP) of 90 and an oxygen saturation below 80 %. He was also noted to have a sucking wound in the left upper chest with active bleeding. The patient was intubated at the scene, and a 3-sided dressing was applied to the wound, and a needle decompression was performed. In the trauma bay, a left-sided chest tube was inserted, however his saturation did not significantly improve. A chest x-ray (CXR) showed significant lung contusions with a rounded metallic FB noticed in his upper chest and a diffuse subcutaneous emphysema with mild pneumothorax were noted (Fig. 2).

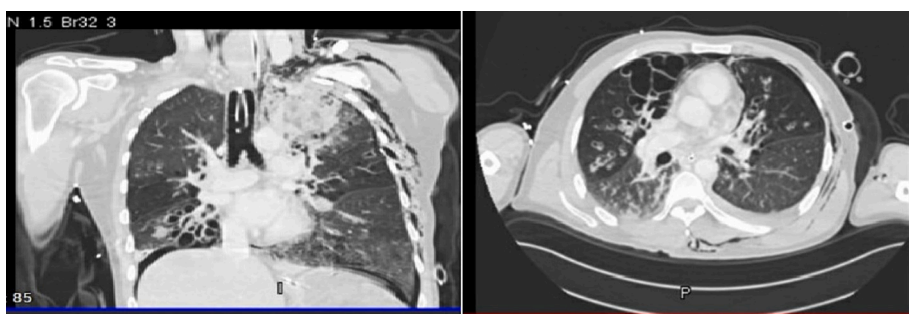
Fig. 3. For case 2: CT scan shows pre-existing cystic bronchiectasis, extensive surgical emphysema on the left side of the chest extending to the neck and abdominal wall.

Chest CT scan showed a metallic FB lying between the left scapula and the skin. There was an evidence of pre-existing cystic bronchiectasis in both lung fields. Extensive surgical emphysema was also noted on the left side of the chest extending to the neck and abdominal wall with bilateral pneumothorax and multiple fractured ribs on the left side and manubrium sternum (Fig. 3).

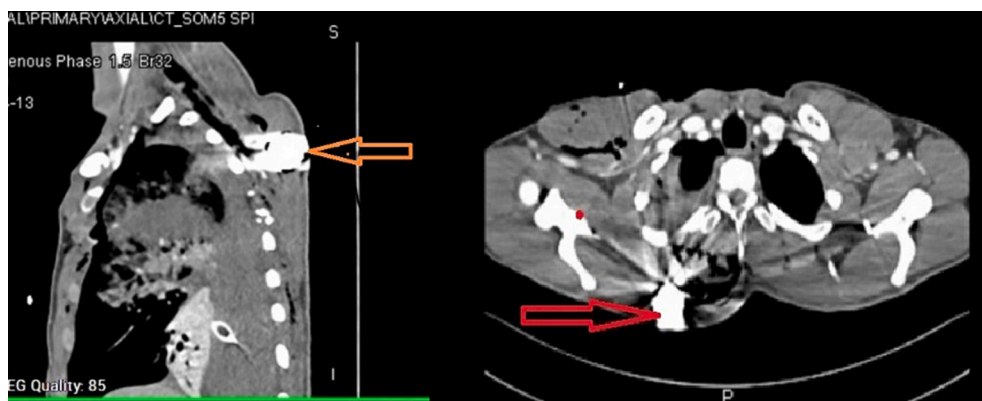
Fig. 4. CT scan for case 3; arrows show the foreign body.

hemopneumothorax with a presence of a round metallic FB at the upper side of chest. The patient was intubated, and a chest CT scan was performed and revealed a dense rounded FB in the right posterior chest wall subcutaneously positioned medial to the right scapula with associated comminuted fracture of scapula with hemothorax. He was taken to the OR and a right thoracotomy was performed. A through and through laceration of the upper lobe of the lung was noted. Hemostasis was achieved and the laceration was repaired. The FB was retrieved via an incision on the back (Figs. 4 & 5). The patient had an unremarkable post-operative course and was discharged home eight days post-injury.

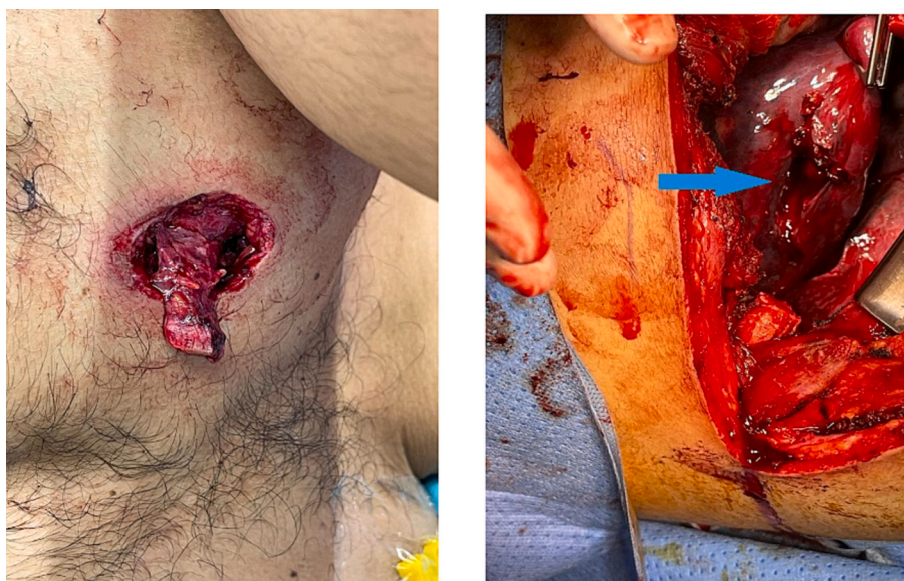
Fig. 5. Surgical image for case 3 (arrow: the entry of the foreign body into the lung tissue).

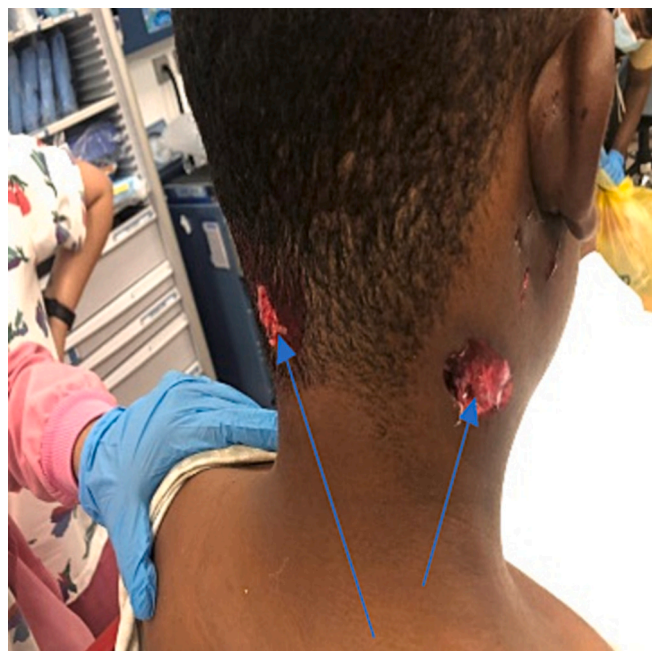
Fig. 7. Case 5: through and through and through injury in the back neck.

A 25-year-old male mechanic who was working on airbag of an 11-year-old compact sedan when the airbag deployed suddenly. He was found by EMS personnel outside of the vehicle with a through and through penetrating injury to the right side of the neck (Fig. 7). He was awake and agitated. He remained hemodynamically stable and had a patent airway. CT scan revealed a small parietal sub-arachnoid hemorrhage and a right sided mandible fracture with no other major traumatic injuries. He underwent debridement and suturing of wounds on his neck and closure of the wound and was observed in the ICU. Later, he underwent elective mandible fixation. Recovery was uneventful with discharge 7 days post-injury, without any neurological deficits.

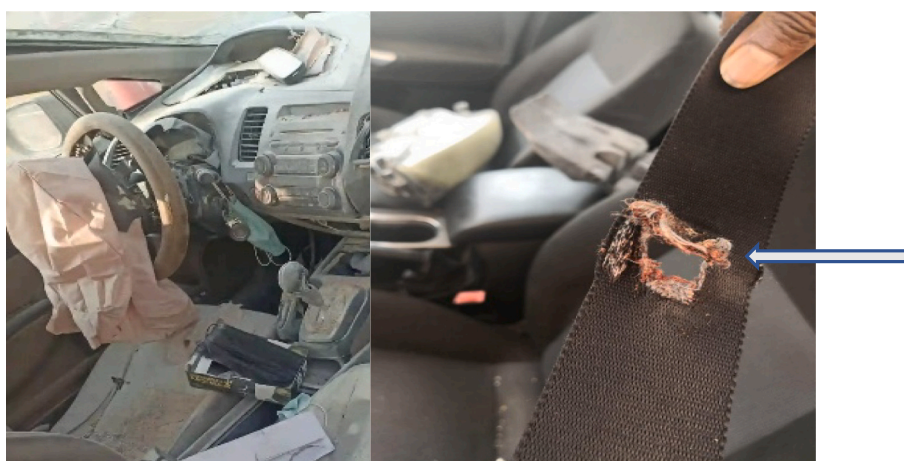
Fig. 8. Interior of one of the cars involved in the present case series; the arrow indicates a hole in the seatbelt made by a projectile component.

This kind of projectile component was reported in casualties which resulted in large scale recalls of vehicles in 2015 due to defective inflators from a single manufacturer [4]. Two out of six patients died in our case series. Fig. 8 is an example of one of the crashed cars and showed the penetration of the seatbelt by the projectile component. Although, the vehicle's recall for airbag safety discussion is important, it is beyond the scope of this paper. Vehicles in this series were at least 9 years old or more, at the time of the crash. The age of a vehicle could be a risk factor for malfunctions of vehicle's airbag. Moreover, it is possible that the long-term high ambient environmental humidity and temperature (as in our region for example) might have a contribution to airbag deployments over time making them prone to unexpectedly explode [7]. Other factors might also make the airbag propellant of vehicles more liable to degradation. In a collision, where the airbag is triggered, there's a risk the inflator will rupture under too much internal pressure, sending metal shrapnel shooting into the cabin.

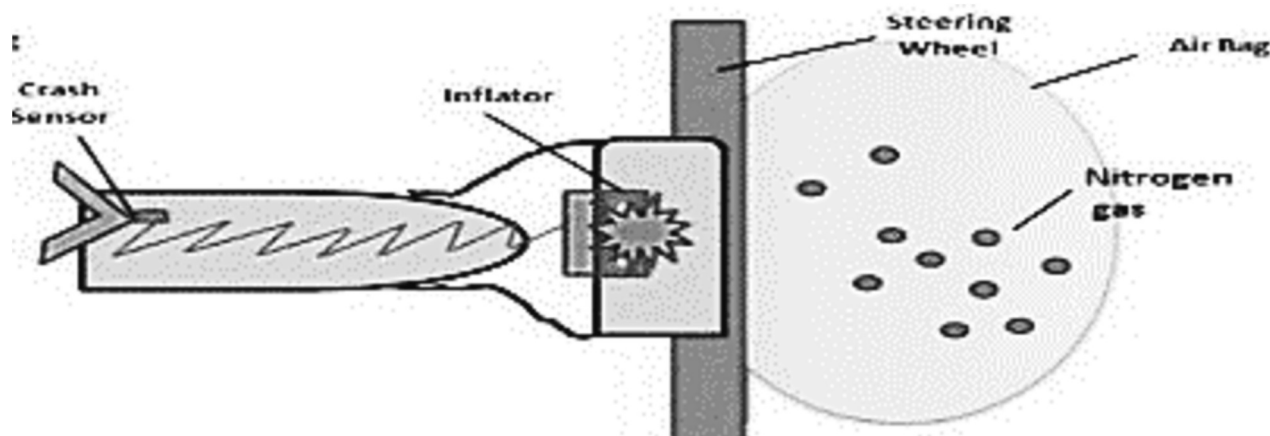
Fig. 9. Components of airbag (source: <https://www.popsci.com/how-airbags-are-supposed-to-work/> accessed on 06 November 2022).

Airbags consist of six parts (Fig. 9); an accelerometer which detects sudden change in the speed of the car and any impacts. The circuit is triggered by the accelerometer after any impact which then activates the heating element resulting in activation of the explosive charge which rapidly inflates the nylon airbag with nitrogen gas at 200 miles per hour [4]. The time taken between crash detection and complete deployment is approximately 0.05 s. This rapid force, though usually lifesaving, has the potential to cause catastrophic damage.
