A Unique Mode of Failure in the Noncontact Bridging Periprosthetic Plating System

ABSTRACT

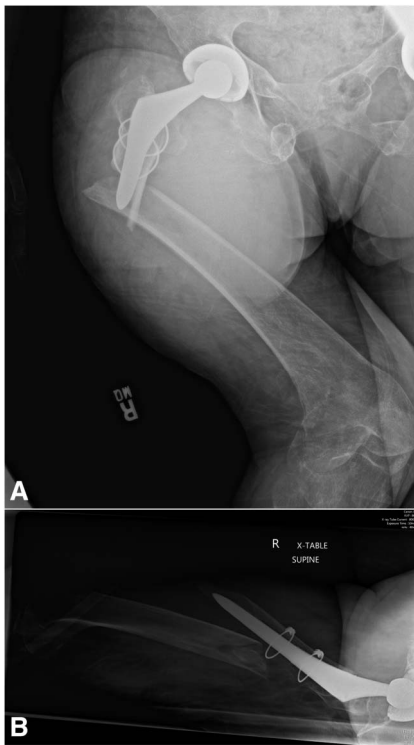
Figure 1

A, AP and **(B)** lateral radiographs of the patient's right hip immediately upon presenting to the emergency department demonstrate a displaced and comminuted periprosthetic spiral fracture of the proximal femur. The femoral implant appears to remain well-fixed.

An 85-year-old woman with a history of dementia and previously treated osteoporosis presented for the treatment of a right proximal femur Vancouver B1 periprosthetic fracture after sustaining a mechanical ground level fall (Figure 1). She had a remote history of a stroke with associated residual right-sided weakness and used a walker with ambulation at baseline. On admission, she was diagnosed with a urinary tract infection and appropriate antimicrobial therapy was initiated. Blood cultures were negative. She was medically optimized and taken to the operating room the following day for open reduction and internal fixation (Figure 2). A subvastus approach to her femoral shaft was used, and after placing one cerclage wire around the fracture, a titanium alloy

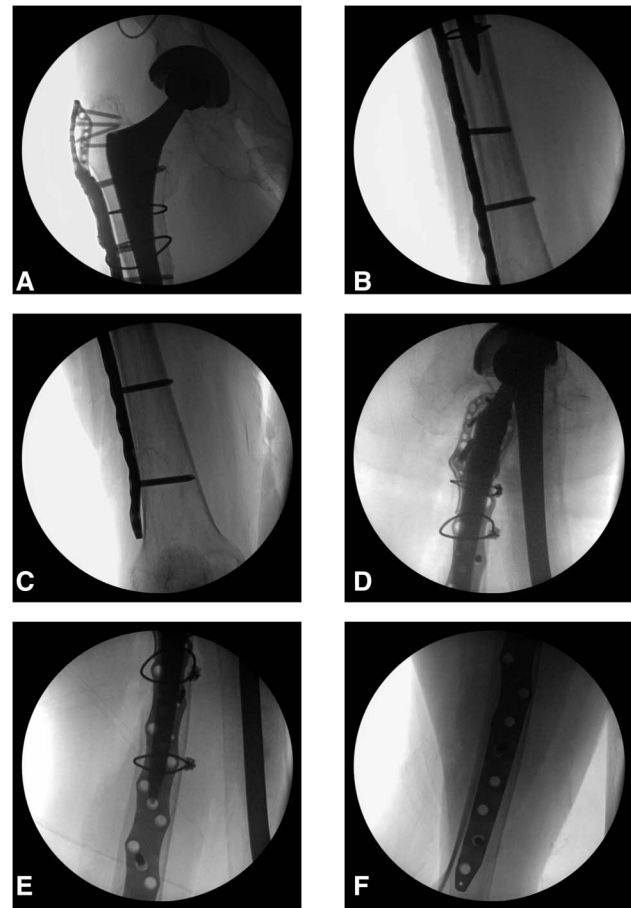
Figure 2

A-C, AP and **(D-F)** lateral intraoperative radiographs of the patient's right femur at the time of open reduction and internal fixation.

NCB Periprosthetic Plate (Zimmer Biomet) with a greater trochanteric attachment was placed. Fixation was obtained via the placement of an additional cerclage wire around the bone and NCB plate, several 3.5 mm and 4.0 mm titanium alloy proximal locking screws, and three 5.0 mm titanium alloy standard screws distal to the fracture. She was discharged on postoperative day 4 back to her assisted living facility. She was allowed to participate in the range of motion as tolerated but was limited to toe-touch weight bearing for 6 weeks. Before discharge, she was evaluated by our endocrinology team who obtained laboratory test results including comprehensive metabolic panel, vitamin D 25 hydroxy, and inorganic phosphate. Several laboratory values were found to be abnormal, and the patient was ultimately started on calcium, vitamin D, and nutritional supplements.

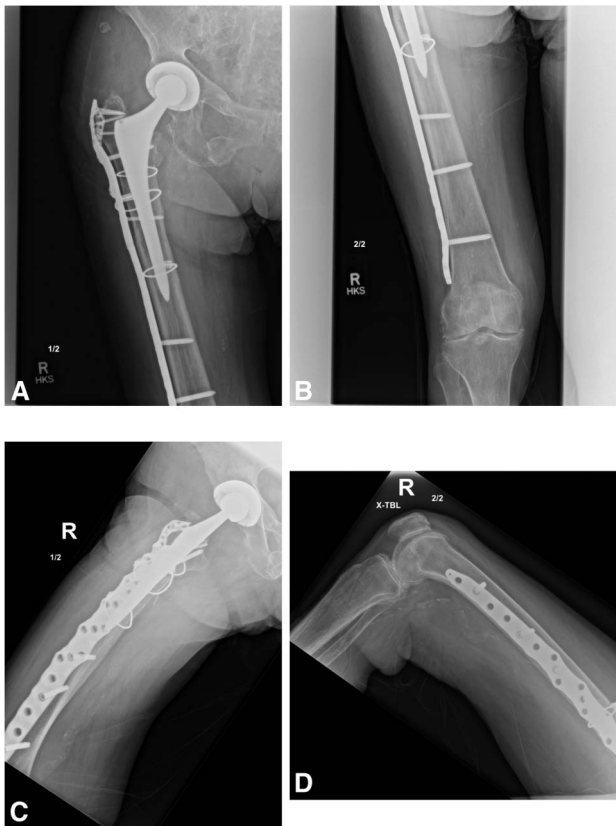
Figure 3

A and B, AP and (C and D) lateral radiographs of the right femur obtained 7 weeks postoperatively demonstrate appropriate fracture healing and no evidence of implant failure.

Given the patient's notable commute to our facility, her sutures were removed by her primary care provider and radiographs obtained approximately 7 weeks postoperatively were sent to the operating surgeon for review (Figure 3). At that time, the patient was reported to be doing well. Radiographs demonstrated appropriate fracture healing without evidence of implant

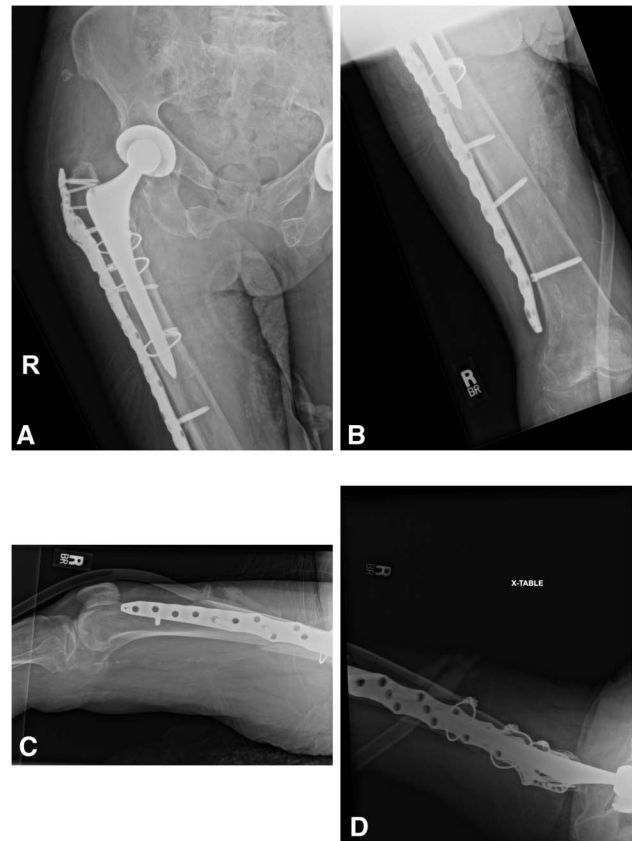
Figure 4

A and B, AP and (C and D) lateral radiographs obtained approximately 11 weeks postoperatively at the time of patient re-presentation to the emergency department for evaluation of right lower extremity pain after a fall. There is an acute supracondylar distal femur fracture as well as evidence of the most distal screw having fretted through the plate.

failure. Approximately 11 weeks after surgery, she again presented to our emergency department for right lower extremity pain after sustaining an additional mechanical ground level fall. Discussion with family noted that the patient had overall seemed to be recovering well from her previous injury and had recently started painless partial weight bearing activities. Radiographs at that time unfortunately revealed an acute right distal femur fracture and fretting of the distal-most screw through the plate (Figure 4). Standard preoperative laboratory studies were obtained and found to have values within normal limits with the exception of a mild anemia. The patient again underwent open reduction and internal fixation of her acute fracture after medical optimization. She was discharged on postoperative day 6 back to her assisted living facility. The patient was ultimately lost to further follow-up because she entered hospice care on postoperative day 12.

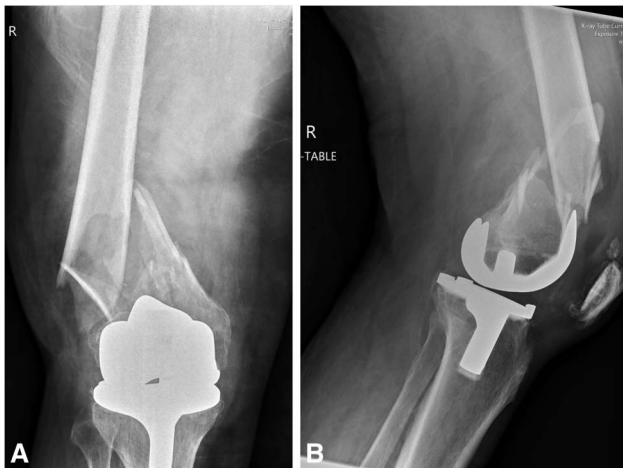
Figure 5

A, AP and **(B)** lateral radiographs of the patient's right knee immediately upon presenting to the emergency department demonstrate a comminuted and displaced periprosthetic supracondylar distal femur fracture.

A 73-year-old man with multiple medical comorbidities including multiple myeloma after chemotherapy, diabetes, and coronary artery disease presented for the treatment of a comminuted right periprosthetic supracondylar distal femur fracture after sustaining a mechanical ground level fall (Figure 5). Before this injury, he was able to ambulate two blocks without difficulty but did use a stair lift at home secondary to chronic left lower extremity weakness, which he attributed to his previous multiple myeloma treatment. He was medically optimized and taken to the operating room the following day for open reduction and internal fixation (Figure 6). After achieving adequate reduction of the fracture through indirect reduction techniques, a limited lateral approach to the distal femur was performed and the proximal end of a titanium alloy NCB Periprosthetic Plate (Zimmer Biomet) was placed submuscularly. Three titanium alloy 5.0 mm standard screws were placed in a percutaneous manner proximal to the fracture and multiple titanium alloy 5.0 mm locked screws were placed in the distal segment.

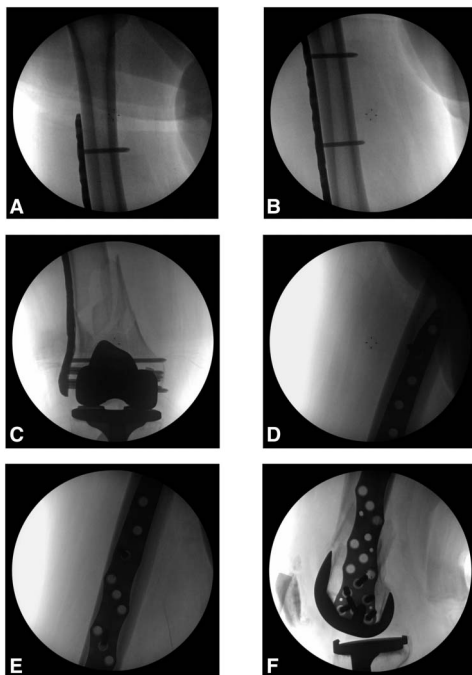
Figure 6

A-C, AP and **(D-F)** lateral intraoperative radiographs of the patient's right femur at the time of open reduction and internal fixation.

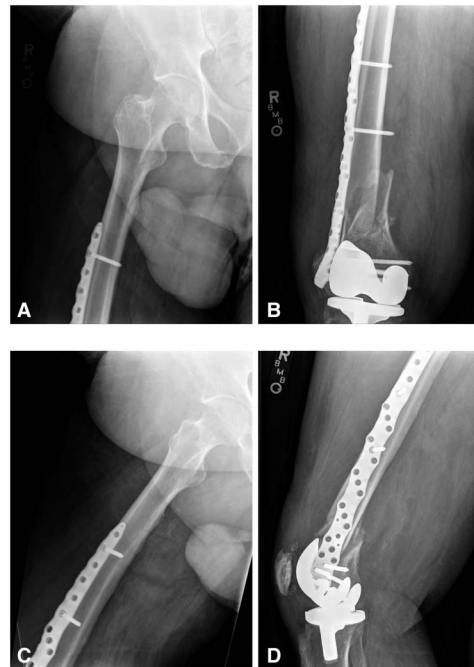
Figure 7

A and B, AP and **(C and D)** lateral radiographs of the right femur obtained 8 weeks postoperatively demonstrate early callous formation without evidence of implant failure.

The patient was discharged to a skilled nursing facility on postoperative day 5. At his 8-week postoperative appointment, new radiographs were obtained (Figure 7). Adequate callous formation was noted, and no concerns for complications were noted. At that time, he did have notable quadriceps atrophy but denied pain with passive or active range of motion. He was advanced to weight bearing as tolerated and given home quadriceps strengthening exercises.

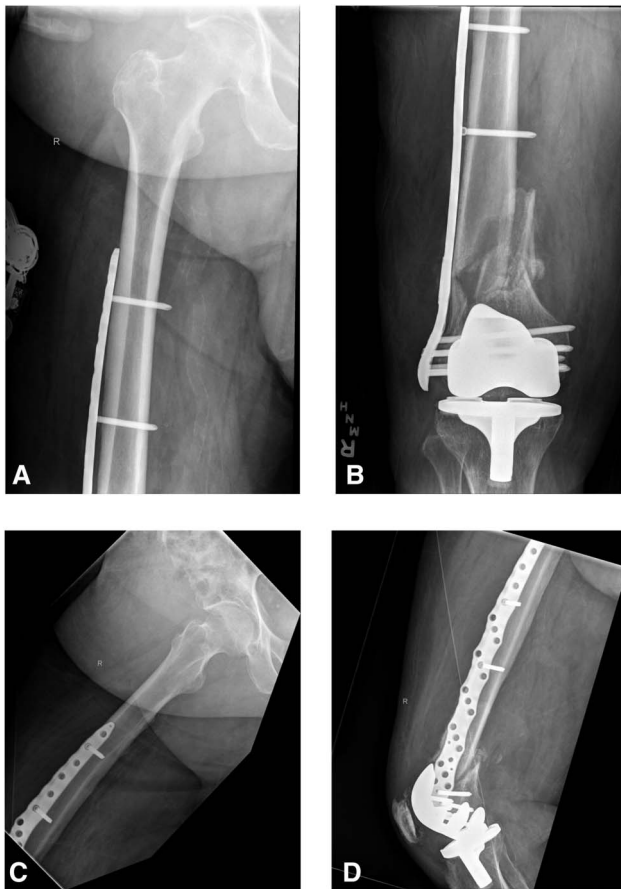
Figure 8

distal thigh. Radiographs were obtained, which demonstrated slight varus malalignment of the fracture and fretting of the distal-most screw placed proximal to the fracture site (Figure 8). He was referred to physical therapy but was unfortunately lost to further follow-up.

A and B, AP and **(C and D)** lateral radiographs of the right femur obtained 14 weeks postoperatively demonstrate slight varus malalignment of the fracture with fretting of the most distal screw proximal to the fracture line through the plate.

requiring hardware removal, symptomatic heterotopic ossifications, and persistent pain.^{3,7,14} There are numerous clinical examples of plate and screw fracture or screw pull-out, but no literature exists demonstrating the unique mode of failure exhibited in our clinical cases in which a standard screw remained within the bone and subsequently fretted through the annular seating of the plate. It is possible that the application of these screws in a locked fashion would have prevented this mode of failure. Additional biomechanical testing is required to elucidate the cause of this mode of failure and its prevention.

Several methods are available to surgeons to manipulate the rigidity of a fixation construct, including the placement of standard screws in the diaphyseal portion of the plate.^{3,14,16} With the knowledge of this failure mode with this particular plate, it may be advantageous to choose a different method to manipulate fracture construct rigidity. Several studies have demonstrated increased complications related to fracture healing in overly stiff fixation constructs.^{5-7,10,11,13} Based on this knowledge paired with our experiences with this specific implant, we consider placing a locked screw adjacent to the fracture within the femoral shaft while placing standard screws for the remainder of the fixation within the shaft to avoid making the construct too stiff. Surgeons must not only be aware of the available treatment options and the associated complications but also be diligent in critically evaluating the presenting fracture pattern and associated clinical scenario when making treatment decisions.
