Article

High Temperature Sensing and Detection for Cementitious Materials Using Manganese Violet Pigment

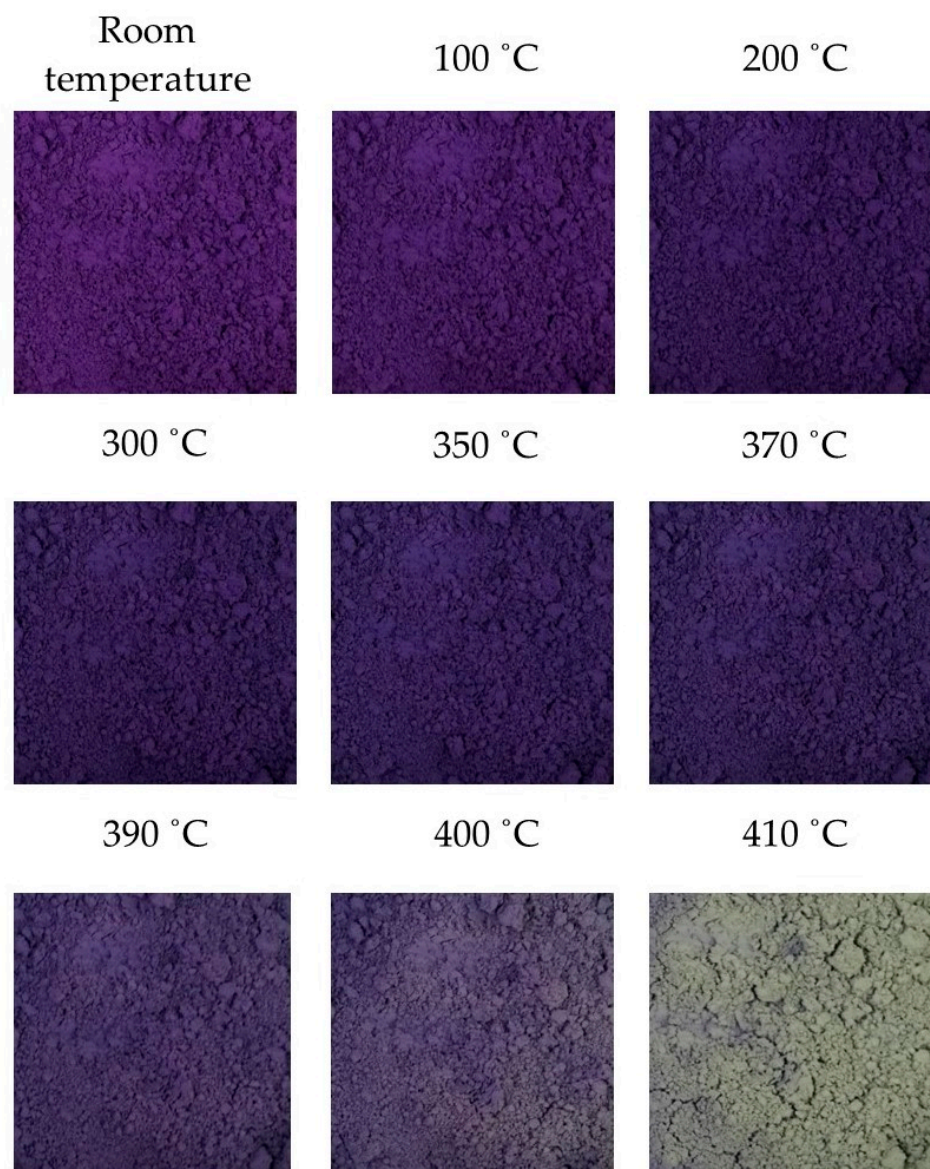
Figure 1. Color changes in the MV pigment with temperatures (Scale: 1000 × 1000 pixels).

In this study, manganese violet pigment was identified in the furnace test to undergo an efficient color change from dark violet to grayish yellow with temperatures above 400 °C. The manganese violet pigment, which is composed of manganese dioxide, ammonium dihydrogen phosphate, and phosphoric acid, presents a dark violet color due to the presence of phosphate and ammonia [30,31]. The color change to grayish yellow results from the evaporation of water and the liberation of ammonia from the pigment particles. The manganese violet pigment was then applied to white cement at a ratio of 1%, 3%, and 5% of the total mass. The white cement is similar to ordinary Portland cement except for the color. The white color was attributed to the decrease in the amount of chromium, manganese, iron, copper, vanadium, nickel, and titanium in the ordinary Portland cement. The white cement confers an advantage for the excellent exposure of color when mixed, and the material properties are unaffected due to a decrease in the above components [32]. The pigment mixed samples were heated in a furnace from room temperature to 450 °C. The mixed samples underwent a typical thermochromic change to a grayish green color. The thermochromic change was observed visually by the naked eye and was evaluated using digital images captured at each temperature interval.

When the temperature reached 410 °C, the MV pigment completely changed from violet to grayish yellow, which is associated with the evaporation of water and the liberation of ammonia from the pigment particles. The changed color was maintained at temperatures higher than 410 °C and when the temperature was returned to room temperature.

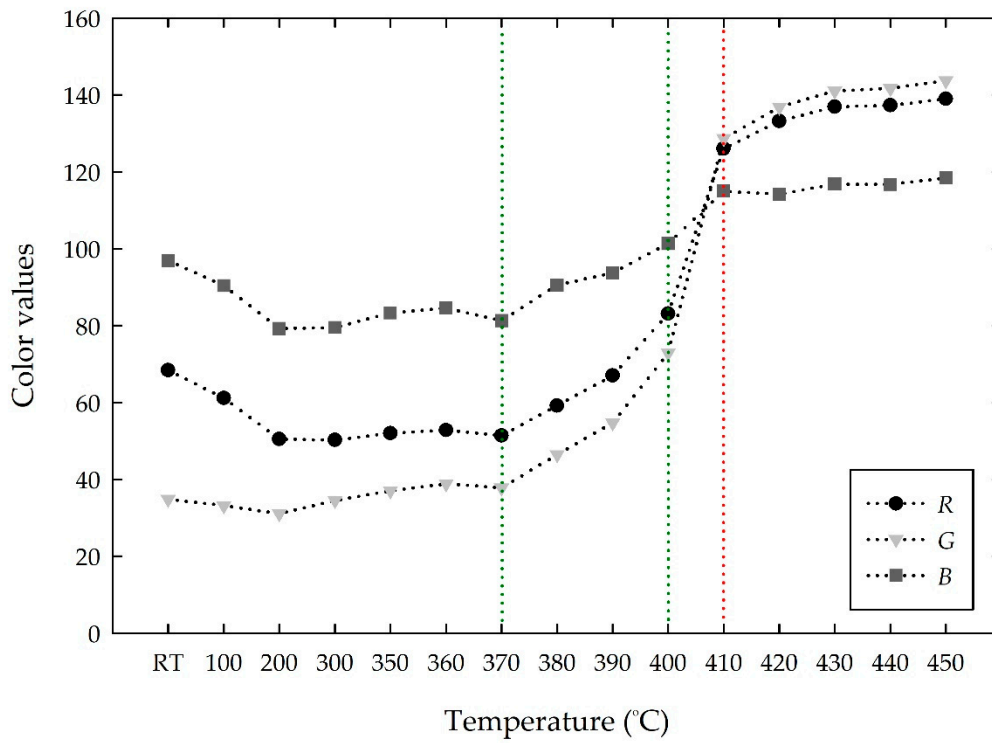
Figure 2. Changes in the RGB values of the MV pigment with increasing temperature.

color. As a result, the *RGB* values at 410 °C were approximately 1.85, 3.76, and 1.19 times those at room temperature, respectively.

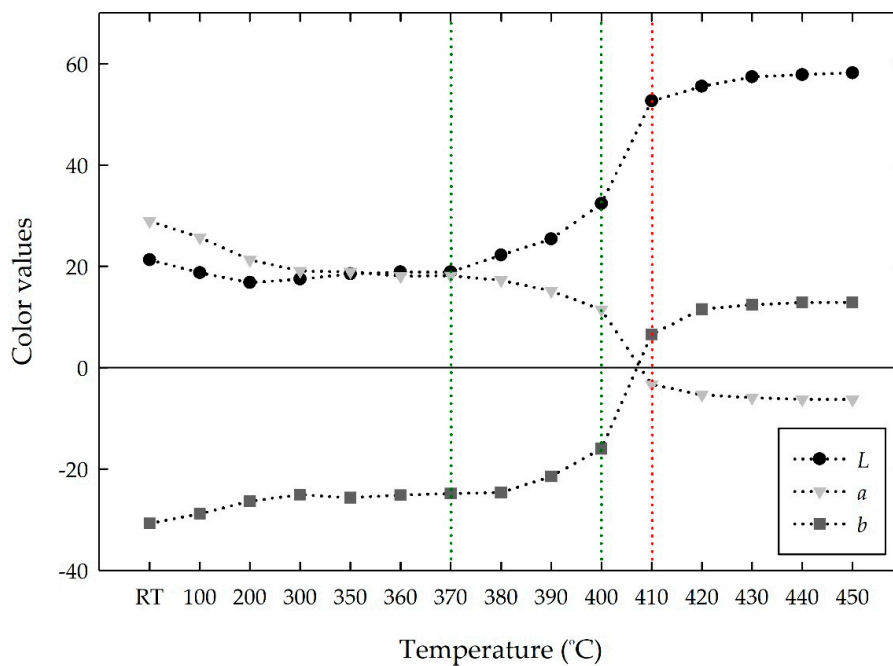
Figure 3. Changes in the Lab values of the MV pigment with increasing temperature.

Figure 3 shows the change in the color values in the *Lab* space. Similar to the *RGB* color values, the *Lab* values were relatively constant from room temperature to 370 °C. At higher temperatures, the *L* value began to gradually increase toward lightness; *b* value also gradually increased, while the *a* value decreased. At 410 °C, the *Lab* color values showed a rapid change to around (52, −3, 6), respectively. The color change means a change from darkness to lightness. That is, the lightness index of the *L* value increased by approximately 248% from 21 at room temperature. The *a* value decreased from positive (28 at room temperature) to negative (−3 at 410 °C), which indicates a greenness intensity, whereas the *b* value increased from negative (−30 at room temperature) to positive (6 at 410 °C), which indicates yellowness. These three *Lab* color values at 410 °C were combined to produce a grayish yellow color. Above 410 °C, little change in the *Lab* values was observed.

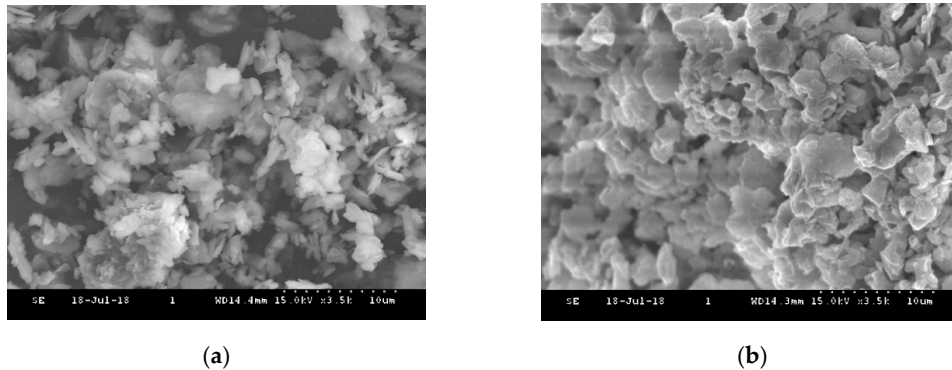
Figure 4. SEM images of the MV pigment: (a) Room temperature; (b) 410 °C.

For further characterization, SEM (S-4300 FE-SEM, Hitachi, Tokyo, Japan) was performed on the MV pigment at room temperature and at 410 °C to follow the microstructural changes because of the heat treatment. Figure 4 presents SEM images of the morphology and structure of the MV pigment. From the figure, the MV pigment at room temperature revealed a cluster of rod-shaped, spherical,

and hexagonal crystal structures. As the temperature was increased to 410 °C, the rod-shaped and hexagonal crystal characteristics of the MV pigment tended to change through the loss of water and ammonia. The dehydration process at high temperatures disintegrated their edges and provided a cluster of ring-shaped void structures.

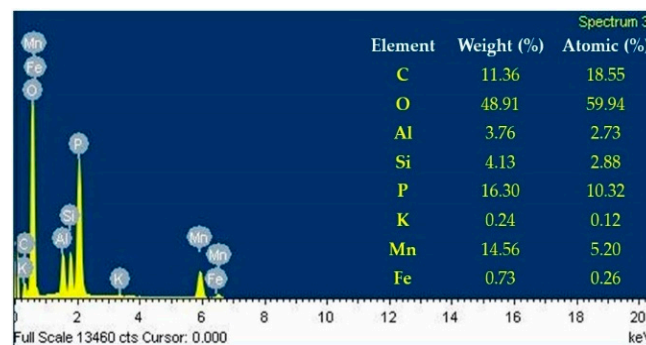
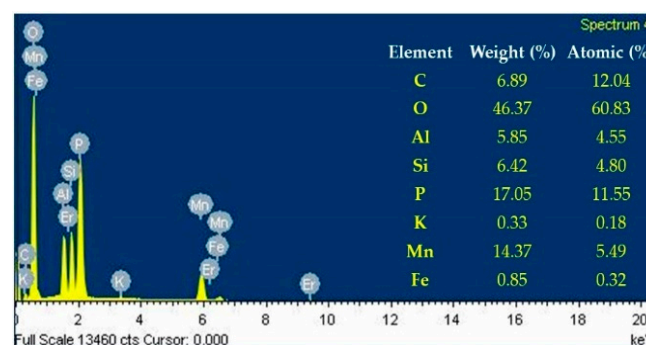
Figure 5. EDX analysis of the MV pigment: (a) Room temperature; (b) 410 °C.

EDX analysis (EMAX-7000, HORIBA EDX system, Kyoto, Japan) was carried out to assess the changes in the mineralogical composition of the samples caused by the increase in temperature, as displayed in Figure 5. In the unaltered sample at room temperature, the EDX pattern exhibited the presence of more intense peaks of C, O, P, and Mn with the mass contents of 11.36%, 48.91%, 16.30%, and 14.56%, respectively, and less intense Al, Si, K, and Fe peaks. When exposed to 410 °C, the mass of C, O, and Mn decreased by 39%, 5%, and 1.35%, respectively, and P increased by 4.6%, in which the mass contents of the C, O, P, and Mn changes to 6.89%, 46.37%, 17.05%, and 14.37%, respectively.

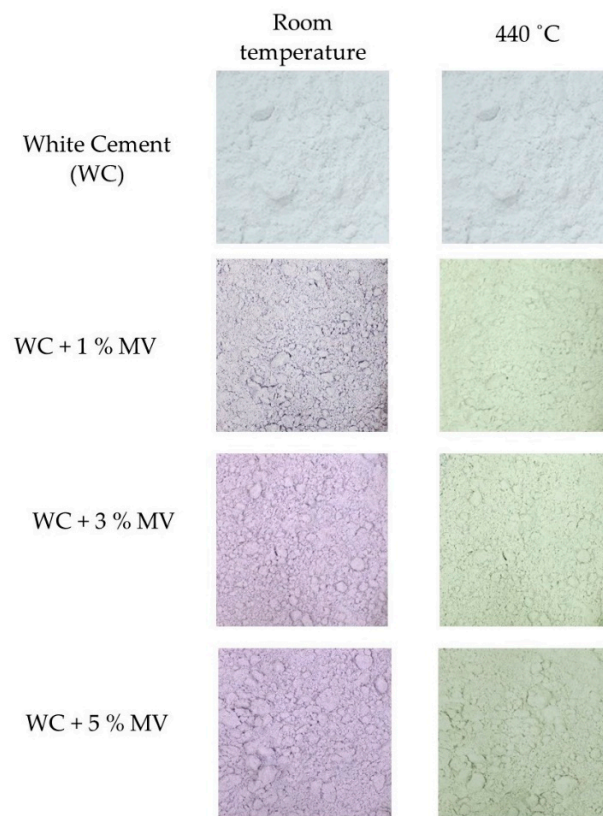
Figure 6. Color changes in the white cement and MV mixed samples exposed to different temperatures (Scale: 1000 × 1000 pixels).

White Portland cement is widely used in cement composites for the good exposure of color with pigments. Primarily, white cement remains a stable silver or pale white under high temperature conditions. Therefore, this study manufactured the white cement composite samples with the MV pigment. The MV pigment was separately added in 1%, 3%, and 5% of the weight of white cement. The mixed samples were heated individually in the furnace from room temperature to 450 °C. The photographs were recorded to examine the color of the samples at 100 °C, 200 °C, 300 °C, 350 °C, and 370 °C, and after that, every 10 °C up to 450 °C. Figure 6 shows the original and fully changed colors of the mixed samples at room temperature and 440 °C, respectively.

With the addition of white cement, the color of the pigment changed from violet to blue at room temperature. When heated, the mixed samples exhibited similar thermochromic changes as the pure MV pigment. Between room temperature to 410 °C, the mixed samples underwent a process of water removal from the pigment, but the color change was insufficient to be observed with the naked eye. Subsequently, the surface color of the mixed samples tended to fade away. When the temperature reached 440 °C, the mixed samples with 1%, 3%, and 5% of the MV pigment completely changed to a grayish green color. The color change was attributed to both the evaporation of water and the decomposition of ammonia from the pigment particles. The mixed samples did not recover their original color upon cooling to room temperature, indicating an irreversible color change. The color change occurred at 410 °C in the pure pigment but at 440 °C for the mixed samples. This might be due to the reduced temperature intrusion between the layers due to the mixing of white cement.

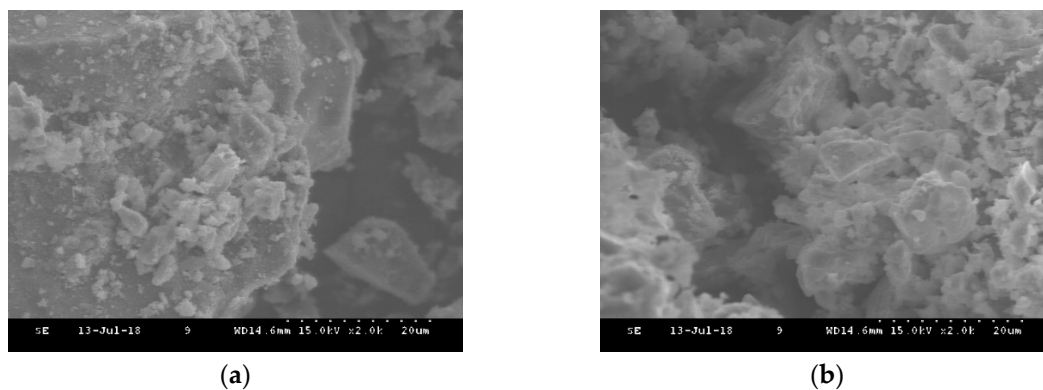
Figure 7. SEM images of the white cement: (a) Room temperature; (b) 440 °C.

Figure 7 shows SEM images of the white cement to characterize the changes in the morphology associated with high temperatures. At room temperature, the particles of the white cement have a structural diversity with globular shapes, including hexagonal, spherical, and some irregular tiny particles. When heated to 440 °C, a slight change was found due to the breakage of particles, and the white cement was relatively stable. Figure 8 presents SEM micrographs of the mixed sample at room temperature and at 440 °C, respectively. From the figure, the mixed sample at room temperature exhibits triangular, hexagonal, and spherical particles with a small cluster of rod-shaped structures due to the presence of MV pigment. At 440 °C, the hexagonal and rod-shaped cluster structures disappeared due to the dehydration of MV particles, which changed the mixed sample to irregular bundled structures.

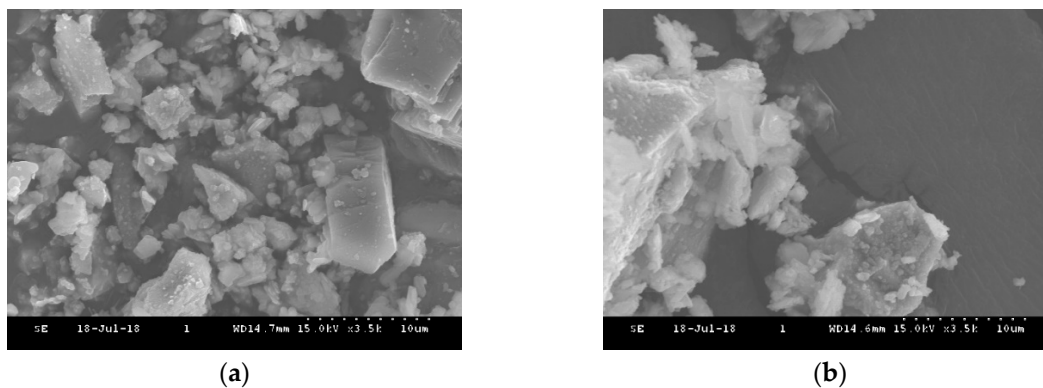
Figure 8. SEM images of the mixed samples: (a) Room temperature; (b) 440 °C.

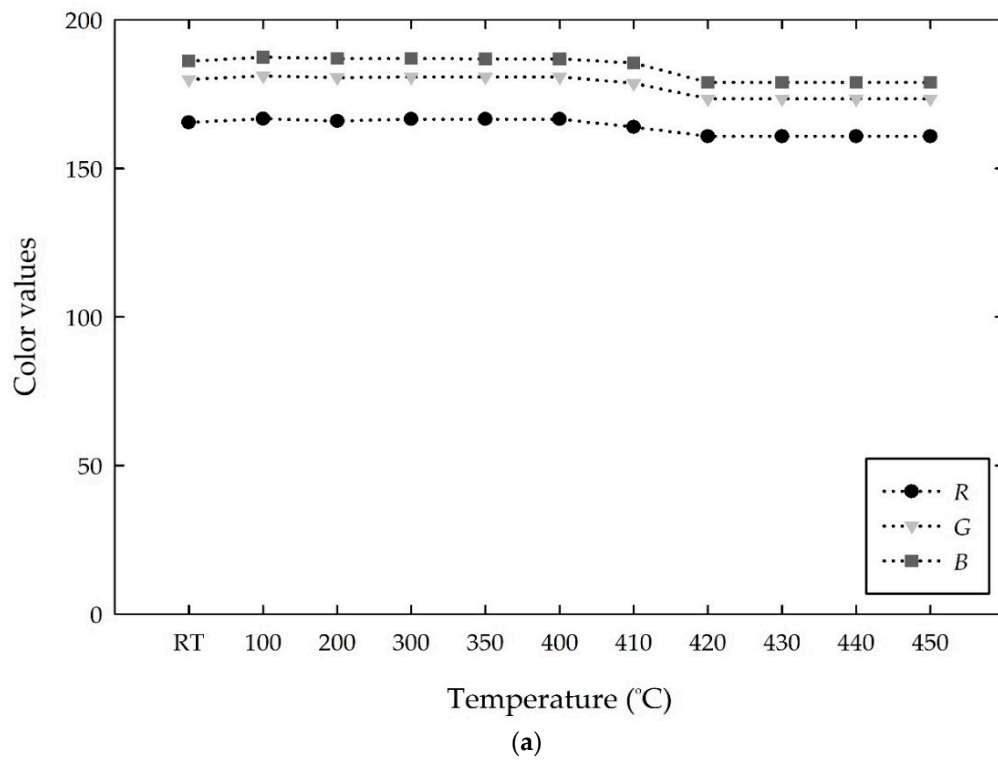
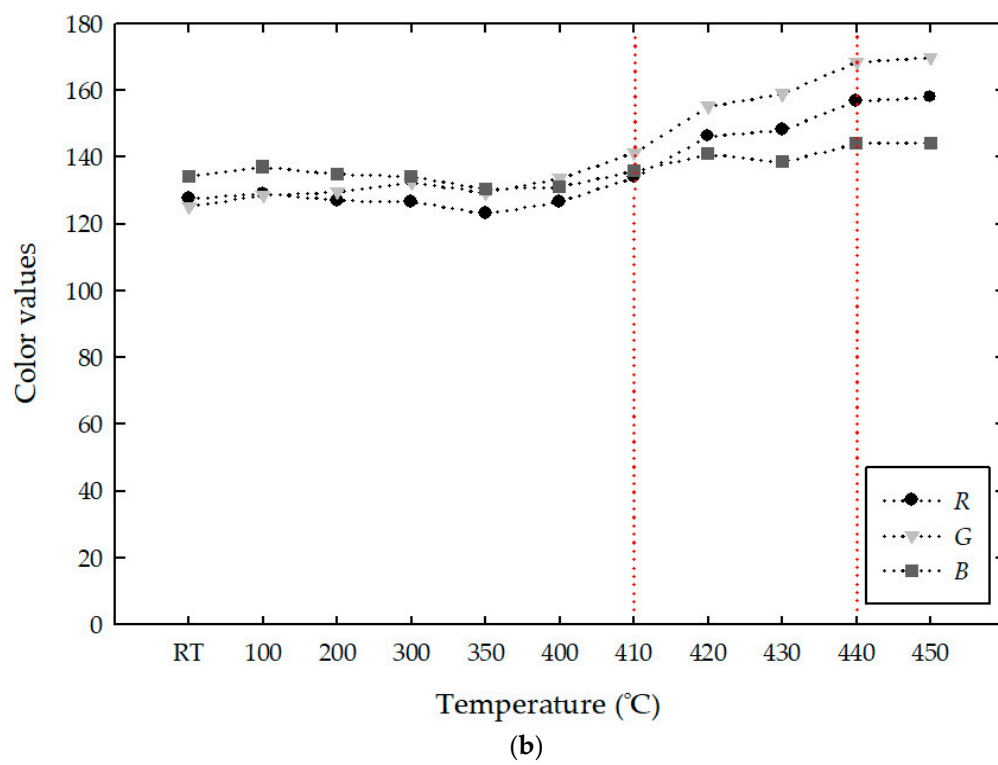
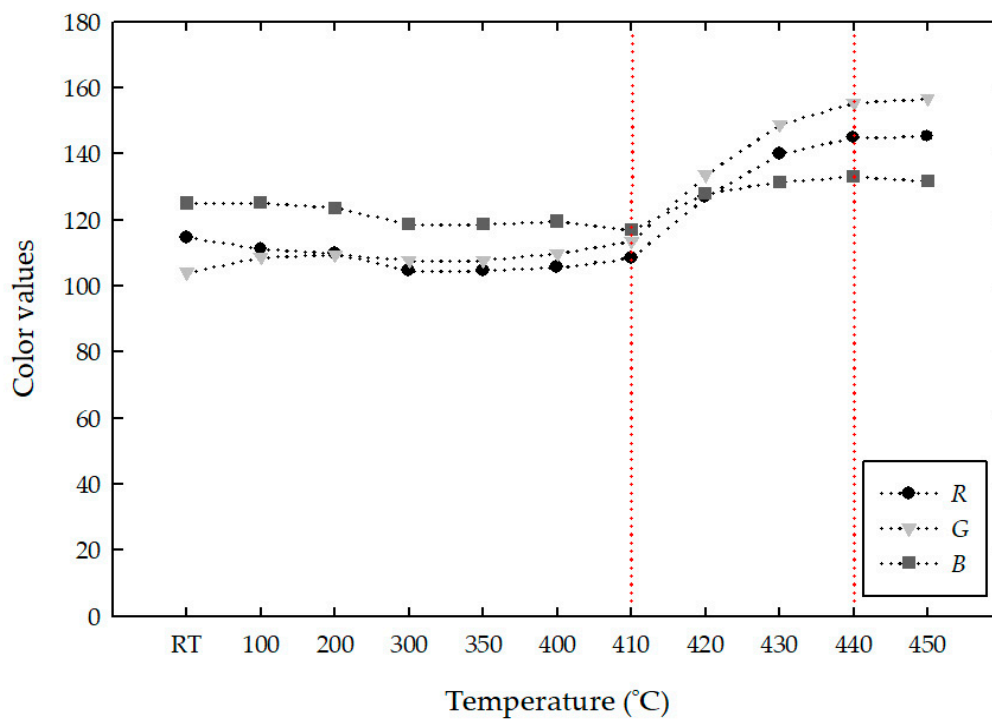
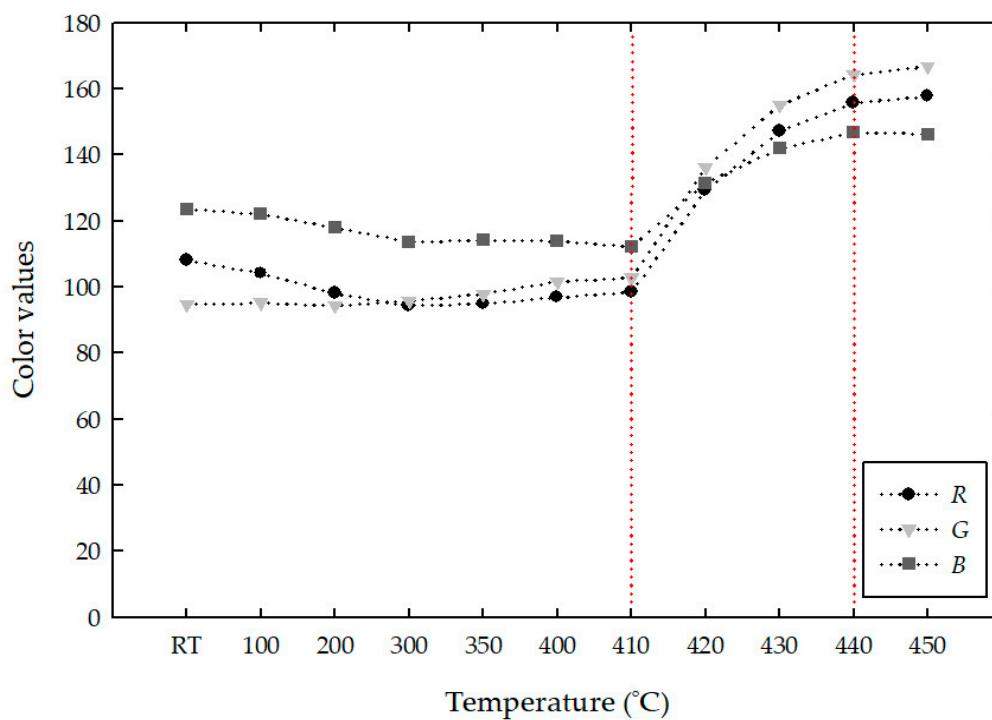
Figure 9. Changes in the RGB values of the white cement (WC) and MV mixed samples with increasing temperature: (a) WC; (b) WC + 1% MV; (c) WC + 3% MV; and (d) WC + 5% MV.

The color changes of the white cement mixed samples were evaluated using *RGB* and *Lab* color spaces. Figure 9 shows the changes in *RGB* values with increasing temperature. The white cement showed stable and high *RGB* values from room temperature to 450 °C, as shown in Figure 9a. At room temperature, the *RGB* color intensities of white cement were (165, 179, 186), which represents a grayish blue color. Heating of the white cement barely changed the color and thus displayed stable values with the mean *RGB* values of (164, 177, 183) from room temperature to 450 °C. Figure 9b–d show the changes in the *RGB* values of the mixed samples with increasing temperature. The addition of 1% pigment to white cement decreased the *RGB* values at room temperature from approximately (165, 179, 186) to (127, 125, 134), which corresponds to a 22% to 30% (R: 22%, G: 30%, B: 27%) decrease. In the mixed samples with 3% and 5% pigments, the *RGB* values decreased by approximately 30% to 42% (R: 30%, G: 42%, B: 32%) and 33% to 47% (R: 34%, G: 47%, B: 33%), respectively. The decrease in the *RGB* values in the mixed samples indicates the disappearance of the whiteness intensity and the development of a mild violet color with the addition of 1%, 3%, and 5% pigments. With increasing temperature from room temperature to 410 °C, the mixed samples with 1%, 3%, and 5% pigments were almost stable with mean *RGB* values of approximately (127, 131, 133), (108, 108, 120), and (99, 97, 116), respectively, which are very close to those at room temperature. At higher temperatures, the *RGB* increased gradually toward the whiteness intensity, and the color completely changed at 440 °C. The *RGB* values of the mixed samples with 1%, 3%, and 5% MV at 440 °C were similarly (156, 168, 144), (145, 155, 133), and (157, 164, 146), respectively. Considering the reference *RGB* values of gray and green colors, the color obtained in the mixed samples at 440 °C can be defined as a grayish green color. Above 440 °C, the *RGB* values were stable and irreversible.

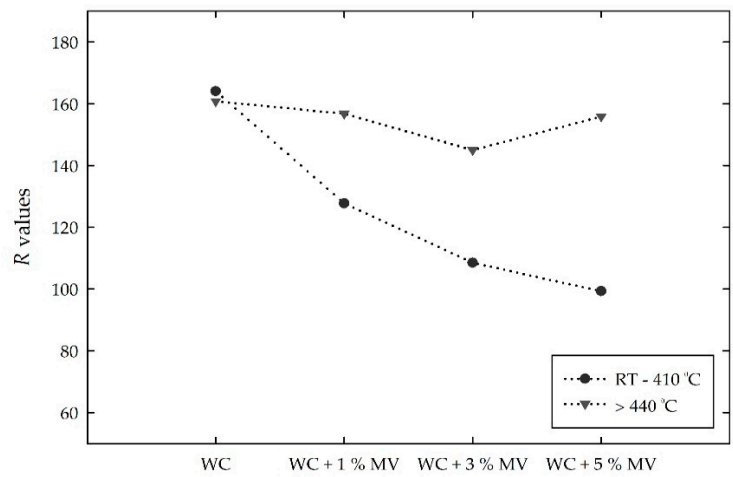
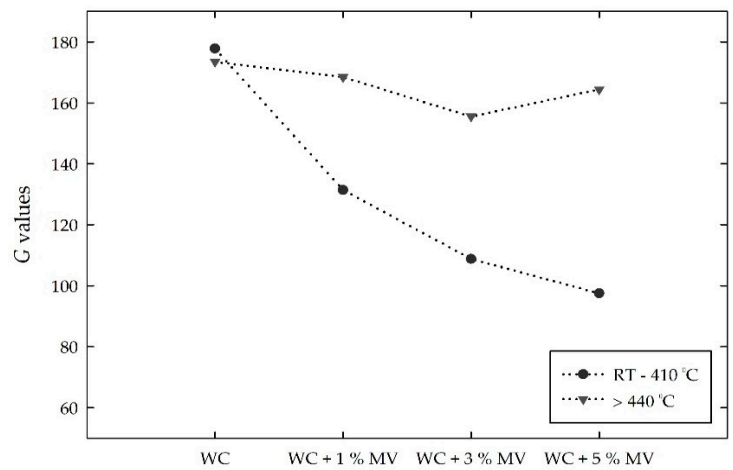
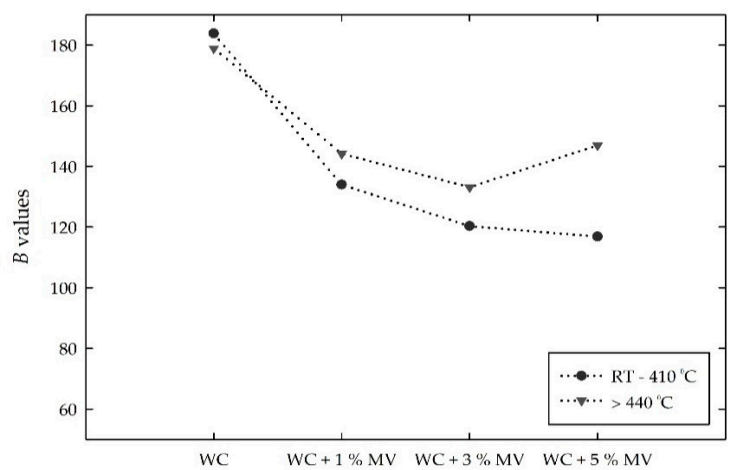
Figure 10. Comparisons of the RGB values for the white cement (WC) mixed samples with increasing temperatures: (a) R values; (b) G values; and (c) B values.

With increasing pigment content, the mean RGB values of the mixed samples from room temperature to 410 °C, in which the color of the samples was stable, were compared with those at a critical temperature of 440 °C, as shown in Figure 10. Compared to R values in between room

temperature and 410 °C, those at 440 °C increased by approximately 22%, 33%, and 55% in the WC + 1% MV, WC + 3% MV, and WC + 5% MV specimens, respectively, as shown in Figure 10a. At a critical temperature of 440 °C, which completely changed to a grayish green color, the mixed samples with 1%, 3%, and 5% pigment showed *R* values in the range of 144 to 155. This indicates that the *R* value decreased due to the inclusion of pigment at room temperature, but increased to a similar range at a critical temperature of 440 °C. Figure 10b shows the change in *G* values for the white cement mixed samples. With increasing MV pigment, the *G* values decreased at room temperature. At 440 °C, the *G* values of the white cement with 1%, 3%, and 5% of MV pigment increased by 28%, 42%, and 68%, respectively, and showed a similar range of 155 to 168, irrespective of the content of MV pigment. Figure 10c shows the change in the *B* value for the white cement mixed samples. The *B* intensities, which were also stable between room temperature and 410 °C, decreased from approximately 183 to 116 with increasing content of MV pigment from zero to 5%. The *B* value at the critical temperature of 440 °C increased to 144, 133, and 146, which corresponds to a 7%, 10%, and 25% increase for the white cement samples with 1%, 3%, and 5%, respectively. The addition of pigments decreased the *B* values, but the amount of the increase is relatively small compared to that of the *R* and *G* values.

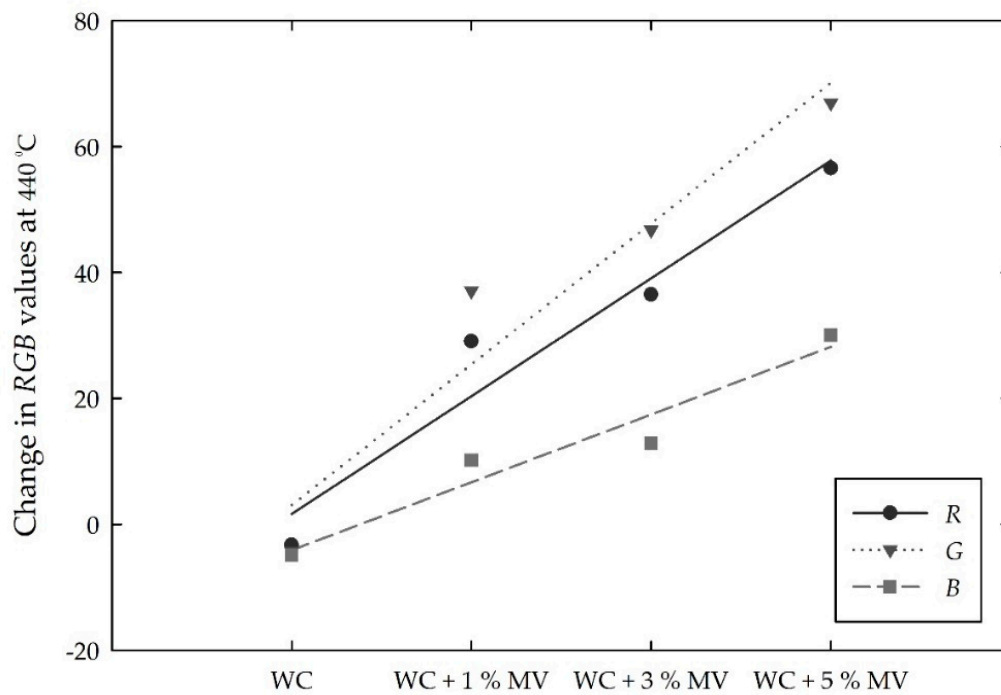
Figure 11. Changes in the RGB values for the white cement (WC) mixed samples with increasing MV pigment contents at 440 °C.

In the *RGB* color intensities, the incorporation of MV pigment particles in 1%, 3%, and 5% decreased the *RGB* intensities, which were stable between room temperature and 410 °C. The color intensities began to increase from 410 °C and completely changed to grayish green at 440 °C, at which point little difference of the *RGB* values was found among the white cement mixed samples. That is, with increasing pigment content, the *RGB* intensities decreased at room temperature but obtained relatively constant values at 440 °C. The *RGB* values and color intensities after 440 °C exhibited a slight difference, irrespective of the amount of MV pigment added to the white cement. Therefore, the magnitude of the change in the *RGB* values at 440 °C is also discussed. The changing magnitude of the *RGB* values mainly depends on the pigment to white cement ratio, as shown in Figure 11. With increasing addition of MV pigment from 1% to 5%, the magnitude of the change in the *RGB* almost linearly increased. According to the linear trend analysis, the *R* and *G* values showed a 10.9 and 13.0 increase at 440 °C per 1% addition of MV pigment to white cement, respectively. The approximately 6.5 increase in the *B* value per 1% MV pigment was relatively small. This suggests that the *R* and *G* values, which show a higher change at 440 °C than the *B* value, would be an index to instantly identify and evaluate cementitious materials subjected to a critical high temperature.

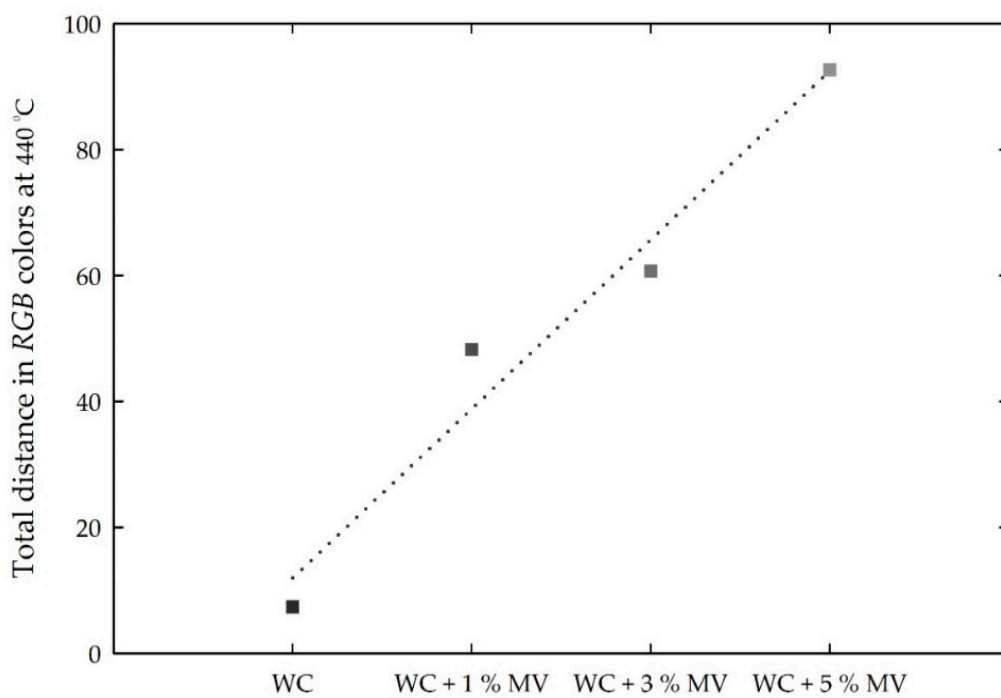
Figure 12. Total distance in the RGB intensities for the white cement (WC) mixed samples with increasing MV pigment content at 440 °C.

The color changes of the white cement mixed samples are related to the increasing number of *RGB* values. Therefore, the total color changes in the *RGB* color intensities are defined as the Euclidean distance (\bar{d}) using the following equation:

where ΔR , ΔG , and ΔB represent the differences of the *R*, *G*, and *B* values, respectively, 440 °C and those between room temperature to 410 °C. These also show a linear increase with increasing MV pigment ratio, as shown in Figure 12. The increasing rate of \bar{d} is approximately 14.7 per 1% addition of MV pigment to white cement. As a result, the total color changes of white cement mixed with MV pigment can be effectively determined using the increases in *RGB* color values and \bar{d} .

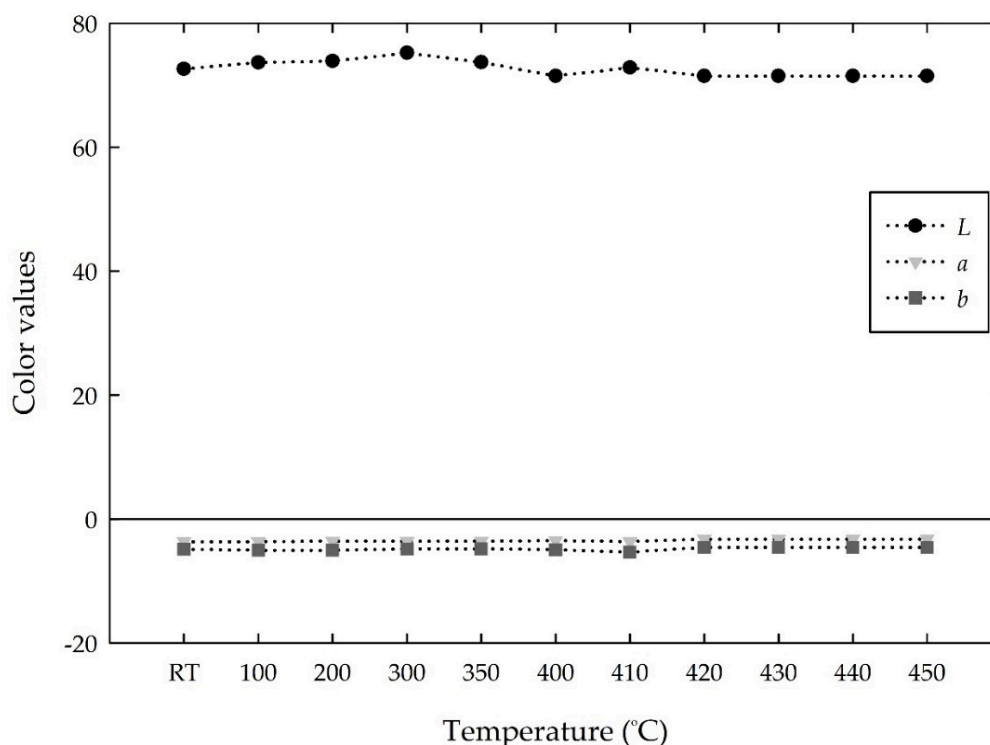
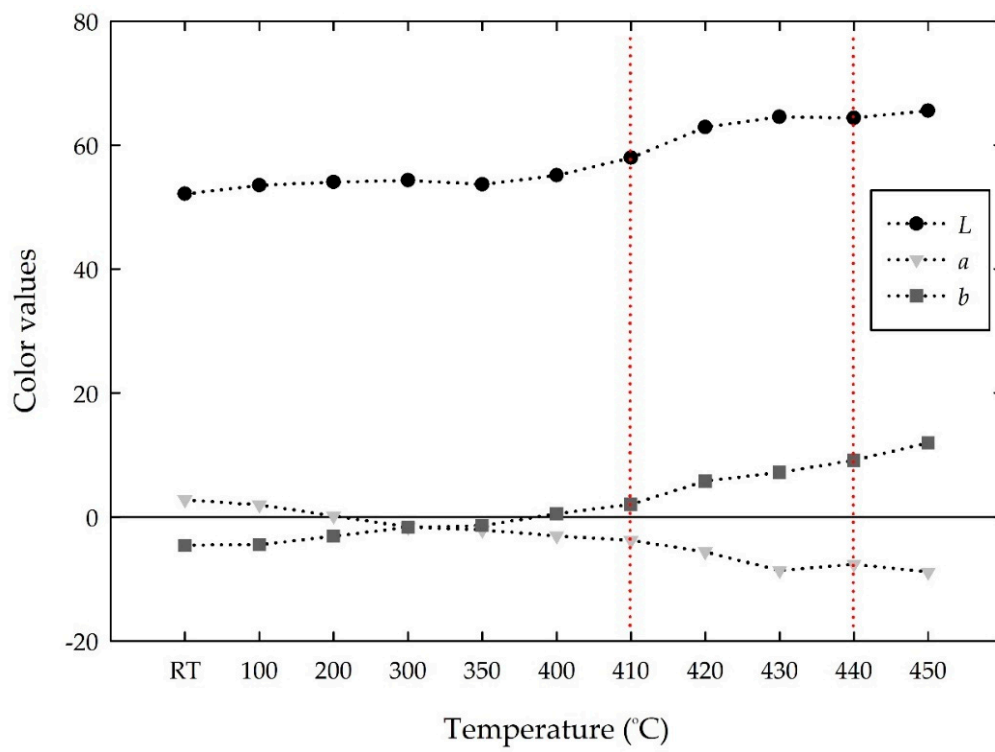
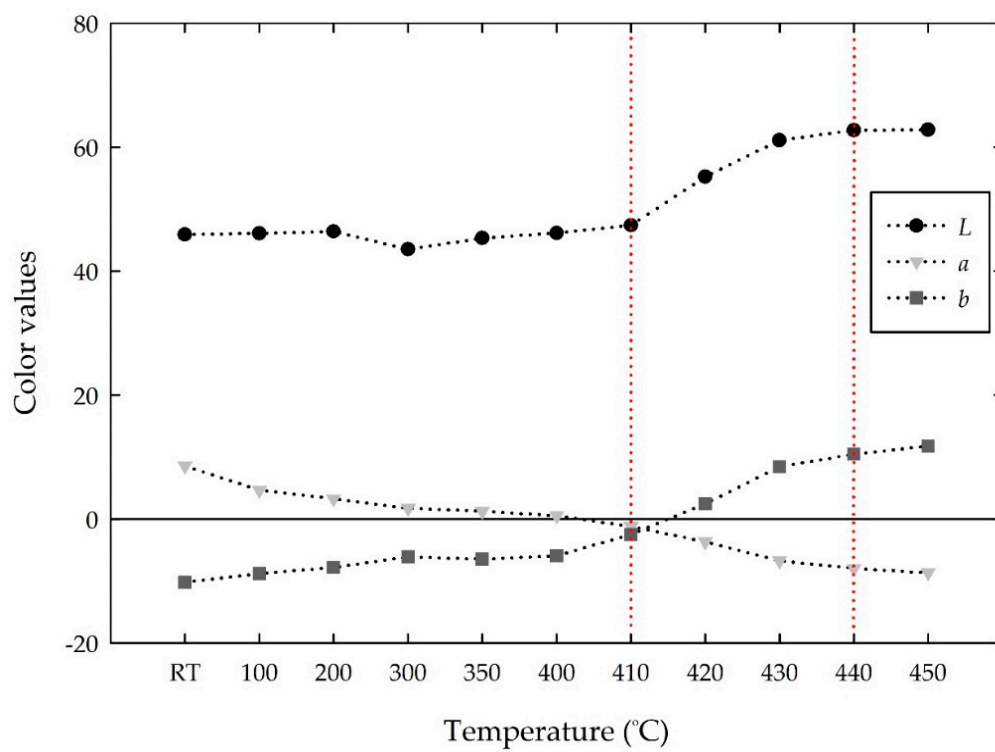
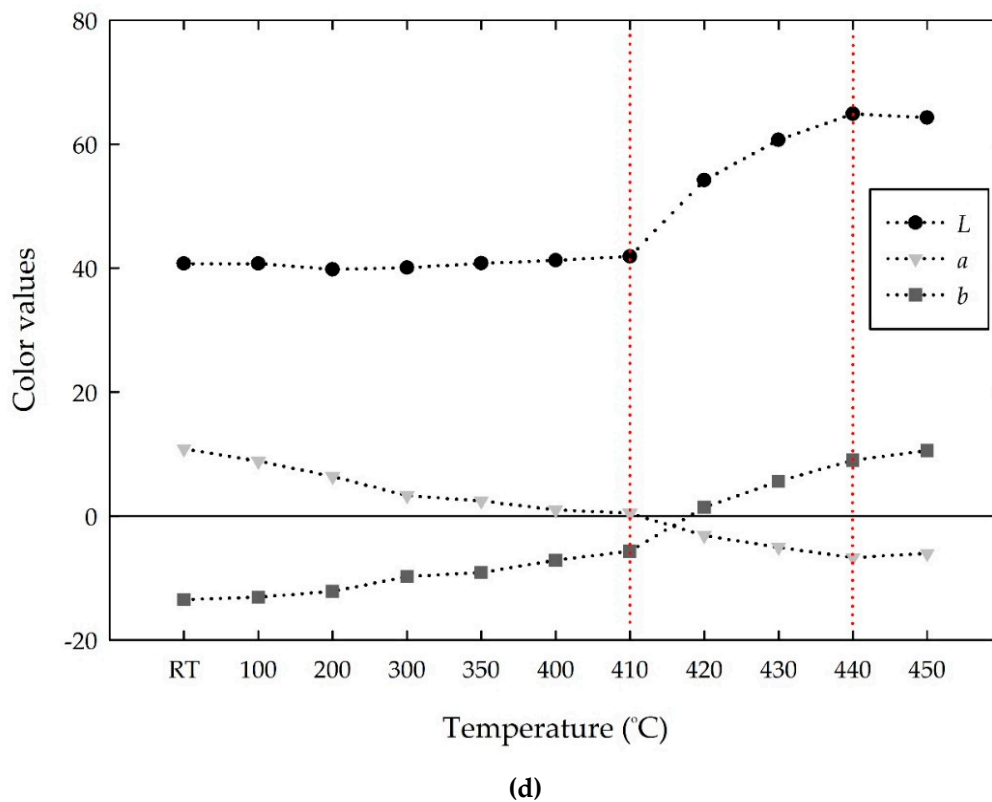
Figure 13. Changes in the *Lab* values of the white cement (WC) and MV mixed samples with increasing temperature: (a) WC; (b) WC + 1% MV; (c) WC + 3% MV; and (d) WC + 5% MV.

Figure 13 shows the changes in the Lab values of the white cement mixed samples with increasing temperature. The white cement exhibited a constant high L value of approximately 72, and the a and b values present negative constant values of approximately −3 and −4, respectively, with increasing

temperature from room temperature to 450 °C, as shown in Figure 13a. This suggests that the white cement is stationary with increasing temperature. The addition of MV pigment decreased the L and b values, whereas it increased the a value at room temperature, as shown in Figure 13b–d. The mixed samples with 1%, 3%, and 5% of the MV pigment showed a decrease in L value from 72 to 52, 45, and 40, corresponding to a 28%, 36%, and 43% decrease, respectively. The a value, which was -3 at room temperature for white cement, changed to positive values (redness degrees) of 2, 8, and 10 for the mixed samples with 1%, 3%, and 5% of MV pigment, respectively. In contrast, the b intensity, which was negative for the white cement, showed a further decrease to a negative value (blueness degree). The change in the Lab values influences the development of color on the mixed samples. That is, the WC + 1% MV sample with the Lab of (52, 2, -4) represents a dark grayish blue color, and WC + 3% MV and WC + 5% MV samples with the Lab of (45, 8, -10) and (40, 10, -13), respectively, illustrate dark grayish violet color at room temperature. As the temperature increased from room temperature to 410 °C, the L value was relatively constant, the a value gradually decreased from positive to negative, and the b value increased from negative to positive. However, the changes in the Lab values were too low to observe the color change of the mixed samples until 410 °C.

After 410 °C, the color of the samples started to show a grayish green color with increasing L value and changing a from positive to negative and b from negative to positive values. The increase in L value increases the lightness intensity, and the decrease in a and increase in b indicate the greenness and yellowness intensities, respectively. At 440 °C, the mixed samples completely changed to a grayish green color and showed Lab values of (64, -7 , 9) for 1% MV, (62, -7 , 10) for 3% MV, and (64, -6 , 9) for 5% MV samples. As discussed in the RGB color spaces, the Lab values were also similar at the critical temperature of 440 °C, irrespective of the amount of MV pigment added to the white cement. Above the critical temperature, the mixed samples exhibited stable and invariable Lab values.

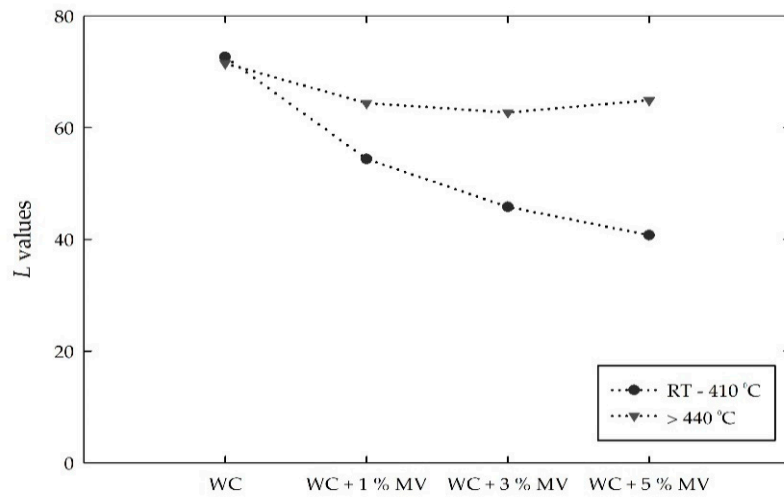
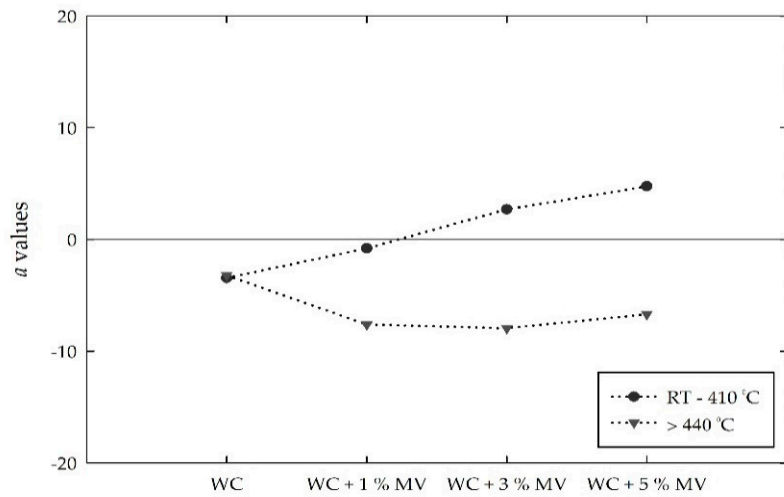
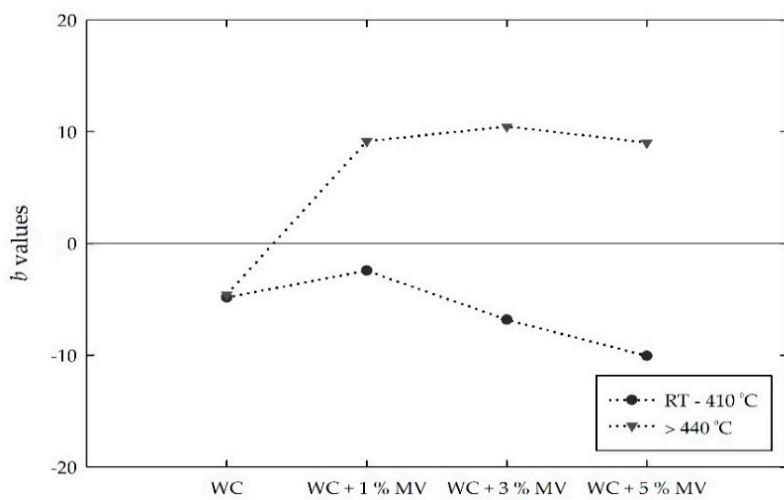
Figure 14. Comparisons of the *Lab* values for the white cement (WC) mixed samples with increasing temperature: (a) *L* values; (b) *a* values; and (c) *b* values.

Figure 14 compares the *Lab* values of the mixed samples averaged from room temperature to 410 °C with those at a critical temperature of 440 °C. As shown in Figure 14a, the *L* value (or, the lightness intensity) decreased when the pigment concentration was increased from zero to 5%. However, the *L* value at 440 °C showed a similar level, ranging from 62 to 64, which indicates a grayish color. Figure 14b shows the change in *a* value. Compared to those between room temperature and 410 °C, the *a* values at the critical temperature of 440 °C decreased from positive to negative, resulting in a very similar range of -7 to -6 for all three mixed samples. In contrast, the *b* value increased from negative to positive, ranging from 9 to 10, which illustrates the increase in yellowness intensity, when the mixed samples reached the critical temperature of 440 °C, as shown in Figure 14c.

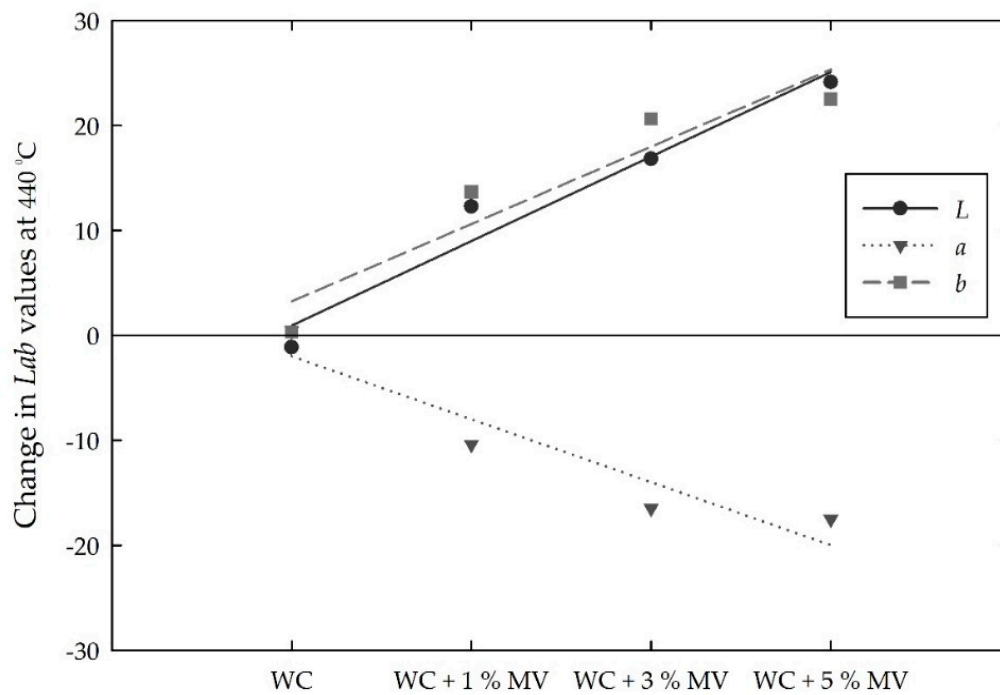
Figure 15. Changes in the *Lab* values for the white cement (WC) mixed samples with increasing MV pigment content at 440 °C.

Based on the mean *Lab* values between room temperature and 410 °C, in which no major change was obtained in all the white cement mixed samples, Figure 15 shows the magnitude of the change in the *Lab* values at 440 °C. The *L* and *b* values changed to positive values, and the *a* values changed to negative values. That is, with increasing MV pigment from zero to 5%, the *L* and *b* values increased almost linearly from -1.9 to 23.8 and from 0.3 to 20.6 , respectively, whereas the *a* value decreased from 0.4 to -11.1 . A linear trend analysis showed that the magnitude of the *L* and *b* values at 440 °C increased by approximately 4.7 and 3.6, respectively, and the *a* value, the change of which was relatively small, decreased by approximately 2.1 per 1% increase in MV pigment.

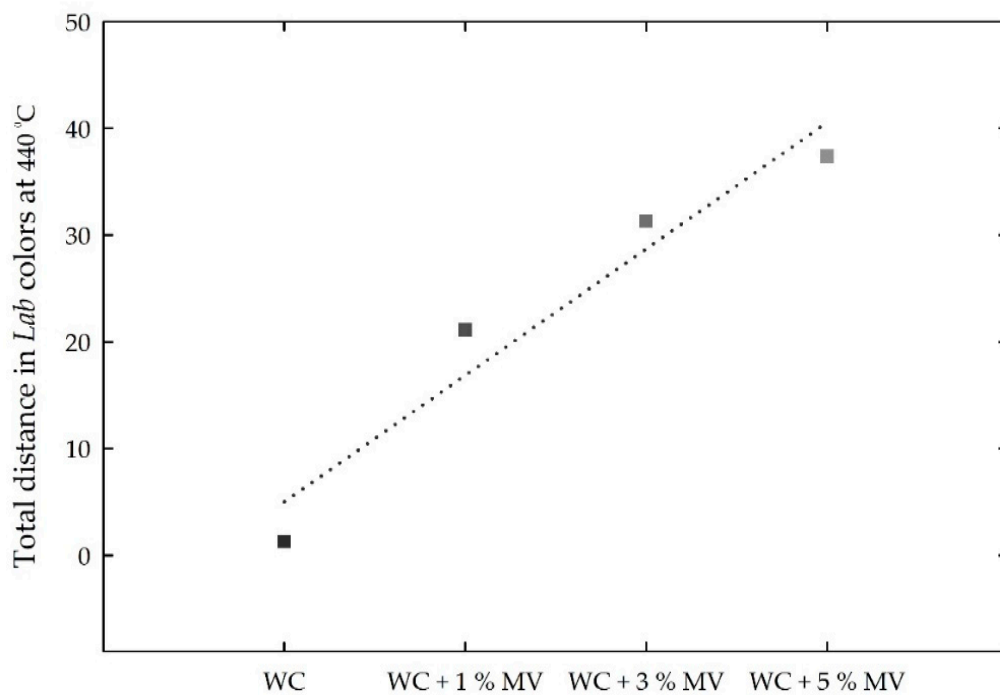
Figure 16. Total distance in the *Lab* intensities for the white cement (WC) mixed samples with increasing MV pigment content at 440 °C

In addition, the total changes in the *Lab* intensities at the critical temperature of 440 °C were calculated, as shown in Figure 16. Similar to Equation (2), the total change was defined as the Euclidean distance (\bar{d}), using the difference between the mean *Lab* values from room temperature to 410 °C and those at 440 °C. As the content of the MV pigment added to white cement increased from zero to 5%, \bar{d} tended to increase almost linearly at a rate of approximately 5.8 per 1% addition of MV pigment to white cement. Along with *RGB* intensities, the *Lab* changes can be used to determine the color change at a critical temperature with the white cement-mixed samples containing MV pigment.
