## CASE REPORT

# Avoidance and early diagnosis of erroneous permanent pacemaker placement into the left ventricle: A case report

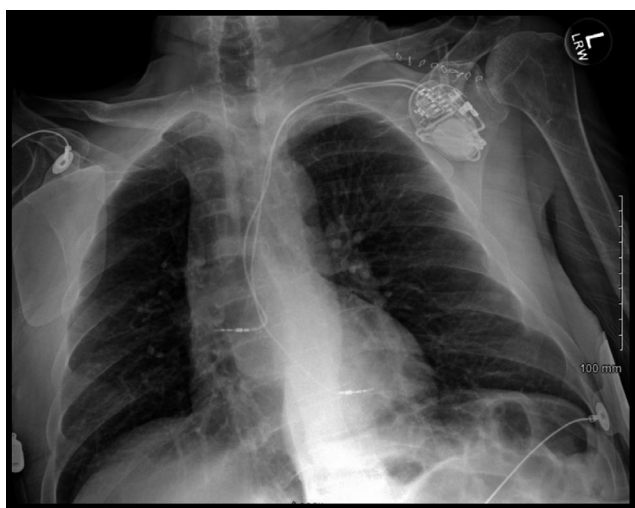
**FIGURE 1** Anteroposterior view of the chest showing no evidence of pneumothorax with the atrial lead in good position while the ventricular lead is higher. This can suggest inadvertent lead placement but lateral chest X-ray is needed for further evaluation

During implantation of a permanent pacemaker, the right atrial lead was appropriately placed via the left subclavian vein into the right atrial appendage. However, the ventricular lead was placed via the subclavian artery into the left ventricular cavity. He was admitted to the hospital overnight and a chest X-ray was obtained the next day, showing no evidence of pneumothorax (Figure 1). Surprisingly, his ECG showed atrial pacing with long AV delay and intermittent ventricular pacing with the paced ventricular beats showing right bundle branch block morphology contrary to the expected left bundle branch block morphology seen when the lead is inside the right ventricular cavity (Figure 2). A limited bedside Echo was obtained that showed the ventricular lead clearly crossing the aortic valve to the left ventricular cavity and fixed into the inferolateral wall of the left ventricle (Figure 3). Early recognition of this serious pacemaker implantation complication

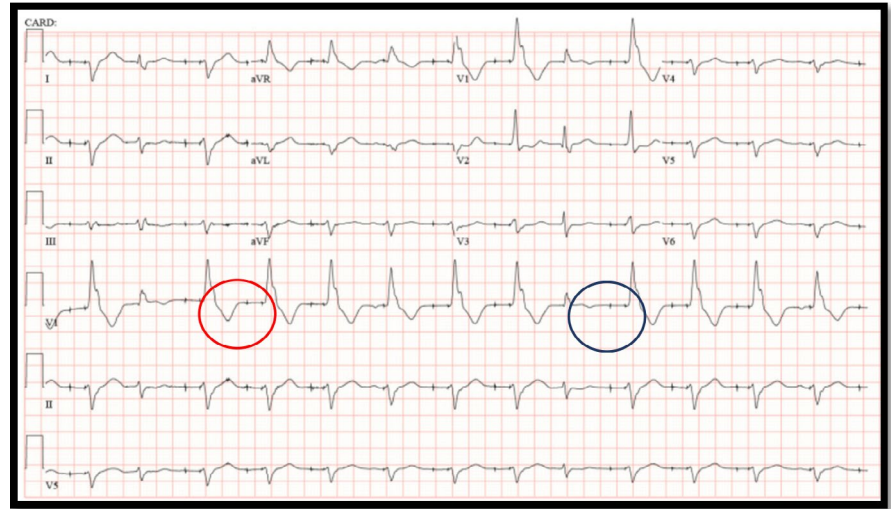
**FIGURE 2** A 12-lead ECG showing atrial pacing with long AV delay (blue circle) and intermittent ventricular pacing (red circle). The key point is that the ventricular paced beats are conducted with right bundle branch block morphology rather than the expected left bundle branch block with right ventricular pacing

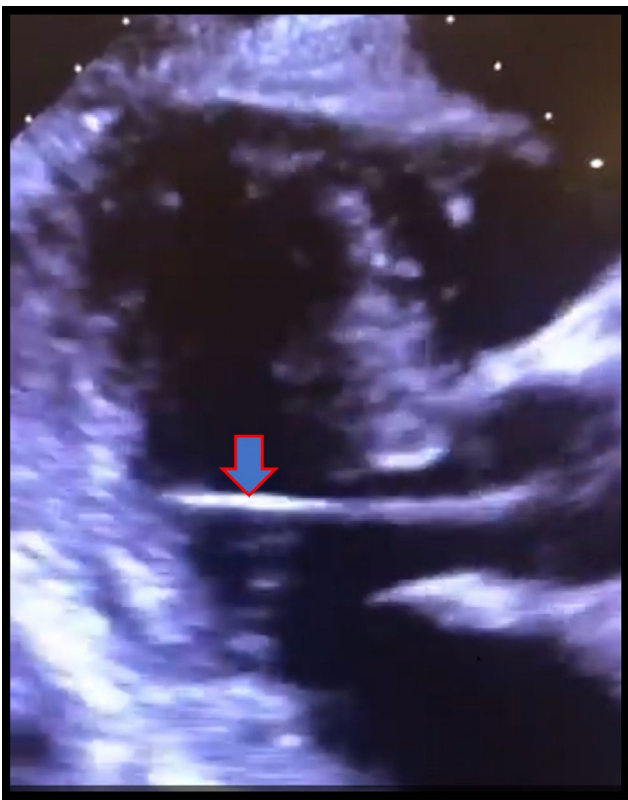
**FIGURE 3** Parasternal long-axis view showing pacemaker lead (arrow) crossing the aortic valve into the left ventricular cavity and fixed to the inferolateral wall of the left ventricle

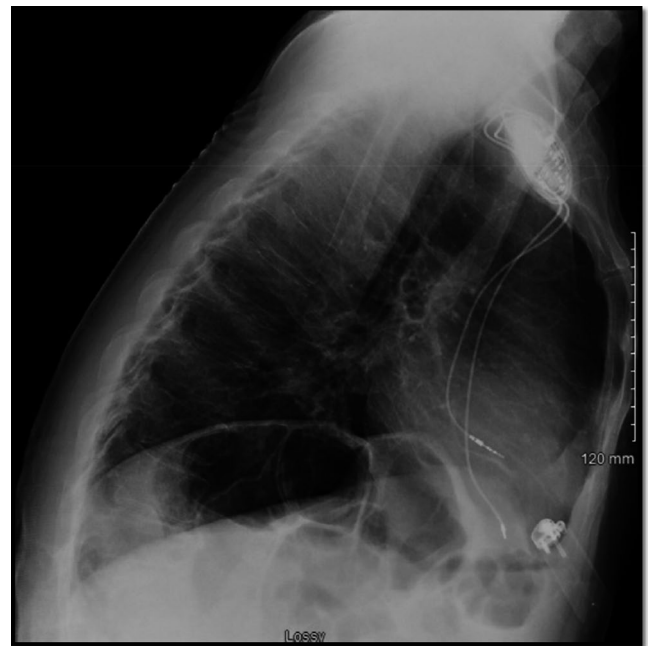
**FIGURE 4** Lateral chest X-ray view post-pacemaker revision with the ventricular lead directed anteriorly suggesting right ventricular position

led to pacemaker revision the same day with extraction of the arterial lead and reinsertion of the ventricular lead via the left subclavian vein into the right ventricular cavity (Figure 4). The pacemaker revision went uncomplicated.
