Hindawi Case Reports in Pulmonology Volume 2022, Article ID 2541285, 4 pages https://doi.org/10.1155/2022/2541285

# Case Report

# Noninvasive Management of Fractured Indwelling Tunneled Pleural Catheter Valve

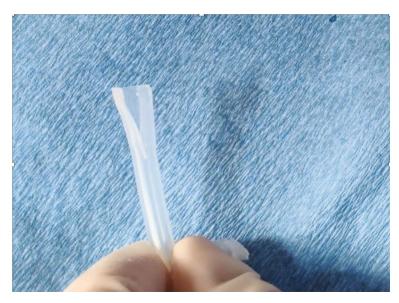
FIGURE 1: Longitudinal incision made on the distal end of the new indwelling pleural catheter tip to free the drainage valve.

Risks and benefits of replacing the drainage valve versus replacing the entire IPC were discussed, and both patients opted to replace the valve alone. Under sterile conditions, the IPC was clamped, and the fractured valve was removed by cutting the catheter distal to the clamp. A new pleural catheter drainage valve was obtained from a pleural catheter drainage kit by making a longitudinal incision at the distal end of the catheter tubing fitted onto the tapered end of the drainage valve (Figure 1). Cyanoacrylate tissue adhesive (adhesive used to form a strong bond between apposed wound edges) was applied on the new catheter valve, which was inserted into the exposed end of the old catheter till its base (Figure 2) and tightened using a zip tie (Figure 3). The catheter was then unclamped, and adequate drainage of fluid was seen, which improved both patients' symptomatic dyspnea.

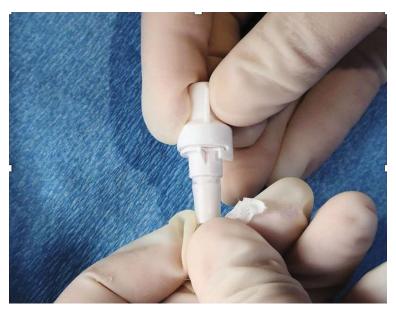
FIGURE 2: Cyanoacrylate tissue adhesive applied to the tapering end of the new drainage valve and inserted into the old catheter.

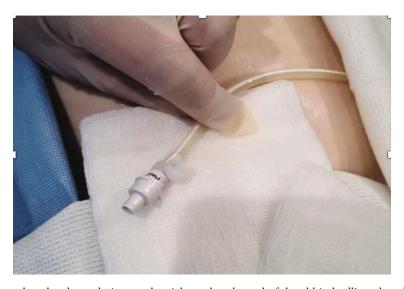
FIGURE 3: New indwelling pleural catheter drainage valve tightened at the end of the old indwelling pleural catheter with a zip tie.
