## RESEARCH ARTICLE

## Local scale interventions dominate over catchment scale controls to accelerate the recovery of a degraded stream

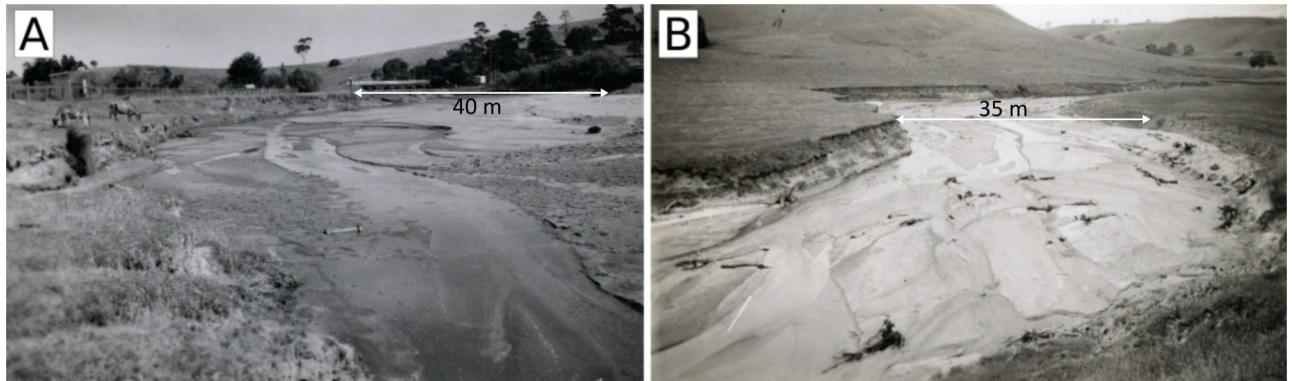
**Fig 2.** The sand pulse in Bryan Creek (A) looking downstream into the reach adjacent to the Coleraine Township in 1950, (B) looking upstream toward the reach immediately above Coleraine in 1944, substantial in-stream extraction was undertaken in this reach between 1954 and 1990. Photo source: Coleraine Historical Society.

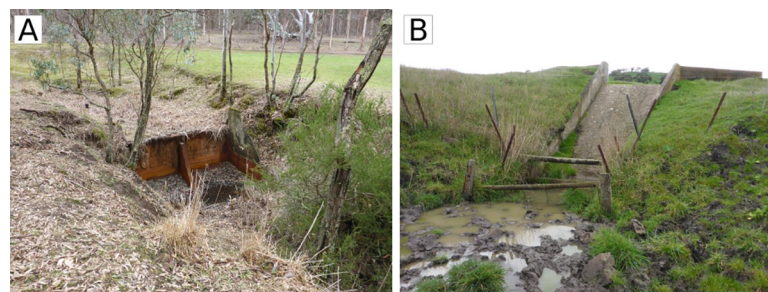
**Fig 3.** Erosion control structures, constructed in the late 1960s and early 1970s, in small headwater streams in the Bryan Creek catchment. (A) 'Drop structures'—small grade control structures which span the channel and trap sediment, (B) concrete chutes which slow erosion by preventing nickpoints from migrating upstream. Photos courtesy of Glenelg Hopkins Catchment Management Authority.

**Erosion control measures in the Dundas Tablelands.** Erosion control works (fencing to exclude stock, wooden or concrete structures to halt gully-head migration, and grade control structures) were undertaken by the Soil Conservation Authority and Glenelg River Improvement Trust between 1950 and 1989 in the gullies that feed water and sediment to the study reach (Fig 3). These works have succeeded in stabilising gullies and have reduced sediment inputs to Bryan Creek [20, 21], allowing the tail of the sediment pulse to move downstream (Fig 4).

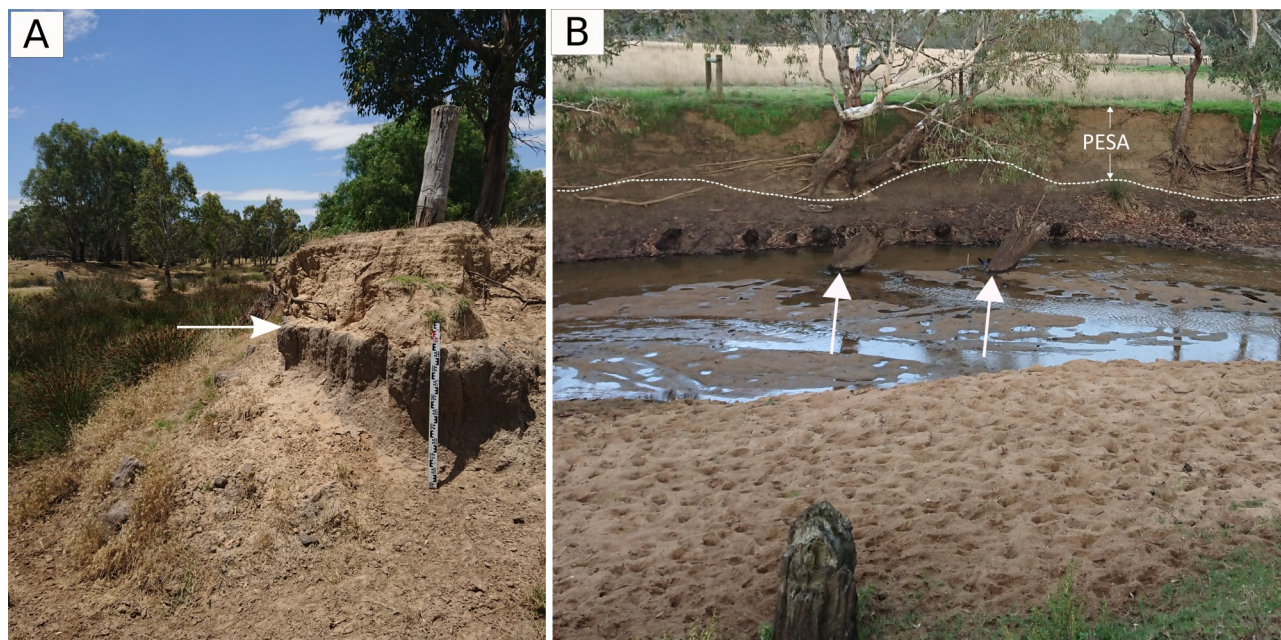
**Fig 4.** (A) Looking upstream into a reach not subject to any intervention, in 2017, the white arrow points to the sharp contact between the pre-pulse riverbank comprised of dark, organic rich sediments, and the upper levee of coarse sand deposited on the floodplain when the bedload pulse formed, (B) looking across towards the left bank in the lower part of Bryan Creek. Dashed white line marks the contact between the former stream bank and the overlying post-European settlement alluvium (PESA), white arrows mark exhumed tree trunks in the channel bed.

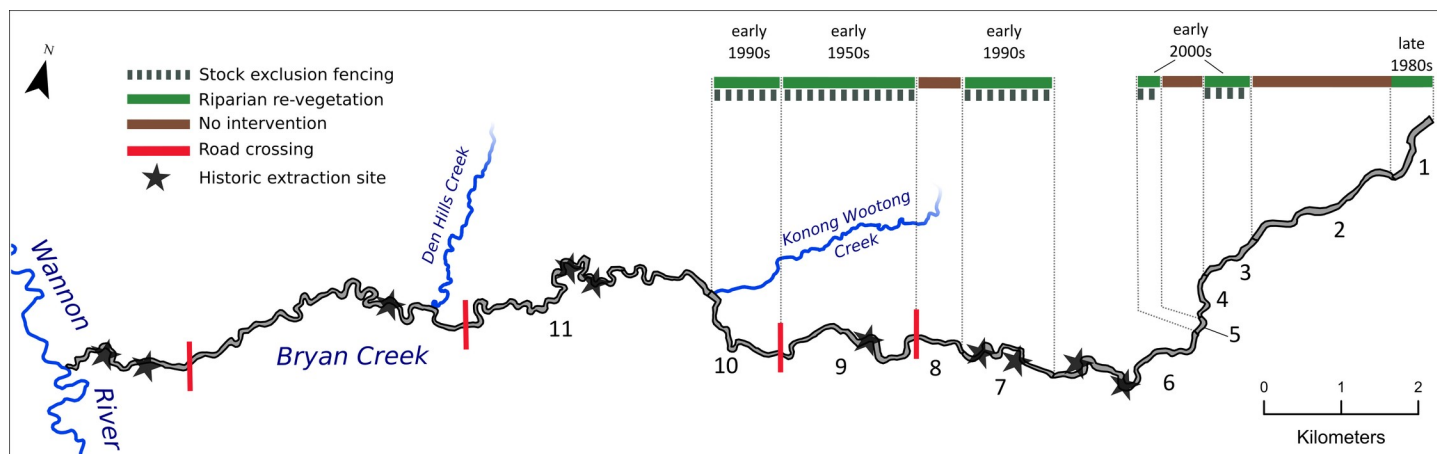
**Fig 5. Study reach of Bryan Creek in western Victoria with treatment reaches numbered.** Coloured bars indicate the type of intervention undertaken in the corresponding reach and the approximate date of intervention. The location of extraction sites (1954 to 1994) and road crossings are also shown. Flow is from right to left.

Since the 1980s stock exclusion fencing, revegetation and in-stream sand extraction have been used in five combinations, across eleven distinct reaches of Bryan Creek (Table 1 and Fig 5).

The following descriptions refer to the reaches shown in Fig 5. In-stream sand extraction was undertaken continually, but in different parts of the river, between 1954 and 1994. Sand was extracted from discrete pits approximately 40 m in length, 30 m wide and 3–4 m in depth, or in the case of reach 7, from a much larger zone approximately 100 m long and 40 m wide. Stock exclusion, which consisted of fencing both sides of the river, and revegetation, which consisted of planting trees on both banks of the river, but not on the streambed, was undertaken in reach 9 first, in the 1950s. When the second phase of interventions began in the 1980s, the tail of the bedload pulse had moved further downstream, exposing a clay bed in the upper 3 km of the river. Thus, when stock exclusion and revegetation treatments were undertaken in reach 1 (Fig 6), the reach had an incising, clay bed. Reaches 7 and 10, which were sand bed reaches at the time of intervention, underwent stock exclusion and revegetation in the early 1990s. Lastly, reaches 3 and 5 (also sand bed reaches at the time of intervention) were fenced to exclude stock and had their banks revegetated in the early 2000s. Fencing in reaches 3 and 5 was not maintained, but stock exclusion fencing in other reaches was. The impact of catchment scale changes in vegetation cover and sediment supply on the morphology of Bryan

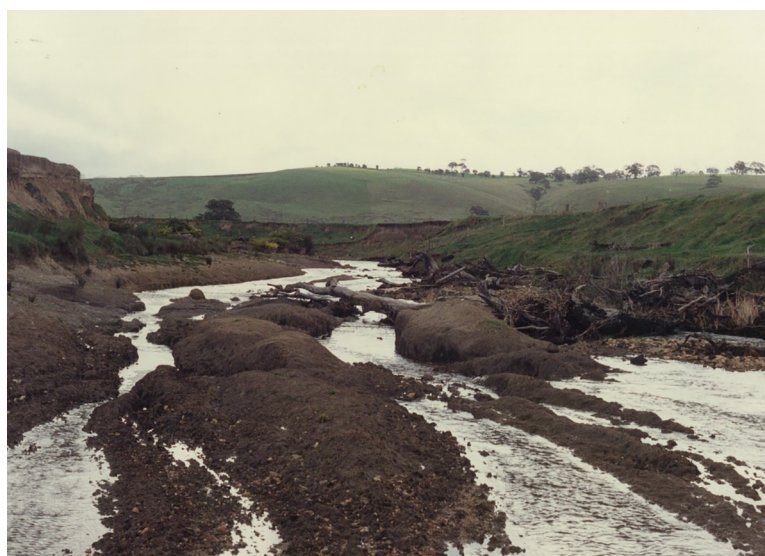
**Fig 6. Looking downstream into the clay bed reach at the upstream end of the study reach (reaches 1 and 2 in Fig 5) immediately prior to intervention in the late 1980s, twenty years after erosion control measures and improved pasture practices in the catchment reduced the supply of sediment to Bryan Creek.** Note incision into the clay bed. Photo source: Glenelg Hopkins Catchment Management Authority.

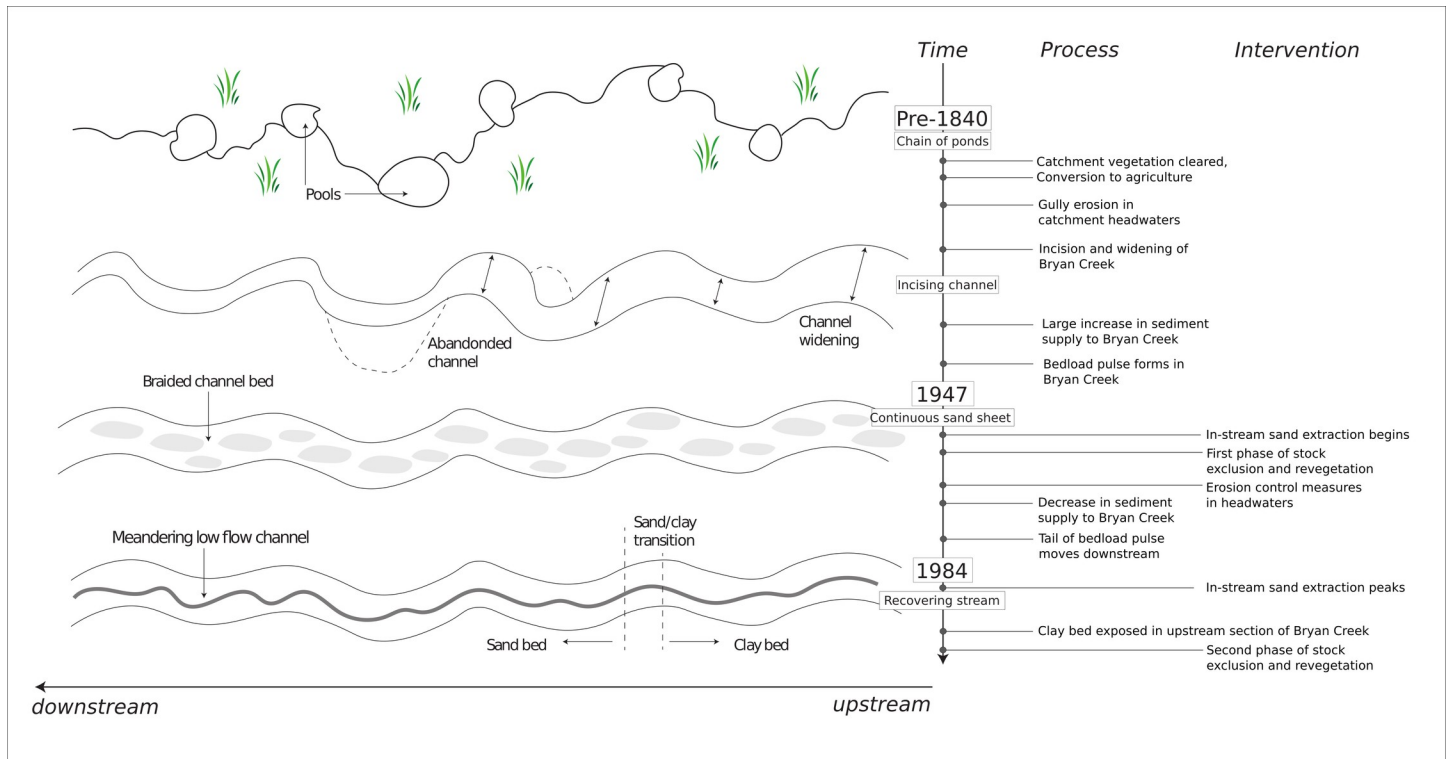
**Fig 7. Changes in the catchment of Bryan Creek, the response of Bryan Creek to catchment changes and the timing of intervention between 1950 and 1984.**

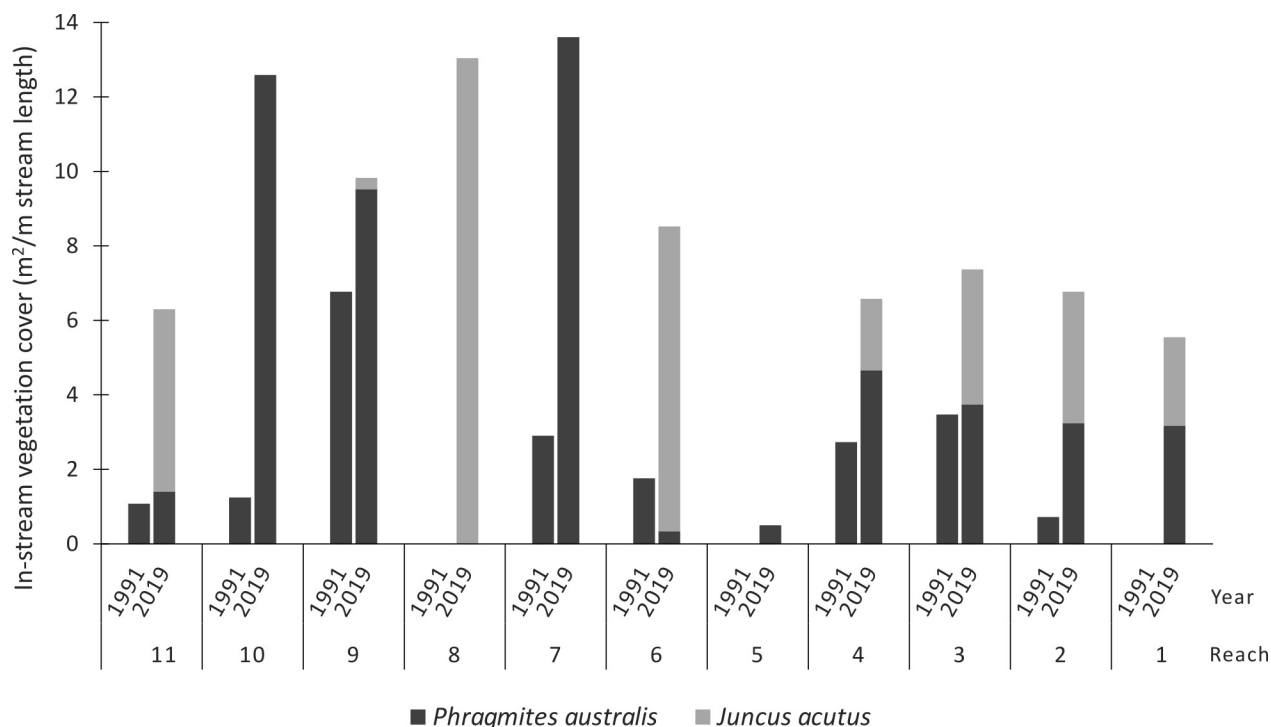
Fig 8. Changes in the coverage and composition of vegetation in the 11 reaches of Bryan Creek between 1991 and 2017.

Vegetation coverage increased in all reaches between 1991 and 2019, but the species responsible for the increased coverage varied between reaches (Fig 8). Reaches 1–3 transitioned to an approximately even coverage of *Phragmites* and *Juncus*. The coverage in reaches 6, 8 and 11 was due almost entirely to *Juncus*, while increased coverage in reaches 7, 9 and 10 was due entirely to *Phragmites* (Fig 8). Reach 5 had the smallest increase in coverage, all of which was *Juncus*. Overall, reaches treated with stock exclusion fencing that was maintained are now dominated by *Phragmites* only, while those that have not had stock excluded or stock exclusion fencing was not maintained, have significant beds of *Juncus* throughout.

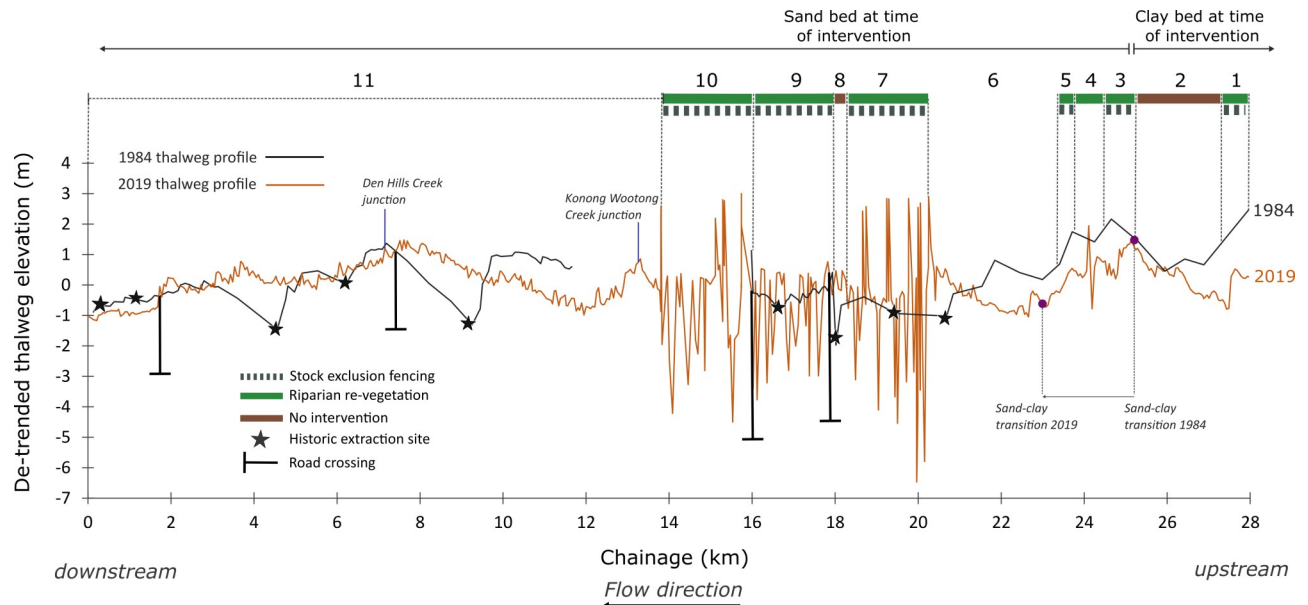
**Fig 9. De-trended, baseline and post-intervention longitudinal thalweg profiles for Bryan Creek.** Black line is the 1984 profile and orange line is the 2019 profile. The eleven intervention reaches, the combination of interventions undertaken in each reach and channel substrate at the time of intervention are annotated. The location of historical extraction sites is marked with black stars (each star is a single extraction pit). The position of the sand-clay transition in 1984 and 2017 is also marked.

**Changes in the longitudinal profile of Bryan Creek.** Between 1984 and 2019 the tail of the bedload pulse (identified as the transition between sand and the clay on the stream bed) has continued to move downstream. This has caused the bed to degrade and has exposed the clay in reaches 3,4,5 and part of reach 6 (Fig 9).

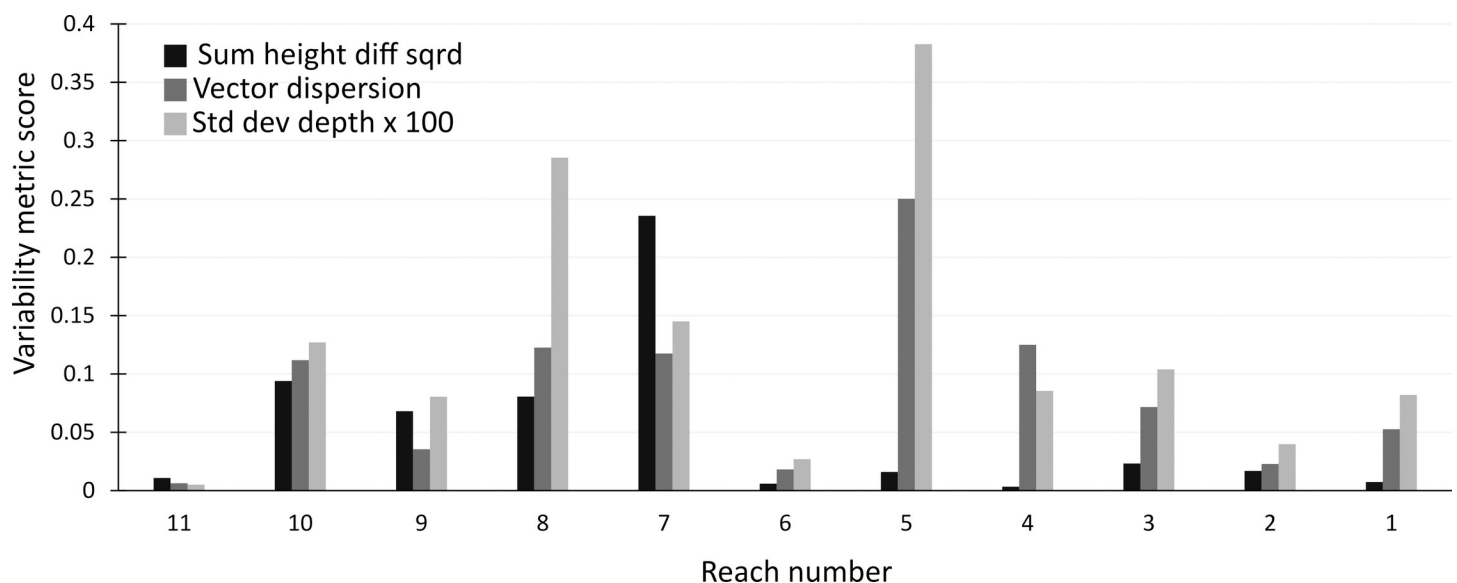
**Fig 10. Post-intervention thalweg complexity values measured using the std dev depths, vector dispersion and sum height diff squared metrics for each of the 11 reaches of Bryan Creek.**

Thalweg complexity values for all metrics are low in reaches 1,2,3, 6 and 11 (Fig 10). Values of sum height diff squared are consistently higher in reaches 7–10 (which mirrors the development of pools evident in the thalweg profile), and to a lesser extent so are values of vector dispersion and std dev depth. Reach 5 has notably higher values for std dev depths and sum height diff squared than surrounding reaches, but there is considerable overlap in calculated values of variability between reaches (Fig 10).

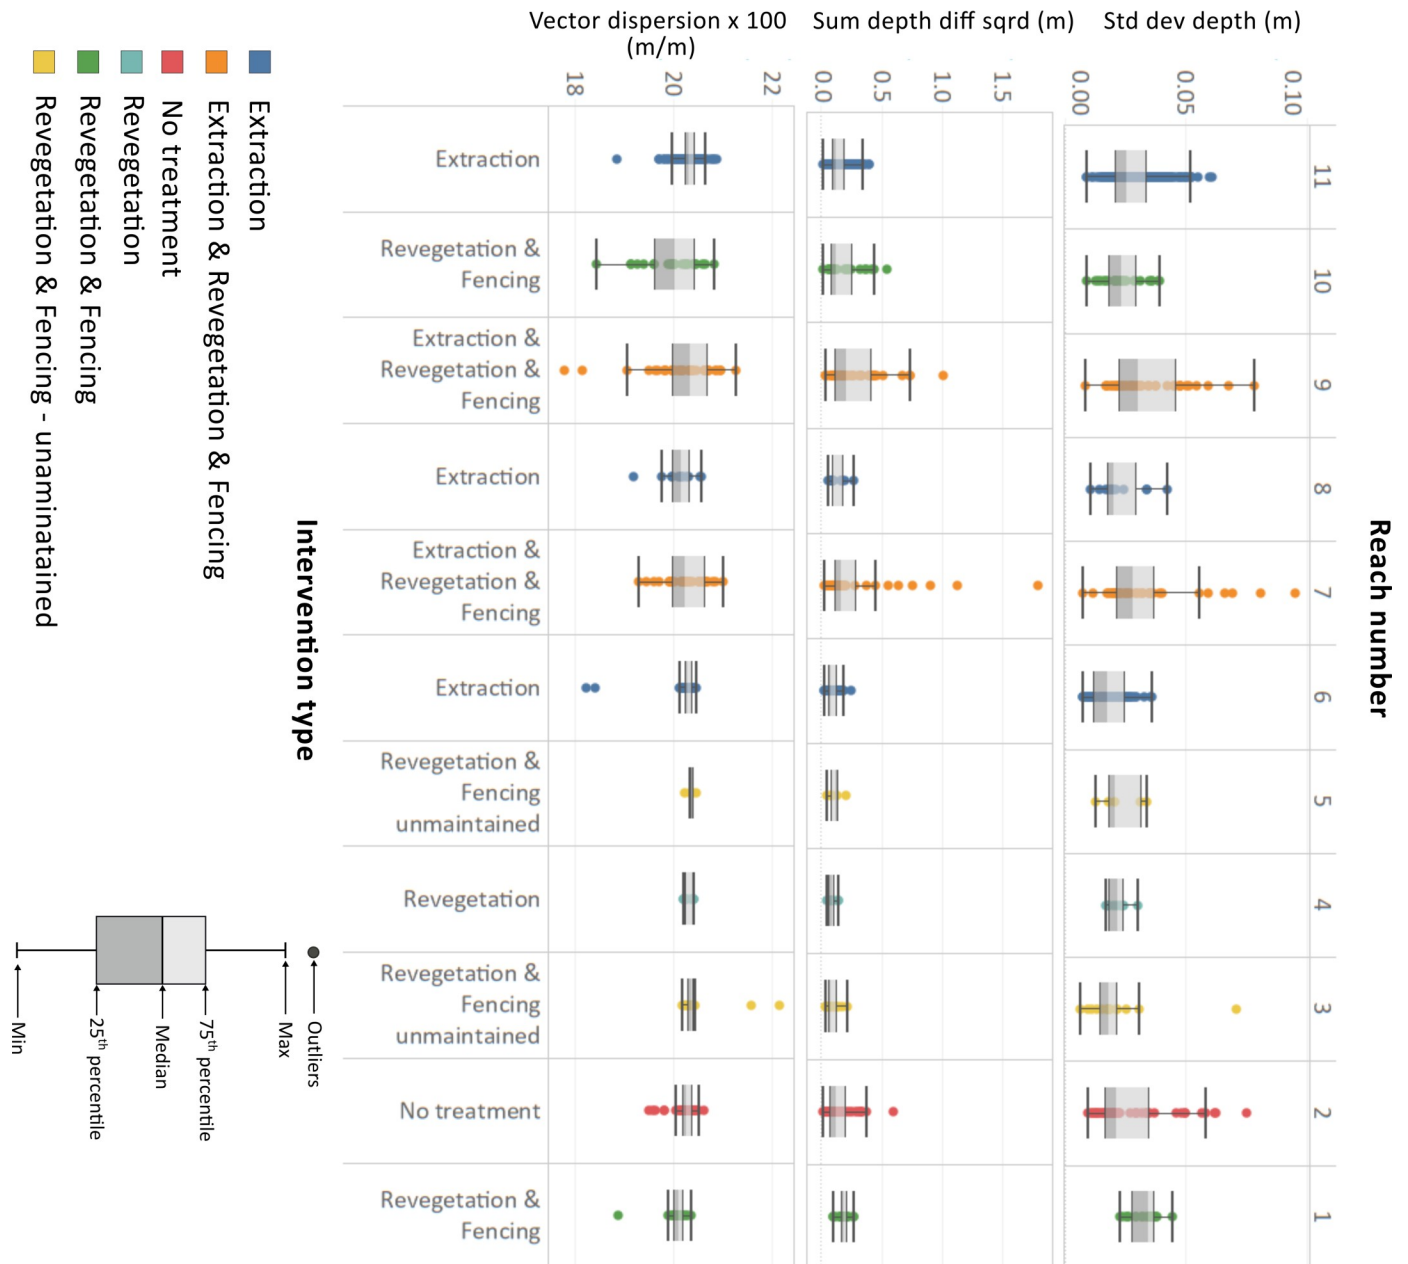
**Fig 11. Cross-section complexity values for the std deviation of depths, sum of depth differences squared and vector dispersion metrics for the 11 reaches of Bryan Creek.** Colours and labels at the base of the plot denote the intervention applied to each reach. Note that max/min values in box plot are defined as the 25<sup>th</sup>/75<sup>th</sup> percentile values  $\pm 1.5 \times$  the inter-quartile range.

**Cross-section variability.** Cross-section variability does not show a clear pattern at the scale of the whole river (Fig 11). There is considerable overlap in the spread (as measured by the inter-quartile range) of cross-section variability values between reaches, regardless of the metric used to measure variability (Fig 11). However, reaches 7–11 have a wider distribution of variability than reaches 1–6, with reaches 7 and 9 having an especially wide range of variability values for all three metrics (Fig 11).

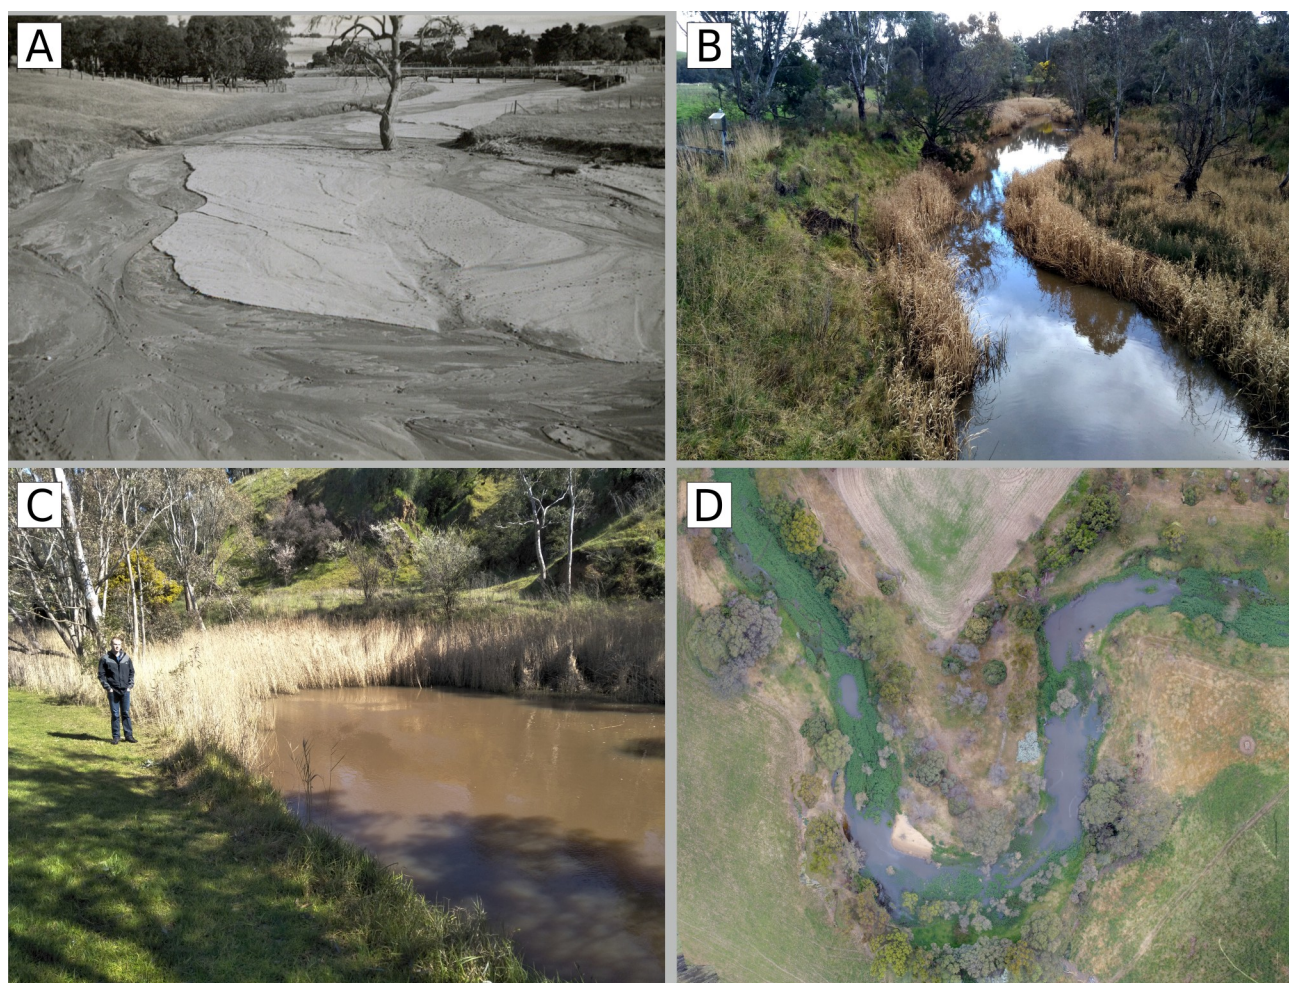
**Fig 12.** (A) View looking upstream into reach 10 beside the Coleraine township in 1940, showing wide, flat bed of sand devoid of vegetation, (B) looking downstream from the upstream end of reach 8 in 2017 showing emergent macrophytes on the margin of a continuous channel, (C) pools in roughly the same location as (A) but looking downstream in reach 10 in 2017, (D) a 2017 aerial image of reach 11 showing the sequence of pools. Photo A is from the Coleraine Historical Society.

Reaches with a sand bed in 2017 (6–11) have transitioned to either a sequence of pools morphology (Fig 12) or a dissected morphology (Fig 13). The sequence of pools morphology has formed wherever stock have been excluded from a reach. All reaches treated with stock exclusion also had their banks revegetated, and the association between stock exclusion and sequence of pools morphology holds where the reach was previously subject to in-stream extraction (reaches 7 and 9).

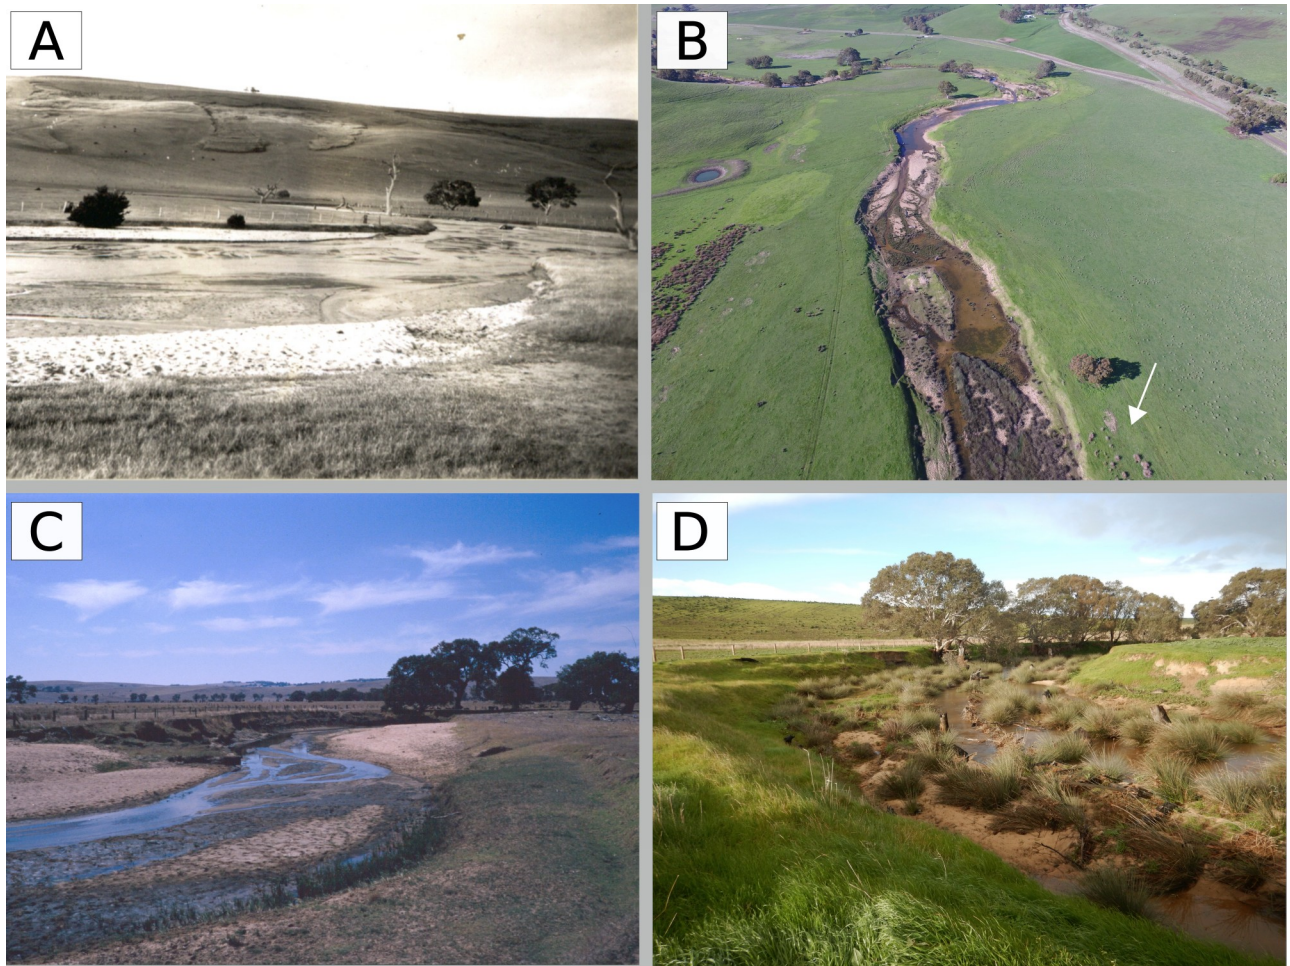
**Fig 13.** (A) Looking north across reach 7 above Coleraine in 1944, significant in-stream extraction began here in 1954, (B) aerial view of the same section in 2017 showing dissected morphology, white arrow indicates the position photo (A) was taken from, (C) representative section of reach 11 in 1994, immediately after extraction ceased, note the absence of *Juncus* on the channel bed, and (D) representative section of reach 11 in 2017, showing *Juncus* colonising the bed, the dissected morphology, and bar-and-bench erosion. Photo source: A, Coleraine Historical Society, B, Glenelg Hopkins Catchment Management Authority.

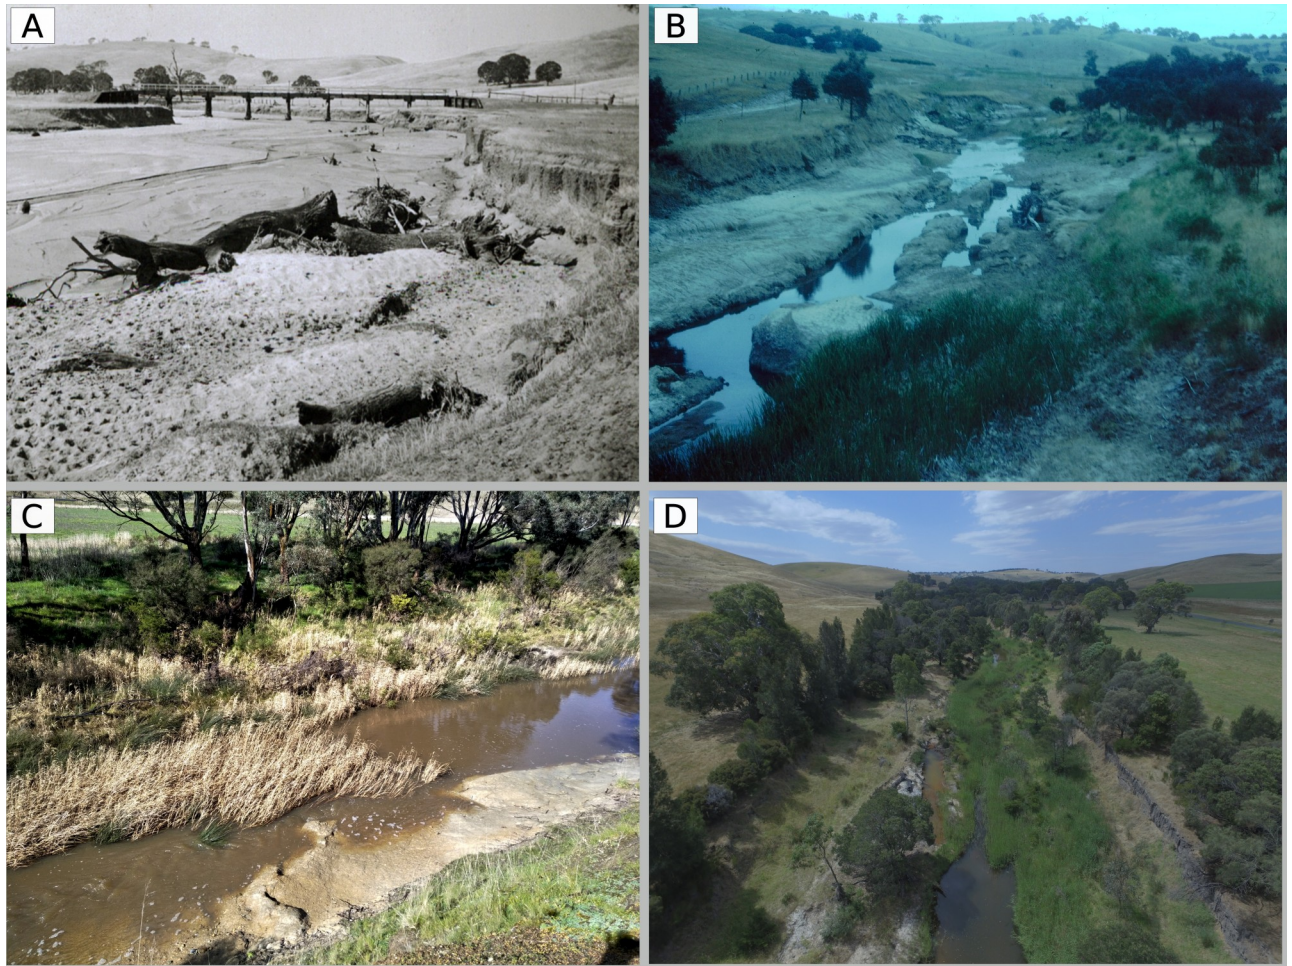
**Fig 14.** (A) Reach below original Douglas-Gaze-McMahon Road bridge, looking upstream, in 1940, (B) reach 1 looking upstream towards the current Douglas Road bridge, which is 300 m upstream from the original bridge, in the late 1980s, incising clay bed and bank-collapse clearly visible, (C) reach 1 in 2017, looking across from the right bank showing revegetated banks, small stands of *Phragmites* and exposed clay bed, (D) oblique aerial view of reach 1 looking upstream, showing formation of a series of shallow runs, emergent macrophytes and bank vegetation. Photo source: A, Coleraine Historical Society, B, Glenelg Hopkins Catchment Management Authority.

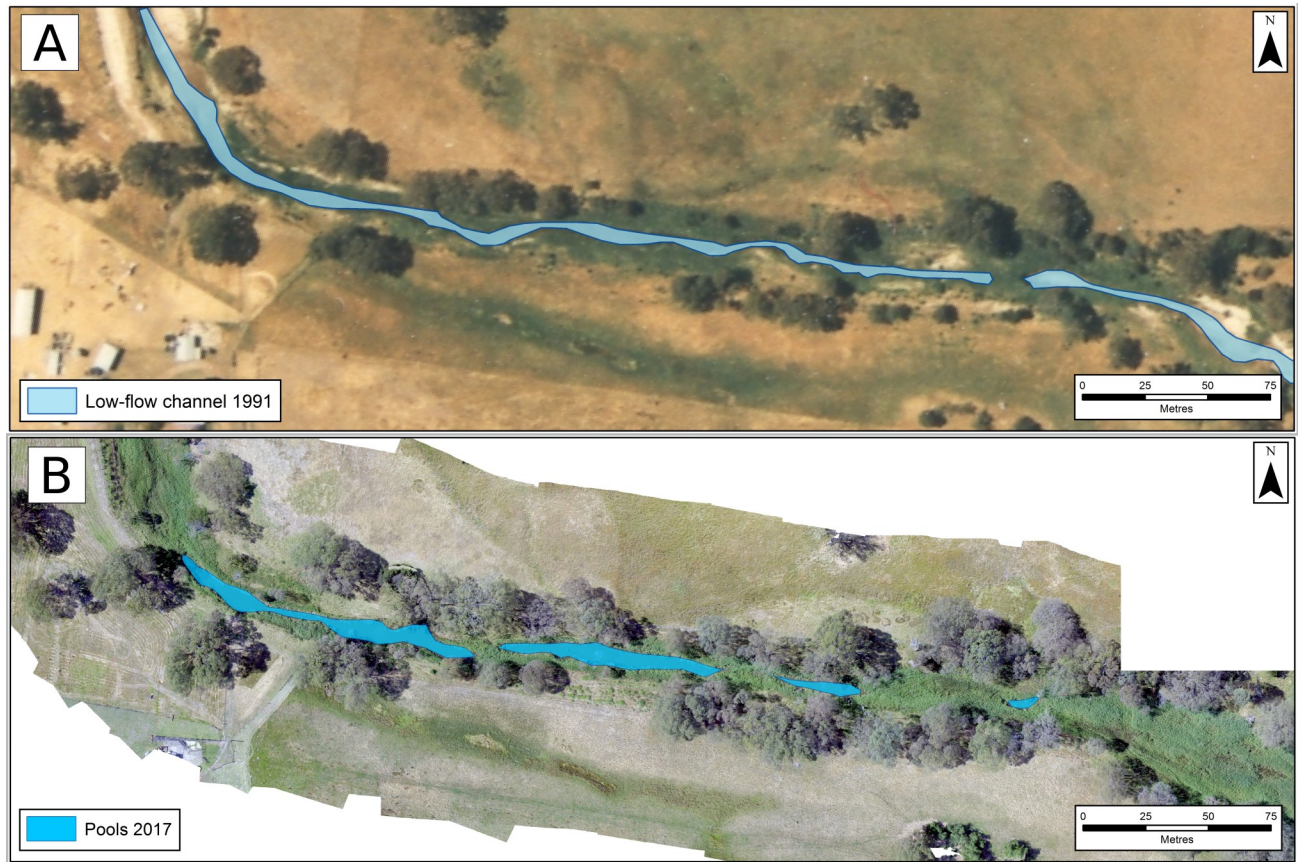
**Fig 15.** The transformation of reach 8, above Coleraine, from (A) a continuous low-flow channel in 1991 to (B) a sequence of pools by 2017. *Phragmites* spread inwards from the channel margins, pinching-off the low-flow channel.

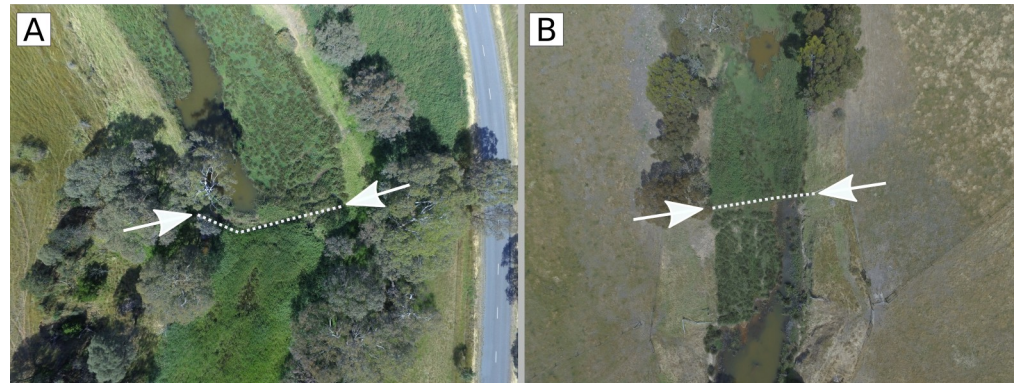
**Fig 16.** (A) The upstream boundary of reach 7 and 8 and the abrupt changes from *Juncus* (upstream, top of photo) to *Phragmites* (downstream, bottom of photo), (B) the downstream boundary of reaches 8 and 9 and the abrupt change from *Phragmites* (upstream, top of photo) back to *Juncus* (downstream, bottom of photo). White lines and arrows indicate the location of stock exclusion fences.

The boundary between different morphologies in sand bed reaches is sharp and is marked by an abrupt change from a dissected to a sequence of pools morphology (or vice versa) (Fig 16).

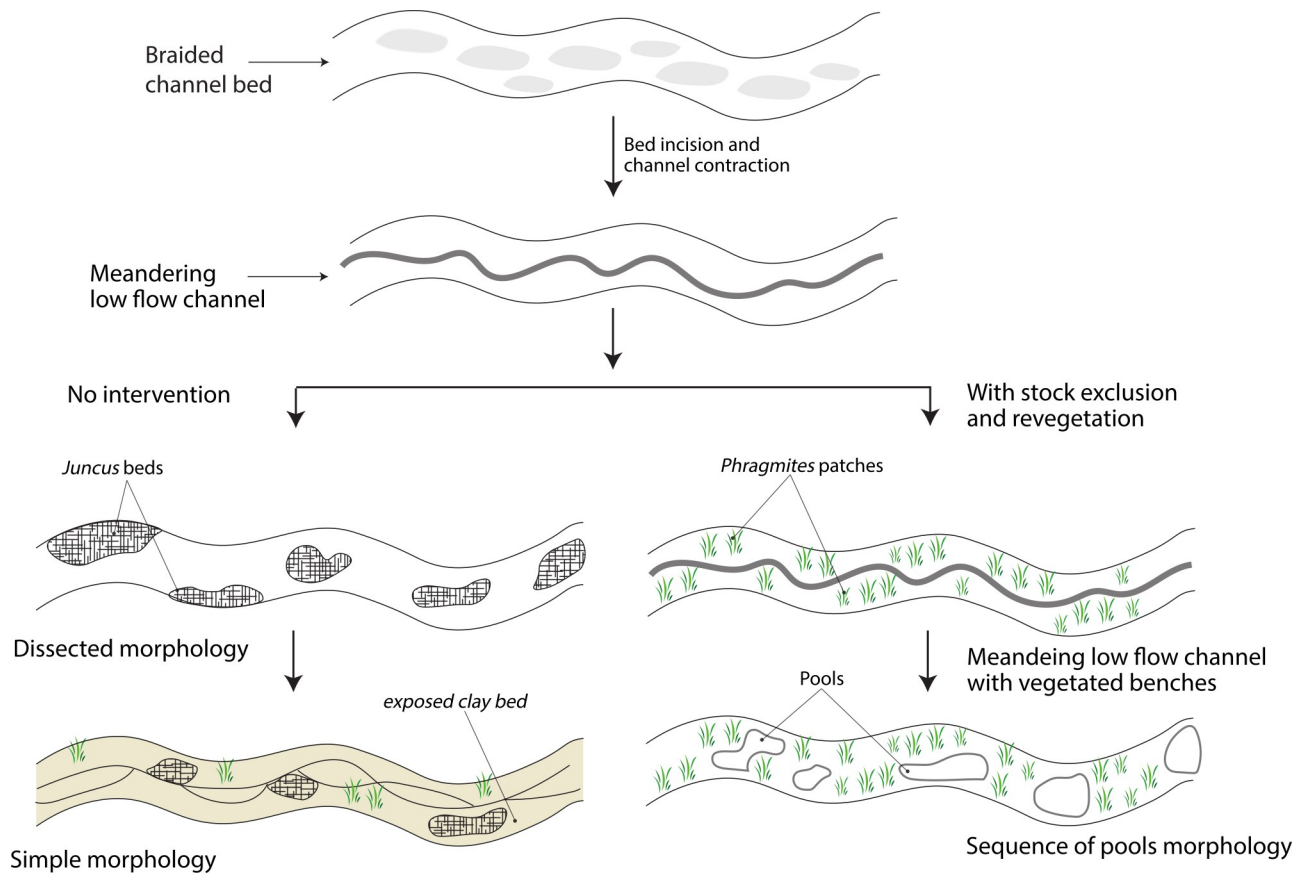
**Fig 17.** A revised conceptual model of the recovery of sand bed streams at the tail of a bedload pulse which have (or have not) been treated with stock exclusion fencing and bank revegetation at the local scale, following the earlier control on sediment supply from the catchment.
