Flange Fracture and Dislocation: An Unusual Complication of Percutaneous Tracheostomy

Keywords: case report, fracture, flange, airway loss, tracheostomy, percutaneous

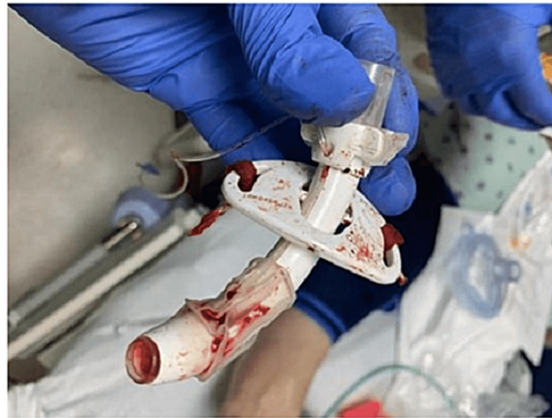
Figure: 1a

PDT. Immediately upon completion of the procedure, the flange was noted to have separated from the outer cannula (Figures 1a-1c).

FIGURE 1: Flange dislocation of percutaneous tracheostomy (1a); another view of the flange dislocation, with an arrow indicating the proper flange pin position (1b); flange dislocation from the second case with an arrow demonstrating the proper flange pin position (1c)

Attempting to reseat the outer cannula into the flange was not successful. To avoid another complication, the decision was made to convert to open tracheostomy and insert a new cannula under direct visualization. The patient was reintubated and returned to the operating room and an open tracheostomy was performed uneventfully.

in which the outer cannula separated from the flange within hours of performing PDT, leading to the impending loss of airway. Both procedures used new tubes placed by different operating teams. On examination, the tracheostomy tubes were cleanly separated at the plastic, pivoting joint between the silicone flange and the PVC outer cannula (Figures 2a-2c).

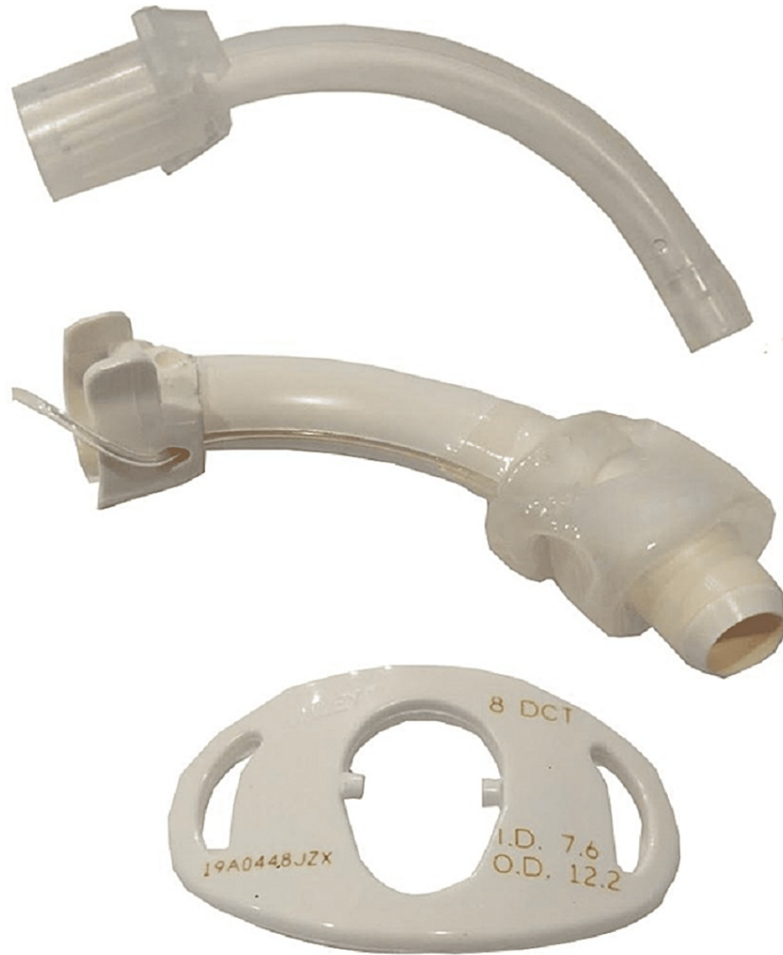
With the introduction of polyvinyl chloride (PVC), silicone, and other materials, the incidence of this particular complication has decreased substantially. Percutaneous tracheostomy tubes have a beveled distal tip and a low-profile cuff designed to reduce insertion force [15-16]. The tracheostomy tube is manufactured in three parts (Figure 2).

FIGURE 2: Components of Shiley tracheostomy - inner cannula, outer cannula, and flange (from top to bottom)

The inner cannula, which snaps into place inside the outer cannula once the latter is in the airway; the outer cannula; and the silicone flange, which is attached to the outer cannula on a restricted pivot point allowing the tube to be secured to the patient. The flange and outer cannula are snapped together during the manufacturing process and are not meant to be separated during placement or use. Communication from Cook (Bloomington, IN) stated that should such an event occur, the recommendation is to discard the tracheostomy tube and proceed with a new kit. The pivot point allows for a more comfortable seating against the patient's neck and helps keep the outer cannula centered in the trachea. This allows for proper angulation after placement but creates potential shearing forces that can fracture the connection between the outer cannula and flange, if not accounted for during insertion [9,15]. As the tracheostomy tube is inserted, the tissue is dilated (as opposed to an open tracheostomy where the dissection is first performed to expose the trachea and then the tracheostomy tube is inserted), therefore, the significant force required for a PDT may have contributed to the flange fracture and dislocation. This complication occurred with a commonly used PDT kit but is not limited to this particular model and may affect other kits as well.
