Surface pretreatment for prolonged survival of cemented tibial prosthesis components: full- vs. surface-cementation technique

BioMedical Engineering OnLine 2005, 4:61 doi:10.1186/1475-925X-4-61

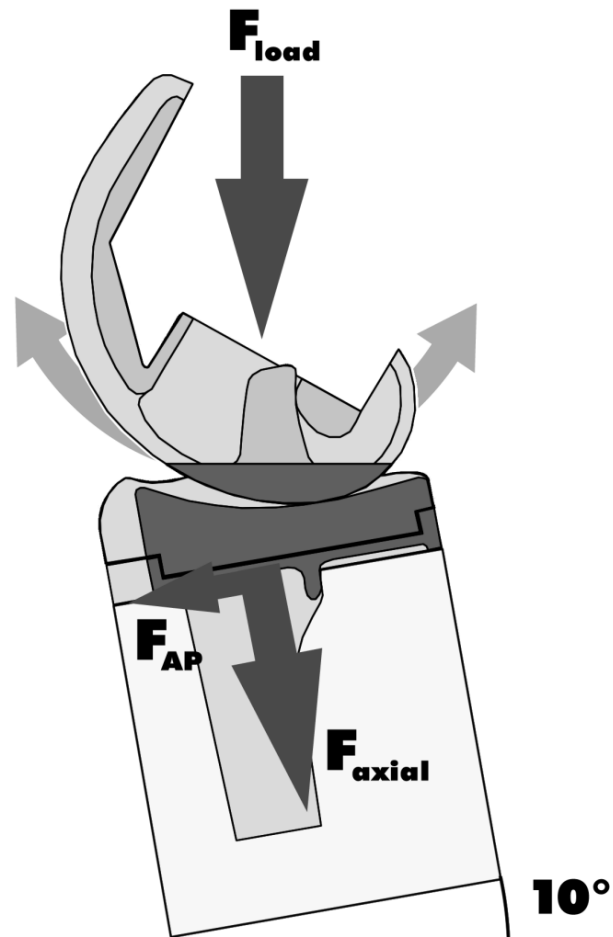
Figure 1
Load geometry for servopneumatically controlled 6kN two-column tabletop tester.

The vibration fatigue test was considered to be a suitable biomechanical model (geometry of load: refer to Fig. 1). It was done using a servo pneumatically controlled 6kN

The test arrangement was mounted on ball bearings for free movement in the anterior-posterior direction and to eliminate all transverse forces while allowing rotation. Inclination of the tibial plane was 10°.

Each tibial implant was exposed to 10⁶ alternating (sine) stress cycles, with a minimum and maximum load of 150 N and 6,000 N, respectively and a cycle frequency of 3 Hz to simulate the physiological conditions in the knee over an average walking period of one year. Total test duration for one component was 3.86 days (about 93 hours). A total number of 8 coated (before PVD-layering abraded by Al₂O₃-blasting (grain size 120 μm) and 12 uncoated (F22 (R_a = 3.41 μm) = 8, Silbermatt (R_a = 0.49 μm) = 2, B60 (R_a = 1.96 μm) = 2; P1 and P2) tibial components were tested. After the vibration fatigue trials, the components were removed and kept in a wet atmosphere at room temperature, as drying was shown reducing crack frequencies and restoring bonding by virtue of water leaving the interface.

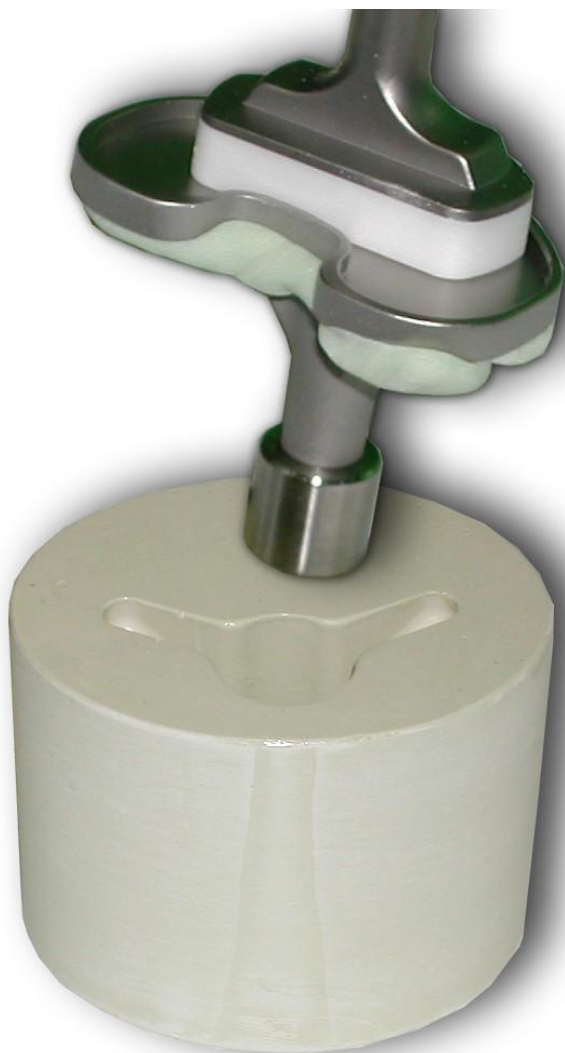
Figure 2
Tibial components ready for surface cementation onto the Technobones (below). Note that the central hole was machined such that there was no "press fit" between the TKA and the Technobones. This ensured maximum stress in the interface.

alloy, for geometry of stem refer to Fig. 2; Aesculap, Tuttlingen, Germany) were tentatively cemented in composite sawbones for biomechanic studies (Sawbones Europe, Malmö, Sweden; note that we did not use "foam bones"; *surface cementing technique applied*). Cementation to cadaver bone was considered not to be feasible for hygienic reasons since we did not succeed in finding a partner which was ready to carry out the saw cuts to be described below. The prosthesis was subjected to a cyclical stress test under near-physiological conditions (37°C, 0.9% NaCl solution) in accordance with ISO 14243. Cyclic loading is considered to resemble the physiological load during walking and it promotes the inception of cracks at voids and flaws and their growth with time in brittle materials [12,13].

two-column tabletop tester (Dyna-Mess, Aachen, Germany). The samples (tibial components cemented to the "technobones": Fig. 2; surface cementing technique applied, no press-fit, stem neither conditioned nor cemented) were kept in a plexiglass chamber under physiological conditions, i.e., at 37°C and at 100% relative humidity while being immersed in a 0.9% NaCl solution. This environmental conditions ensured hydrolytic conditions similar to the human body.

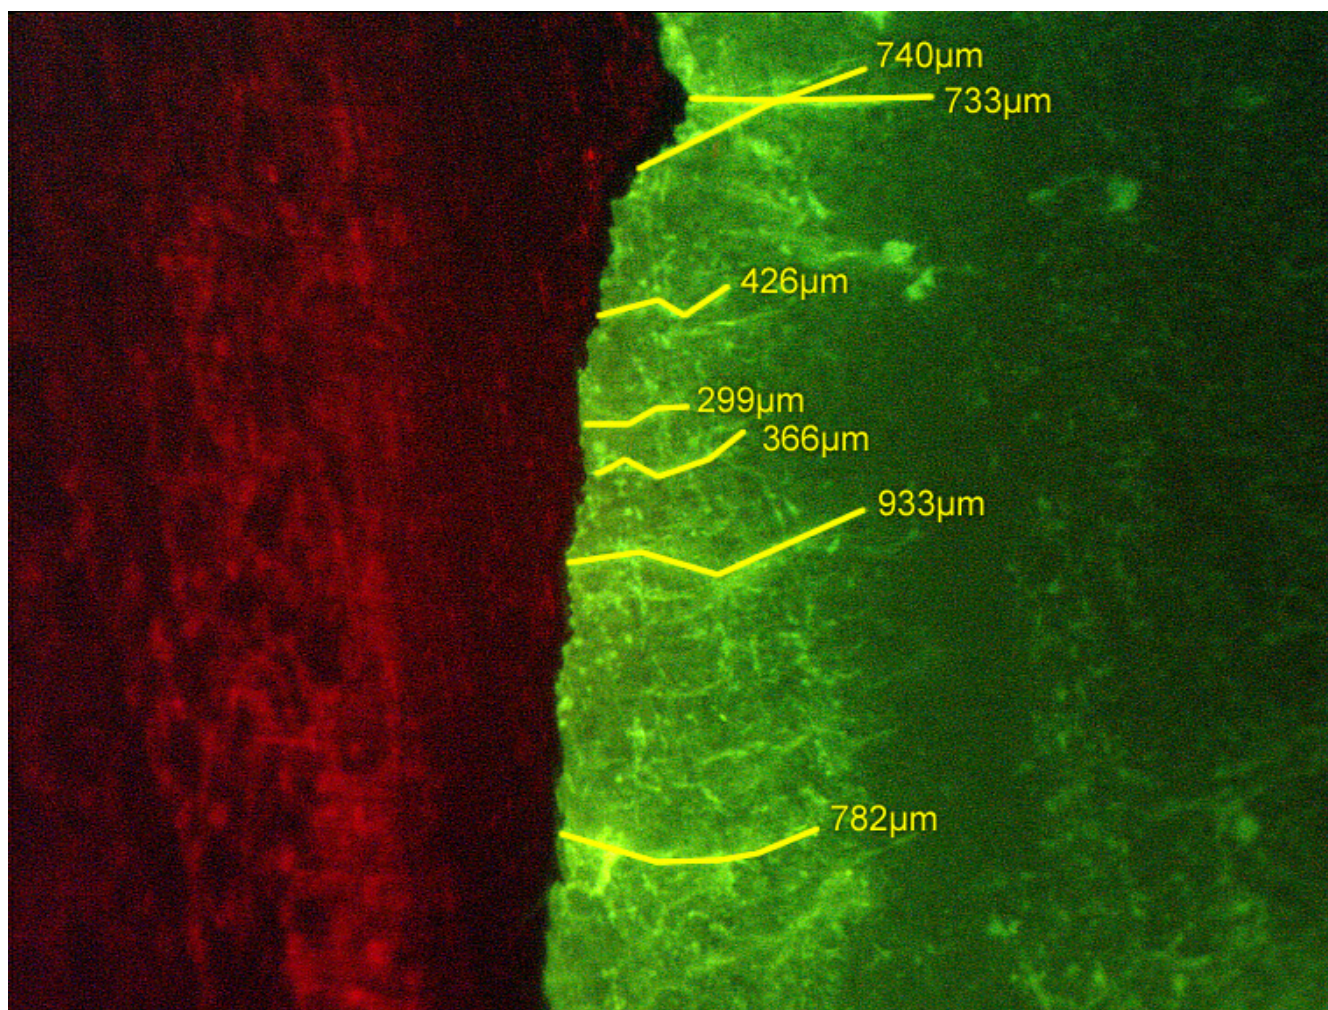
Figure 3
Cracks at the metal (left hand)-cement (right hand) interface made visible using the fluorescence penetration technique.

As with all cyclically loaded systems improving retention stability and reducing debonding tendency means reducing crack, void and flaw frequencies in the interfaces of TKA/bone cement/bone [11]. Cracks originating at the interface metal/bone cement may also influence stability at the interface bone cement/bone, since due to subcritical crack growth promoted by static and in particular due to cyclic loading cracks starting at the interface metal/bone cement can extend to the interface bone cement/bone (distance to be bridged shorter than 2 mm [10]; Fig. 3 reveals

one crack which has already extended to 1 mm). Bone cement has brittle properties and crack branching can play an important part. This is similar to other brittle materials like ceramics and glasses [12,13].

The length and maximum width of all cracks and gaps were recorded. Fig. 3 shows an example of a crack area and Fig. 4 an example of a gap. However, the overall number of gaps detected was much smaller than the number of cracks. Hence we focused to the number and quality of cracks utilizing their numbers and quality as criterions to differentiate between coated and uncoated samples.

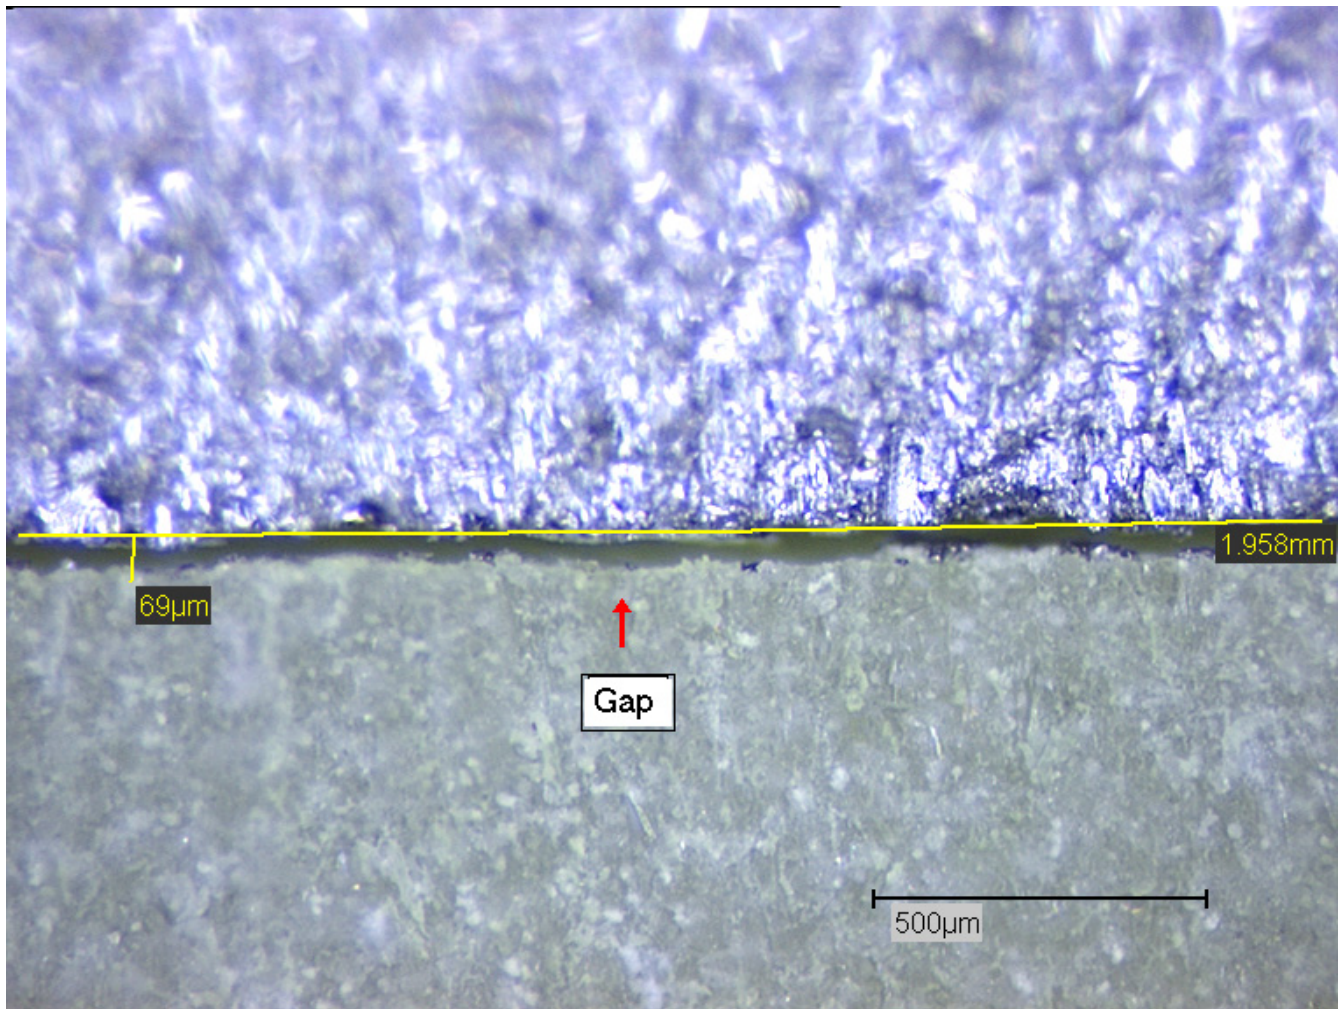
Figure 4
Gap at the metal (above)-cement (below) interface.

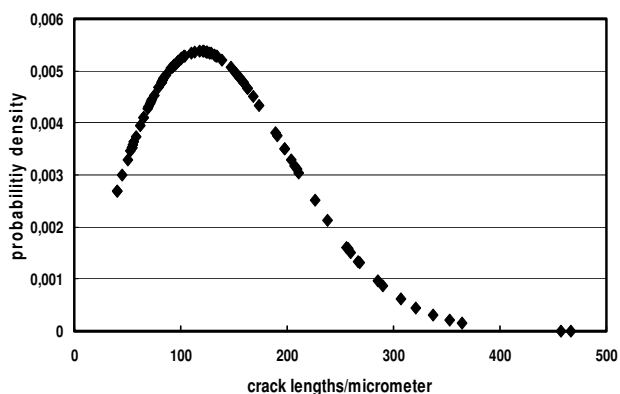
Figure 5
 Prosthesis with surface specification B60: Weibull distribution of crack lengths. Modal value $\pi = 120 \mu\text{m}$ (crack with maximum propability P). Median value of crack length $\delta = 163 \mu\text{m}$ ($P = 63\%$; from Fig. 6). Note that the values given in Tab. 3 for B60 are slightly different ($170 \mu\text{m}$ and $133 \mu\text{m}$ for Median and Modal value, respectively) since those values represent the arithmetic means of characteristic values determined for all prosthesis of this type.

Since there were more short than long cracks, distribution was asymmetrical. This suggested a Weibull statistical analysis (examples and graphical method: Fig. 5 and Fig. 6; summary of results: Table 3) which yielded for Silbermatt components a median of 260 μm , a modal value of 175 μm and the lowest number of cracks (52). The F22 had a median of 239 μm , a modal value of 205 μm and 112 cracks. The B60 components, the interfaces of which were partially debonded on a macroscopic scale during the vibration fatigue trial, had a median of 170 μm , a modal value of 133 μm and 177 cracks (refer also to Fig. 5 and Fig. 6). All the components types have almost the same Weibull shape parameter m = 2. "Median" means

that half of the crack lengths will be less than this value and half will be larger. The modal-value gives the crack length with the highest probability and the shape parameter, m , tells how blurred the distribution is, i.e. if all the crack lengths tend to be not very close to a certain value, the distribution will have a low shape parameter m , and the distribution appears to be very flat and blurred.

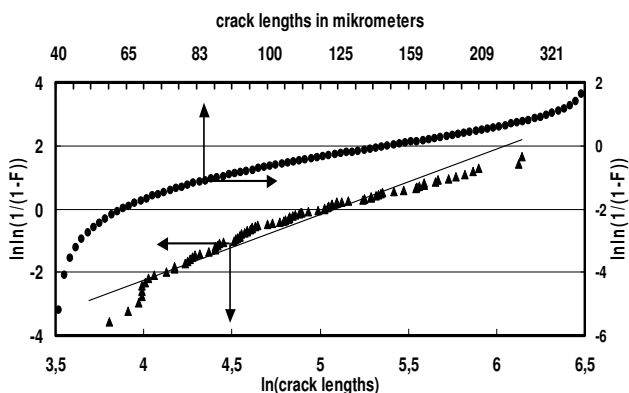
Figure 6
 Prosthesis with surface specification B60: Weibull plot of crack length. Median value of crack length $\mu = 163 \mu\text{m}$. Modal value of crack length $\pi = 120 \mu\text{m}$ (from Fig. 5). Modul $m = 2,1$.

Since there were more smaller than longer cracks, an asymmetrical crack spectrum originated. This suggested to endeavor a Weibull analysis of crack distribution. This kind of analysis revealed to be very suitable for this purpose because it enabled us to list median and modal values characterizing the crack spectra of the uncoated components investigated.
