# Outcome after Two Sequential Revision Hip Arthroplasties for CoC Bearing Fracture with 10 Years Follow-up: A Case Report

**Keywords:** Tribology, Revision Hip Arthroplasty, Ceramic Bearing Fracture

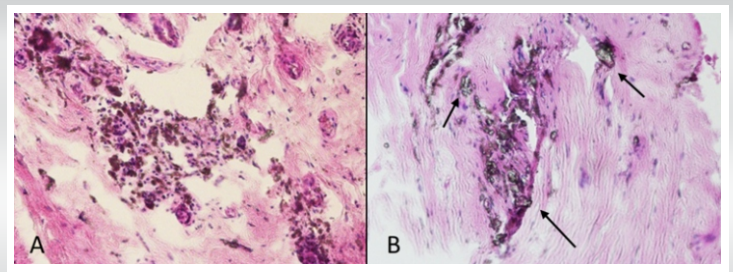
**Figure 3:** Periprosthetic tissue retrieved at revision operation in 2010 following the fracture of CoC bearing with ceramic particles (a); some of them are quite large. (b) (arrows) (Hematoxylin and eosin; obj mag. x20).

(Fig. 2a). The ceramic head was not fractured but covered with severe black metal tracks (Fig. 2b); these originated from the action of sharp ceramic debris against metal parts of the implant. Metal particles thus formed became embedded within the articulating surface of the fractured CoC bearing. The patient underwent revision surgery in November 2010. A direct lateral approach true the primary scar was used. The ceramic fragments were removed, a polyethylene liner was inserted and the ceramic head was replaced with a CoCr femoral head. Therefore, metal-on-polyethylene (MoP) bearing was introduced. An extensive synovectomy was done. Only manual tissue rinsing was done, because of the absence of pulsatile lavage system. Periprosthetic tissue samples were sent for histological analysis, where numerous ceramic particles, some even quite large, were found (Fig. 3). After revision, the patient fully recovered without any pain and discomfort in the hip.

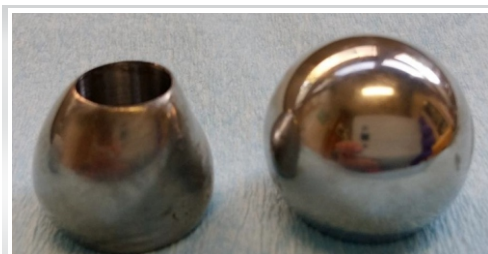
**Figure 5:** Picture of a retrieved worn CoCr femoral head (left) next to an unused femoral head of the same size (right). The femoral head was retrieved at the second revision of MoP bearing in 2013.

At a regularly post-operative check-up about 3 years later (July 2013) a radiograph revealed a worn metal head with a radio-dense shadow by the great trochanter (Fig. 4). The patient underwent a second revision in October 2013. The same operative approach and skin scar were used as in the first two operations. The black-stained pseudocapsule was removed together with the black periprosthetic tissue. There was an obvious infiltration of the muscles with metallosis; however, no clear necrotic sections were seen, so an extensive necrectomy was not necessary. The worn CoCr femoral head (Fig. 5) was replaced with a 4th-generation ceramic head (Bilox delta) with titanium sleeve. Furthermore, we removed the acetabular cup, although well fixed, and replaced it for a cemented Durasul cup with a cross-linked polyethylene liner. The femoral component

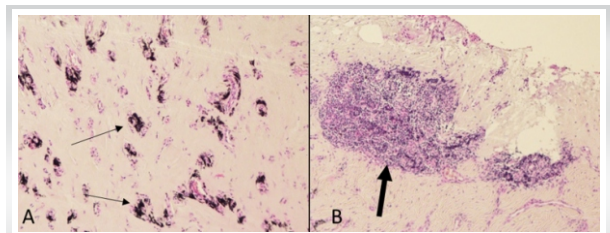
**Figure 6:** Periprosthetic tissue retrieved at revision operation in 2013 due to severe wear of metal femoral head of MoP bearing representing significant metallosis (a) (thin arrows) and with extensive perivascular lymphocyte infiltration (b) (thick arrow) (Hematoxylin end eosin; obj-mag x10).

was also well fixed and the femoral taper was intact so we decided to leave it in. Periprosthetic tissue samples were once again sent for histological investigation with slides now demonstrating significant metallosis with lymphocyte infiltration (Fig. 6). At approximately 10 years after the first and 7 years after the second revision operation the patient is doing fine and fully returned to normal daily activities. A control radiograph (Fig. 7a) taken just after the second revision and a follow-up radiograph (Fig. 7b) taken in July 2020 revealed no osteolytic changes or evidence of complication. Harris hip score [1, 2] for the patients on a last control was 73.

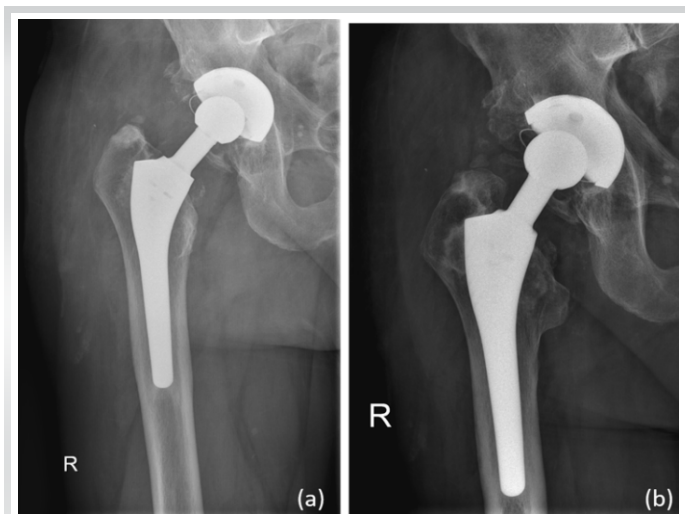
**Figure 7:** (a) Radiograph taken after the second revision operation (year 2013), (b) Radiograph taken on last follow-up (year 2020).
