openheart Complementary role of cardiac CT in the assessment of aortic valve replacement dysfunction

Alastair J Moss,¹ Marc R Dweck,¹ John G Dreisbach,² Michelle C Williams,¹ Sze Mun Mak,³ Timothy Carlidge,¹ Edward D Nicol,⁴ Gareth J Morgan-Hughes⁵

To cite: Moss AJ, Dweck MR, Dreisbach JG, *et al.* Complementary role of cardiac CT in the assessment of aortic valve replacement dysfunction. *Open Heart* 2016;**3**:e000494. doi:10.1136/openhrt-2016-000494

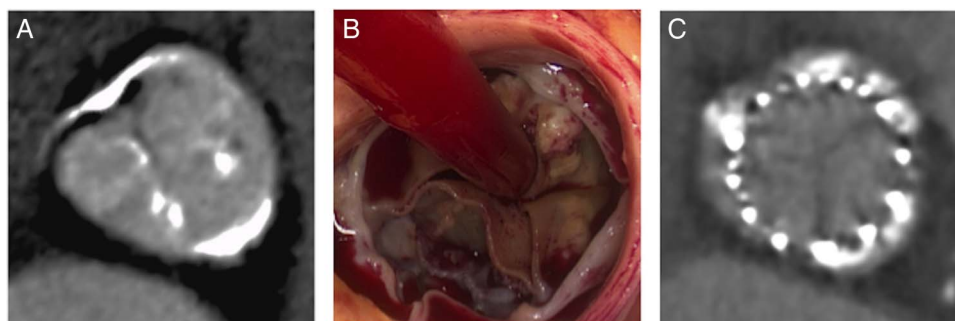
Figure 1 Structural valve degeneration. (A and B) Bioprosthetic aortic valves calcify along the cusp commissures mimicking the pattern found in native aortic valve disease. (C) Calcified leaflets are reflected onto the sinus walls during transcatheter valve implantation.

Reports of early TAVI valve degeneration have again implicated calcification as the key pathological driver, suggesting that CT may once again be off use in detecting early degeneration. This is supported by several recent observations. Deutsch and colleagues noted structural valve dysfunction with several areas of macrocalcification on CT in a 4-year-old CoreValve TAVI bioprosthesis implanted in to a 44-year-old.¹⁷ Similar findings have also been found in elderly patients early after valve implantation.^{18 19} Importantly residual calcium from the original aortic valve around the perimeter of the TAVI bioprosthesis must be differentiated from new calcium formation within the leaflets of the new prosthetic valve (figure 1).

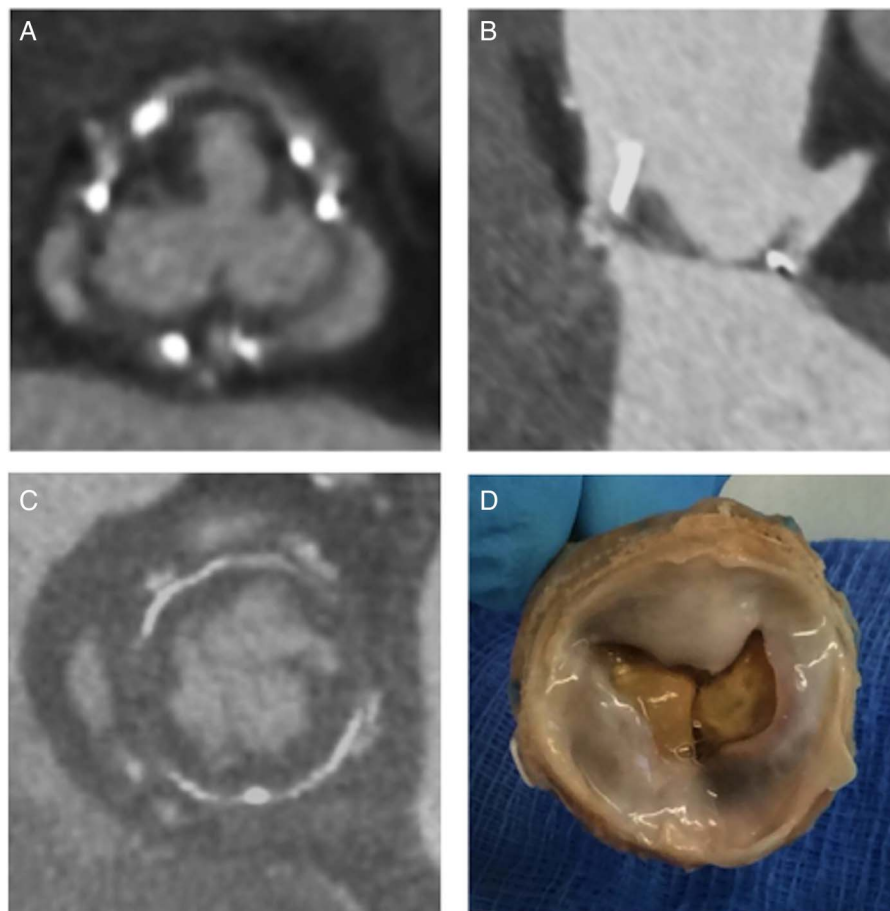
Figure 2 (A and B) Hypoattenuation leaflet thickening suggestive of thrombus formation on the supralvalvular surface impinging leaflet motion. (C and D) Pannus formation underneath the prosthesis can also restrict leaflet motion necessitating surgical removal of the prosthesis.

identified a new phenomenon termed hypoattenuation leaflet thickening (HALT; figure 2). This was first described by Pache *et al*²² in an 86-year-old man with hypoattenuation of a single prosthetic cusp 7 days after implantation of a 29 mm SAPIEN XT valve. Subsequent resolution following coumadin anticoagulation suggested that this finding represented cusp thrombosis rather than pannus formation. Following this initial report, three more recent studies have further investigated the frequency and possible clinical significance of HALT,^{23–25} and each is discussed below.

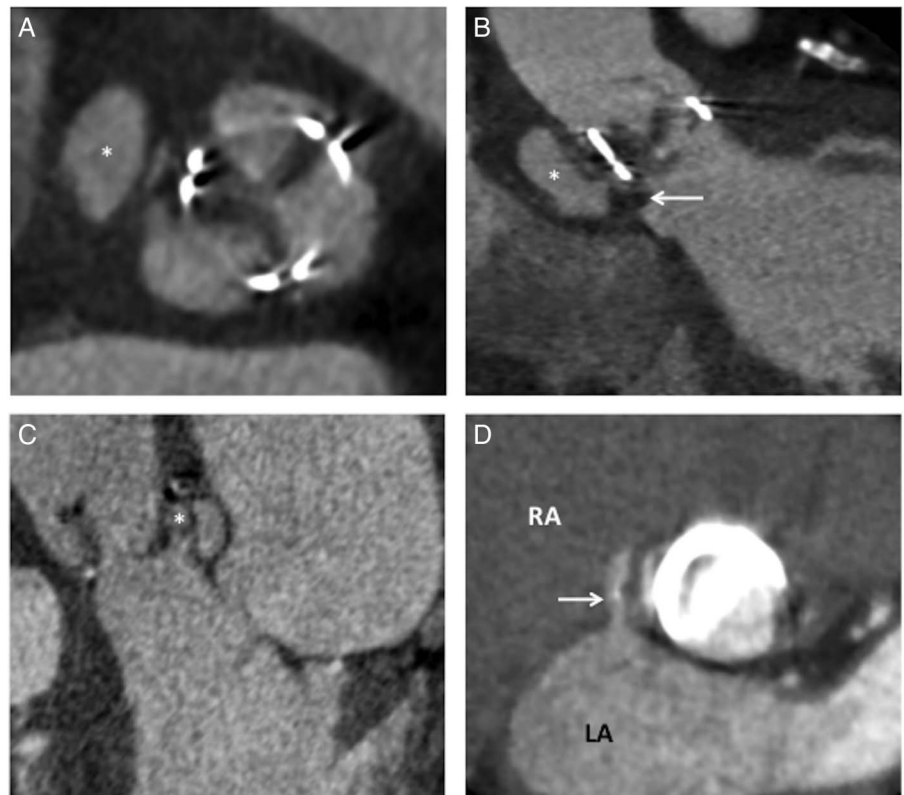
Figure 3 Prosthetic valve infective endocarditis. (A) Complications of prosthetic valve infective endocarditis include the development of perivalvular pseudoaneurysm formation (white asterisk). (B) Saccular pseudoaneurysms (white asterisk) occur in regions where vegetations (white arrow) erode through the annulus with a loss of sewing ring integrity. (C) Bacterial spread into the aortic root results in abscess formation (white asterisk). (D) The anatomical location of erosive shunts (white arrow) and paravalvular leaks due to suture dehiscence can be readily identified using cardiac CT. LA, left atrium; RA, right atrium.

perivalvular pseudoaneurysm formation, which is evident as a focal, contrast-filled saccular or fusiform out-pouching arising from the annulus (figure 3). Extension of infection into the aortic root is more easily detected using CT compared with transoesophageal echocardiography and can further inform surgical management by detecting ancillary features such as pulmonary septic emboli, patency of the coronary arteries, mediastinal gas and collections.³⁸ Importantly, the addition of CT imaging to standard assessments has been shown to change the clinical treatment strategy in a quarter of patients with suspected prosthetic valve infective endocarditis.³⁵

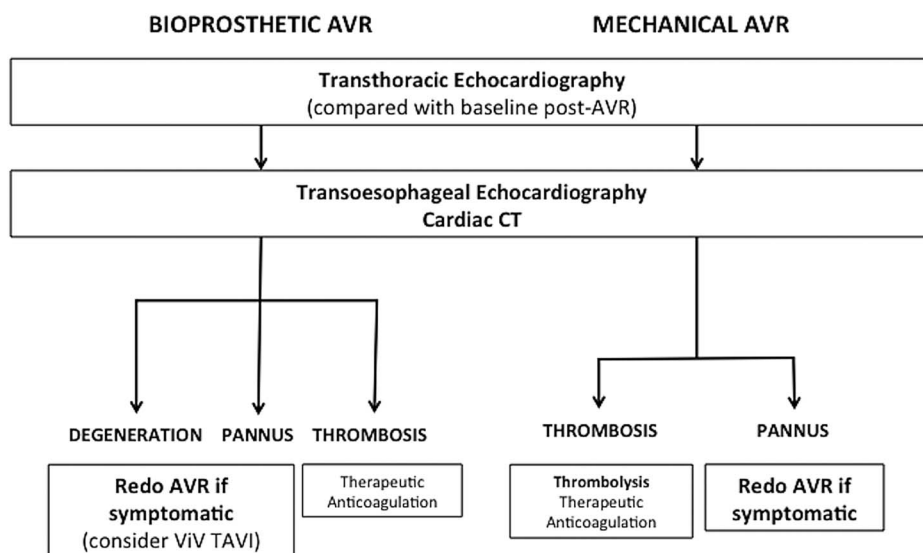
Figure 4 Suggested pathway for assessment of aortic valve replacement dysfunction.

Transthoracic echocardiography with follow-on transoesophageal echocardiography and cardiac CT provides a detailed functional and anatomical assessment to guide further management. AVR, aortic valve replacement, ViV TAVI, valve-in-valve transcatheter aortic valve implantation.

Based on current practice in experienced valve centres, we suggest that CT should be performed as an anatomical assessment following transthoracic echocardiography in patients with suspected prosthetic aortic valve dysfunction (table 2, figures 4 and 5). The detailed structural assessment afforded by cardiac CT more accurately identifies the underlying pathology and facilitates the implementation of appropriate aortic valve intervention.

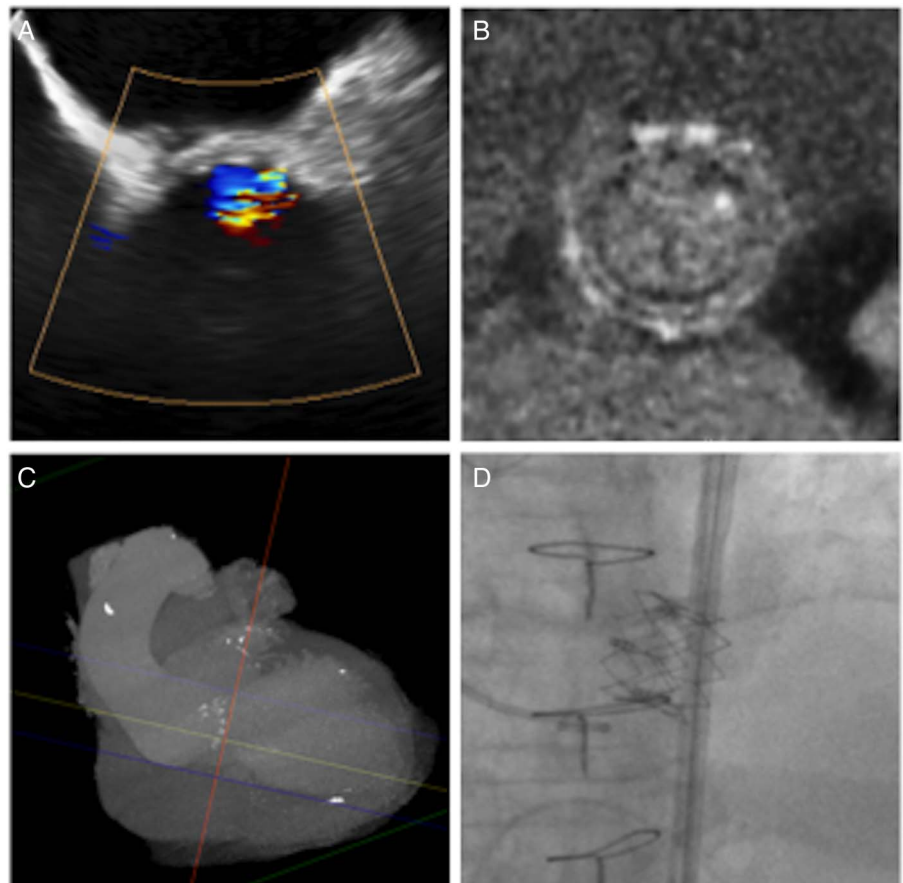
Figure 5 An example adjunctive CT imaging in the management of aortic valve replacement dysfunction. (A) Severe prosthesis regurgitation on transoesophageal echocardiography resulted from calcific structural valve dysfunction of the bioprosthetic leaflets in a 27 mm Aspire bioprosthesis demonstrated on CT (B). (C and D) Preprocedural planning facilitated implantation of a transcatheter aortic valve in valve.
