Analysis of Raised Feature Failures on 3D Printed Injection Moulds

Abstract: Background: Polymer-based 3D Printed Injection Mould (3DIM) inserts are used as a cost-effective method for low volume injection moulding (50–500 parts). However, abrupt failure leading to a short tool life is a common shortcoming of 3DIM. Need: The underlying causes of raised feature failures on 3DIM are not well known. Failure is commonly attributed to bending or shearing of raised features on the tool. Understanding the causes may help in delaying the failure and increasing tool life. Approach: Tool failure was analysed from a first-principles perspective, using pressure and temperature fields as determined by mould flow simulation. Experimental results were also obtained for two types of tool material (Visijet M3-X and Digital ABS) with polycarbonate (Lexan 943A) as the part material. Findings: Results find against the idea that pin failure in 3DIM tools is caused by bending and shear failures induced by injection pressures. We also conclude that failure of raised features is not necessarily an abrupt failure as mentioned in the literature. Originality: The generally accepted explanation for the failu

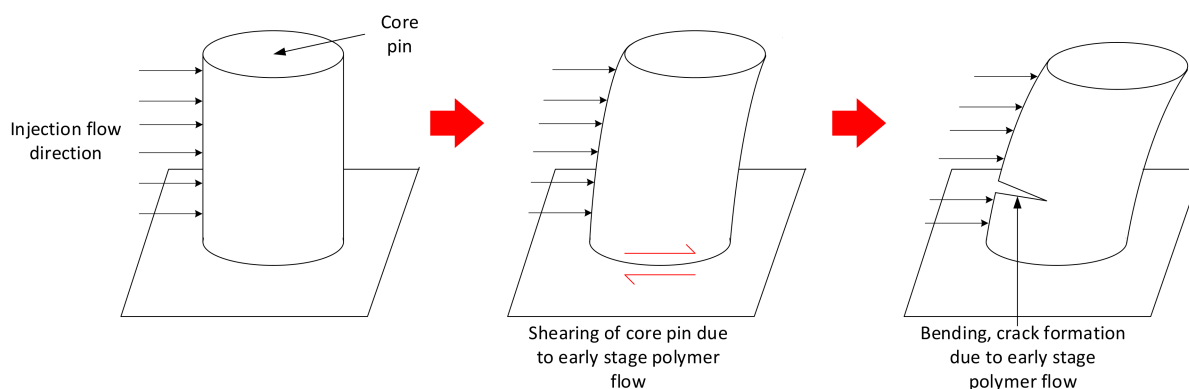
Figure 1. Graphical representation of hypothesized load case. This shows bending and shear of core pin due to incoming polymer flow during the injection stage.

We propose that, during the injection stage, the polymer melt exerts a force on the raised features of the tool, this force causes the raised features to bend and shear, per Figure 1. The bending and shear force cause the raised features to eventually break off. During the injection process, the temperature of the raised features also increases which also results in a lower yield strength, making it more susceptible to failure. This hypothesis is commonly supported in the literature [9,18].

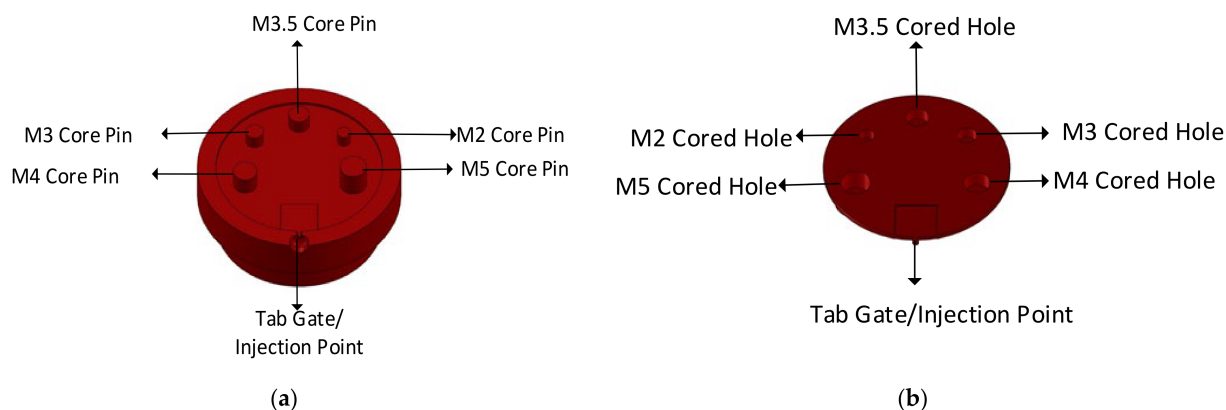
Figure 2. (a) Core side of 3DIM showing the raised features (core pins); (b) face of the part formed by the core insert.

Several injection moulding tools at a plastic injection moulding firm (Talbot Technologies Ltd., New Zealand) were analysed to indicate the simplest and most commonly found raised features on a small-sized IM tool. The most commonly occurring raised features on IM tools were core pins which are used to create screw bosses or screw holes on the part. Following this analysis, a simple part geometry was developed. A flat circular plate design with 5 cored holes was used. The holes were designed to incorporate standard size M1–M5 threaded screw inserts. The sizing for the core holes was done according to specifications from threaded insert manufacturer SPIROL® [31]. Different pin sizes were used to study the effect of geometry and aspect ratio on the tool life. SolidWorks® 2019 [32] was used to design the part and the 3DIM. The specifications of the design are given in Table 1; refer to Figures 2 and 3 for more details.

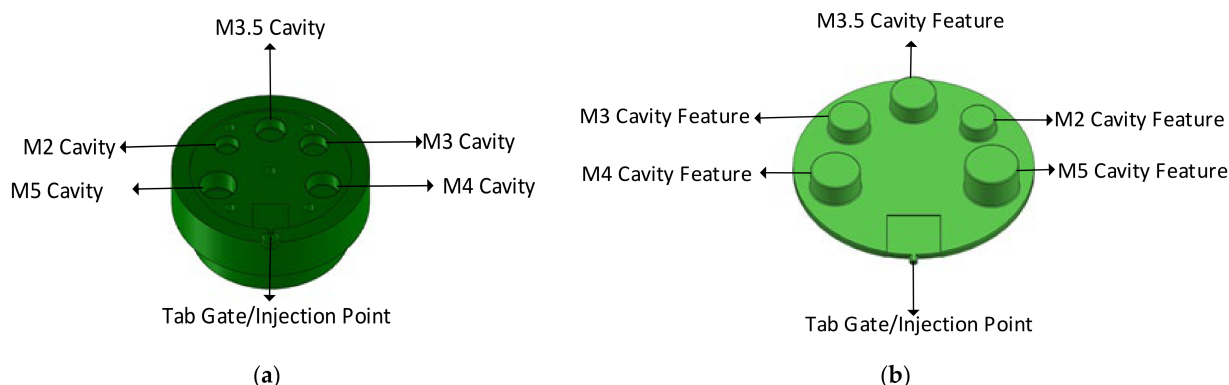
Figure 3. (a) Cavity side of 3DIM showing cored holes; (b) face of the part formed by cavity insert.

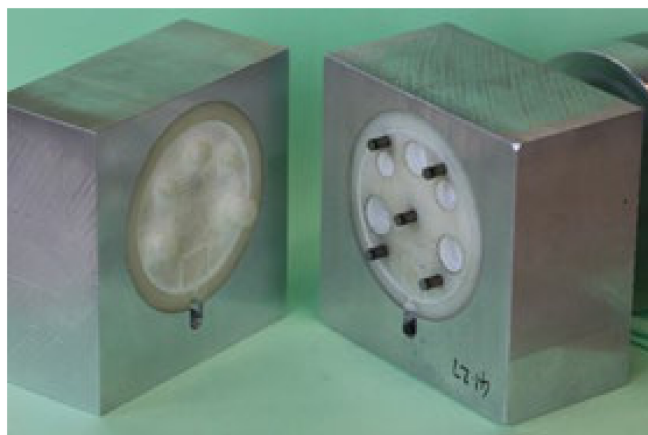
Figure 4. Core and cavity 3DIM inserts assembled inside a MUD base along with ejector pin assembly. The white parts are the 3DIM tools and the aluminium housings are the MUD base.

The 3DIM core and cavity inserts were assembled inside a master unit die (MUD) base as shown in Figure 4. The inserts were then mounted onto a Babyplast 10/12 IM machine as shown in Figure 5. The injection moulding material was dried at 80 °C for 6 h, as recommended by the material supplier, to remove any traces of absorbed moisture. Any unused material from an experiment was discarded as we wanted to avoid reheating the same batch of material before each experiment, which may lead to changes in the material properties.

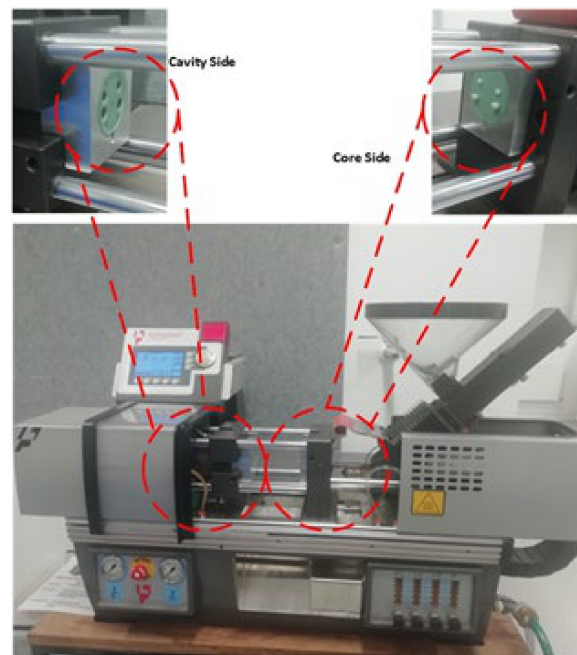
Figure 5. BabyPlast injection moulding machine with core and cavity 3DIM inserts assembled inside a MUD base and mounted onto the machine.

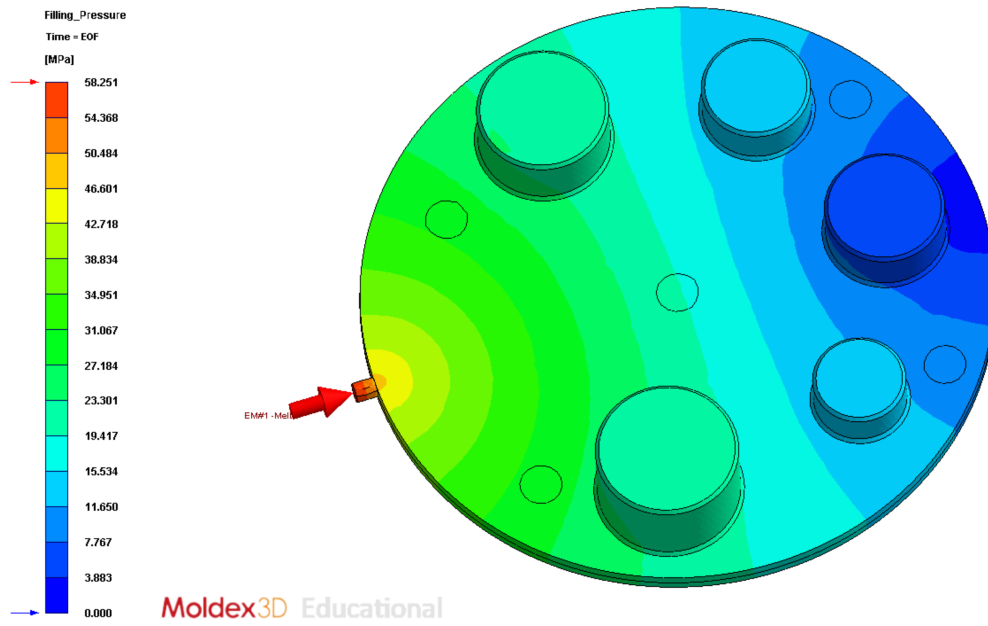
Figure 6. Pressure map at the end of filling cycle. The injection point is at left and the colours show the pressure of the molten polymer in the cavity at the end-of-fill stage.

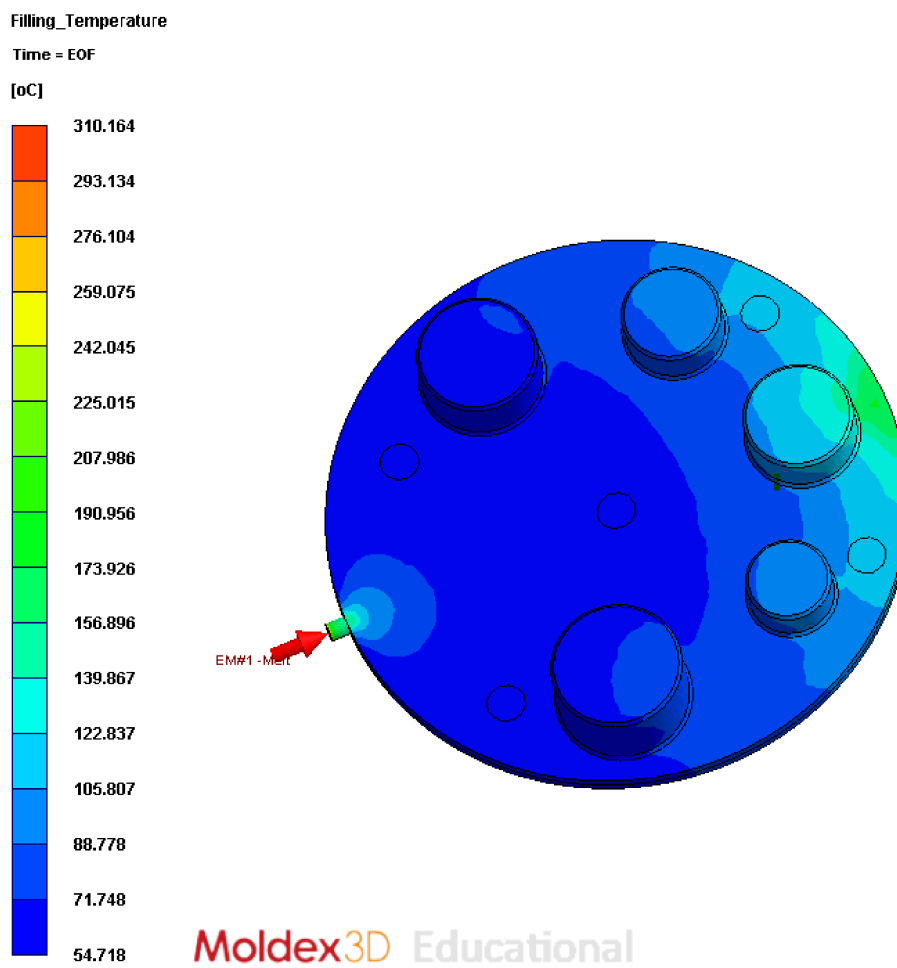
Figure 7. Temperature map at the end of filling cycle; the colours show the temperature of the polymer in the cavity at the end-of-fill stage.

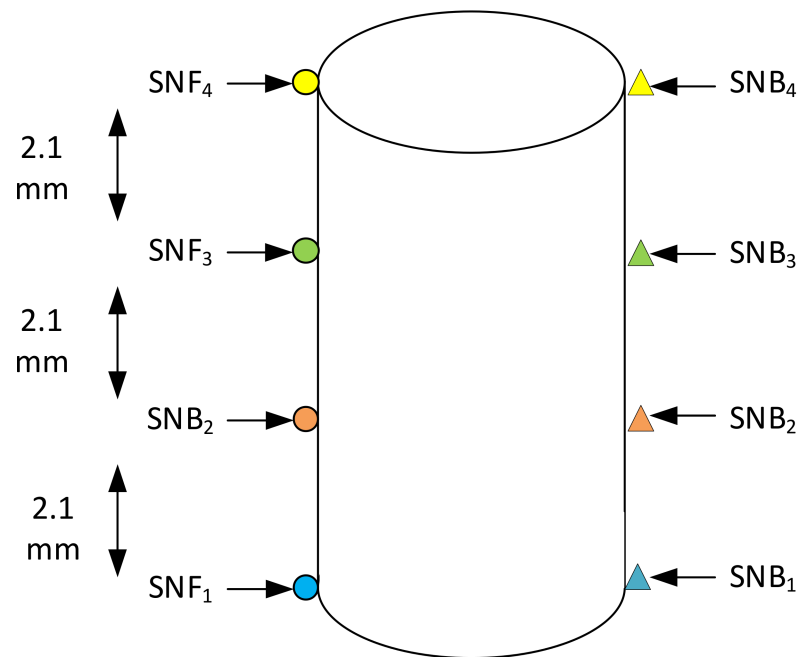
Figure 8. Location of sensor nodes on each of the core pins to determine the flow pressure using Moldex3D.

The pressure and temperature on the on the tool were determined by simulation using Moldex3D. Several sensor nodes, as shown in Figure 8, were placed on the front and back face of each of the core pins to measure the injection pressure with respect to time. In Figure 9, the round dots (SNF₁, SNF₂, SNF₃, SNF₄) indicate the location of the first point (front face) of contact between the flowing polymer and the core pin and the triangles (SNB₁, SNB₂, SNB₃, SNB₄) indicate the location of the last point (back face) of contact between the flowing polymer and core pin. The sensor nodes were placed at a spacing of 2.1 mm starting from the base of the tool. Using these sensor nodes, the flow pressure over the whole injection moulding cycle with respect to time was measured; Figure 9 shows the graph for pressure vs. time for the M5 core pin.

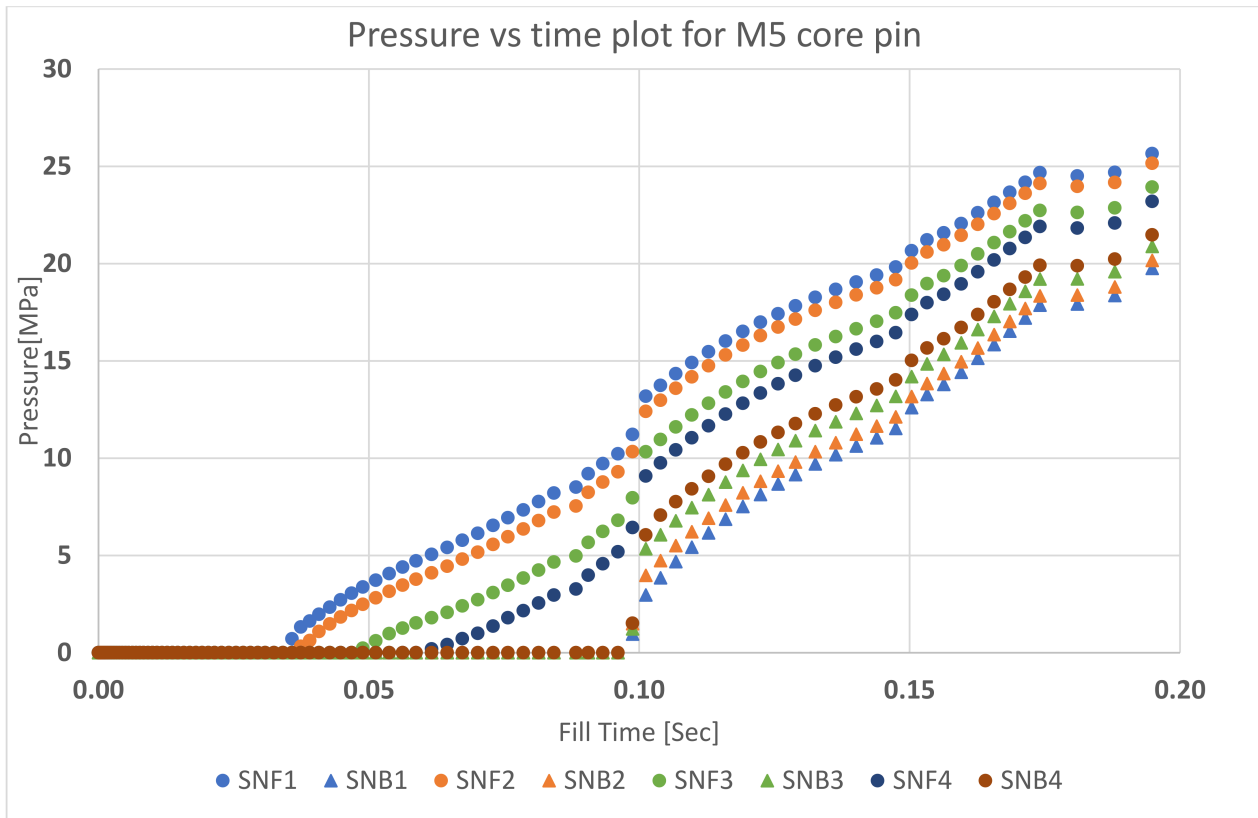
Figure 9. Pressure vs. time plot for M5 core pin. Sensor nodes are colour coded to depict the pressure difference between the front and back face of the core pin at different heights on the core pin.

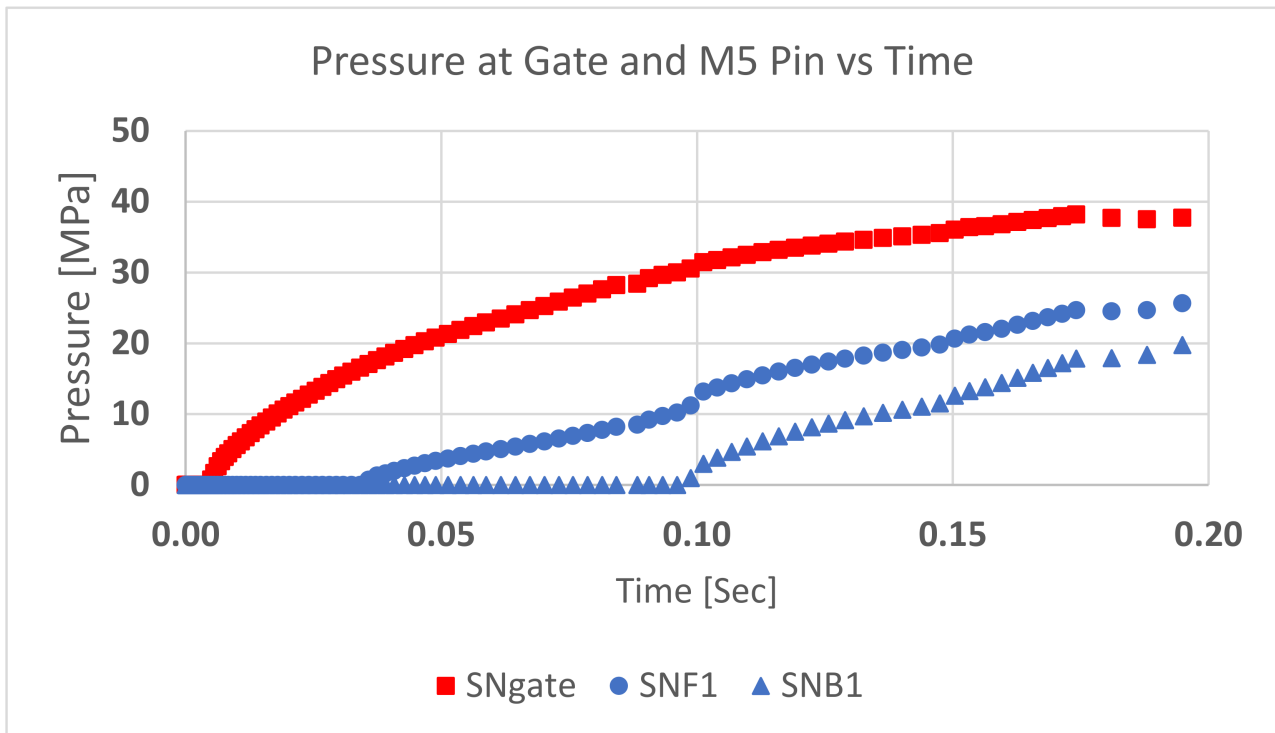
Figure 10. Pressure at the gate vs. M5 core pin. Pressure at the gate (SNGate) is higher than at the front face (SNF1). The pressure at the back face of core pin (SNB1) is less than the front face. The pressure drops along the flow length of the part.

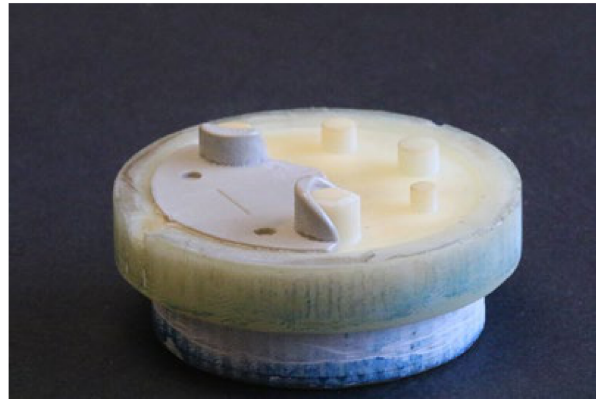
Figure 11. Frozen flow front from an incompletely moulded part; an incomplete part is assembled on the 3DIM to show the flow progression path.

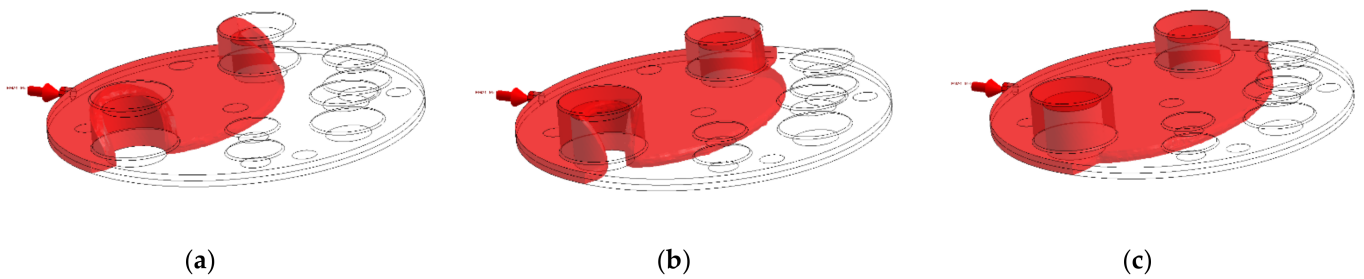
Figure 12. (a) Flow front when it covers the front face of the pin; (b) flow front moving over the pin; (c) flow front when the pin is fully surrounded by the melt.

The second question is where in the cycle to take the pressure. It appears that average cavity pressure at the end of the fill might have been used in some cases [34]. End of fill corresponds to the raised features being entirely surrounded by molten material and a condition of no-flow. Our results for this period are shown in Figure 6 and indicate that, while there is a large pressure gradient along the cavity as a whole, the gradient across any one pin is relatively low. At the end of the fill, the pressure on the front of a raised feature is counteracted by a similar pressure behind it. The time of highest pressure difference is during the fill, not at the end. The point of maximum pressure difference ΔP_{pin} occurs when the melt front has covered the front of the pin and about to reach the rear of the pin, which is at the time t^* . The actual flow pattern in molds is shown in Figure 11. The physical flow of the material over the pin is relatively complex and the progression is simulated and shown in Figure 12.

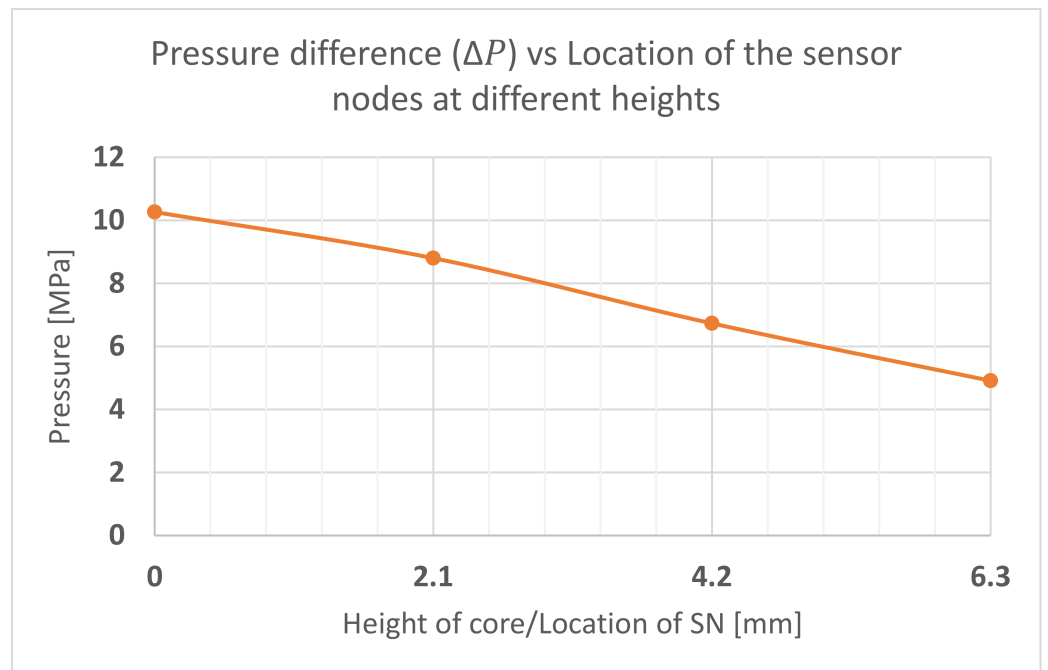
Figure 13. Pressure difference vs. the height of the core pin. The sensor nodes at the front and back were used to simulate the pressure difference. See Figure 9 for sensor node configuration.

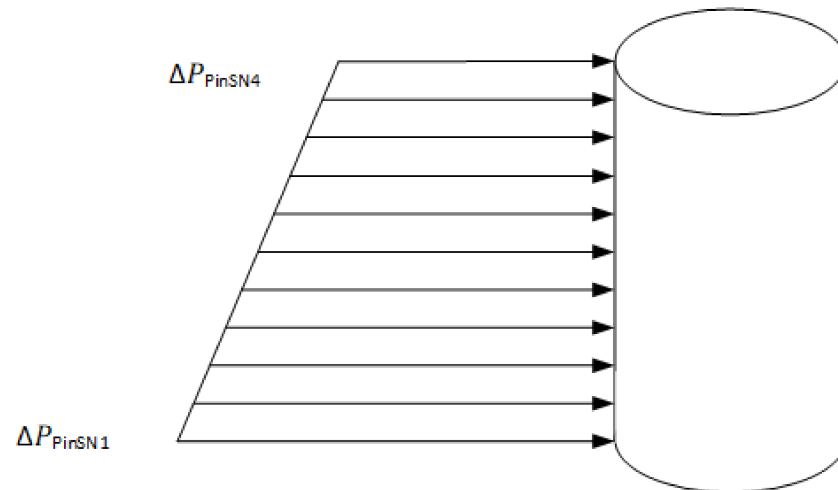
Figure 14. Linearly decreasing pressure profile on the core pin.

The pressure distribution on the core pin can therefore be simplified to a linearly varying load on a cantilever beam as shown in Figure 14.

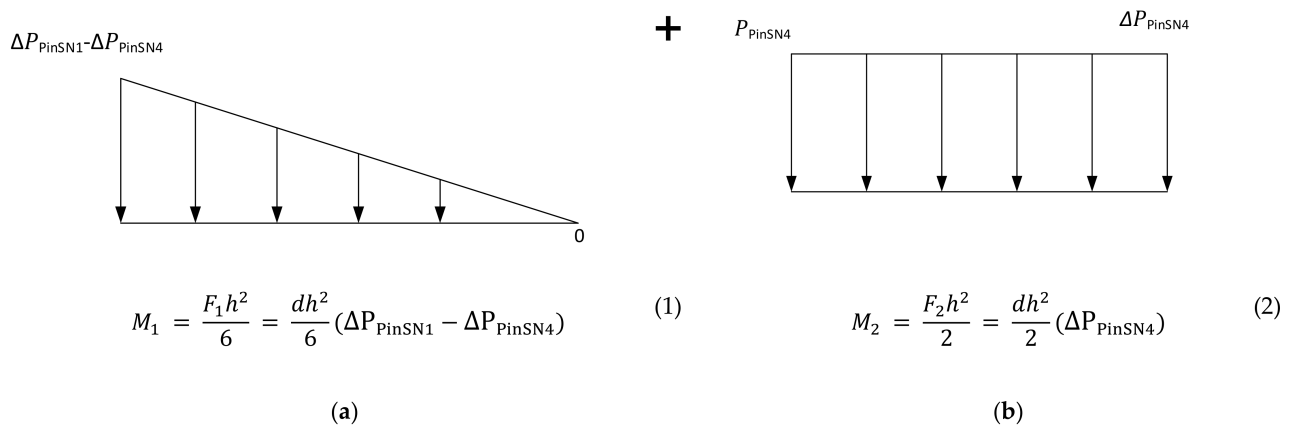
Figure 15. (a) Linearly decreasing load profile; (b) uniformly distributed load profile.

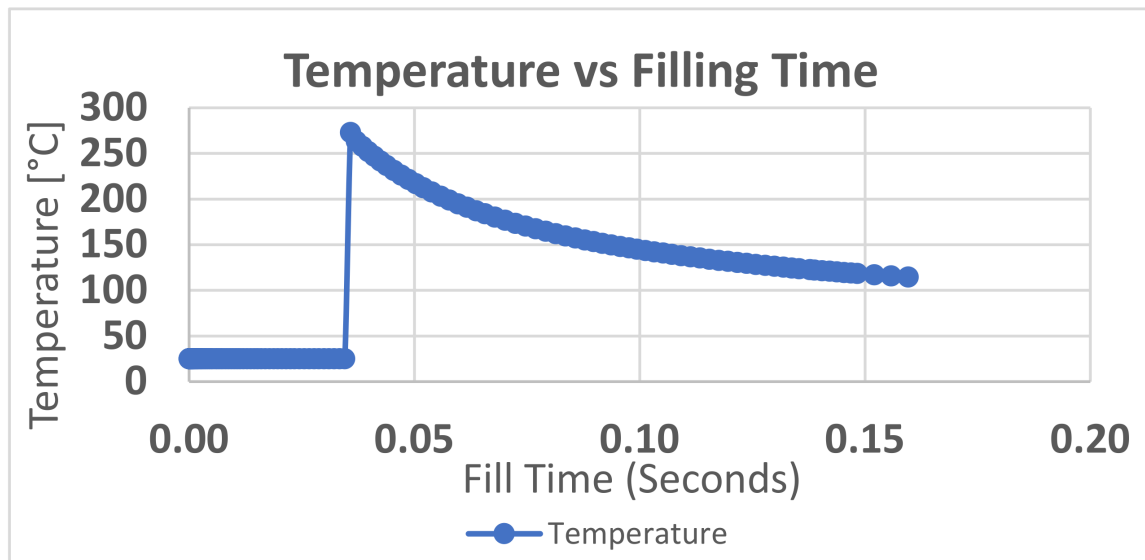
Figure 16. Temperature vs. fill time at SNF1 on M5 core pin from Moldex3D; the temperature of the pin suddenly increases as the molten polymer touches it and it starts to gradually cool over the injection cycle.

288 °C during the injection cycle. The surface temperature variation over the injection cycle is shown in Figure 16.

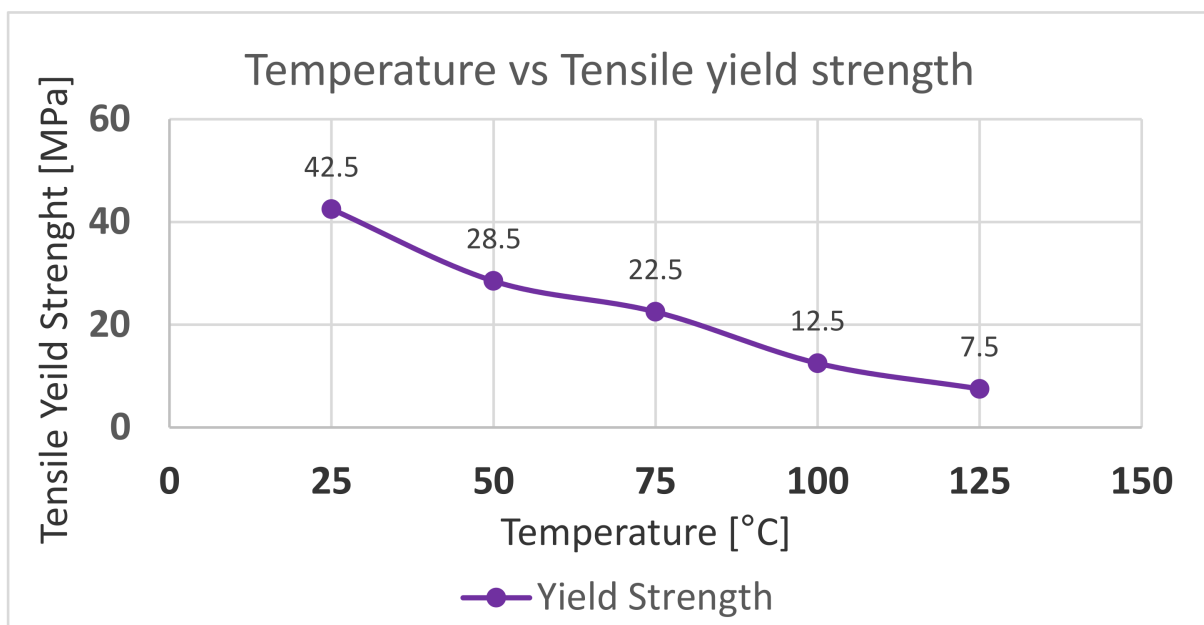
Figure 17. Tensile yield strength vs. temperature as reported in the literature.

Figure 17 shows the yield strength of the material dropping significantly at elevated temperature. Comparing the results in Table 6 with the yield strength of the tool material (7.5 MPa) at operating temperature indicates that the core pins would fail due to the bending and shear stresses. However, due to the short cycle time and the tool material being an insulator, we suspected that the heat does not penetrate the central parts of the core pins and that the temperature distribution would not be uniform.

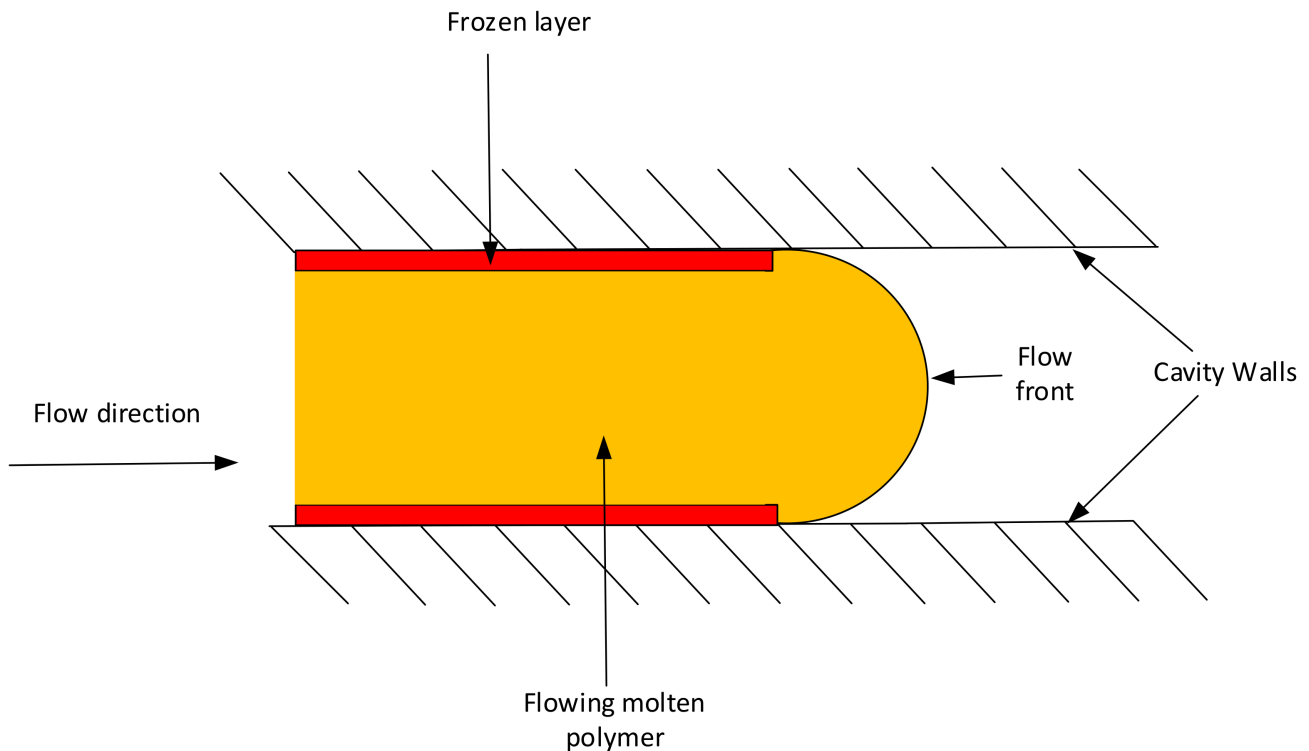
Figure 18. Flow of molten polymer inside the cavity showing frozen layer.

The typical flow of polymer inside the cavity is shown in Figure 18, the molten polymer freezes as soon as it touches the core and cavity walls and forms a frozen layer. The average frozen layer ratio obtained from Moldex3D was 6% (two frozen layers relative to the whole thickness).

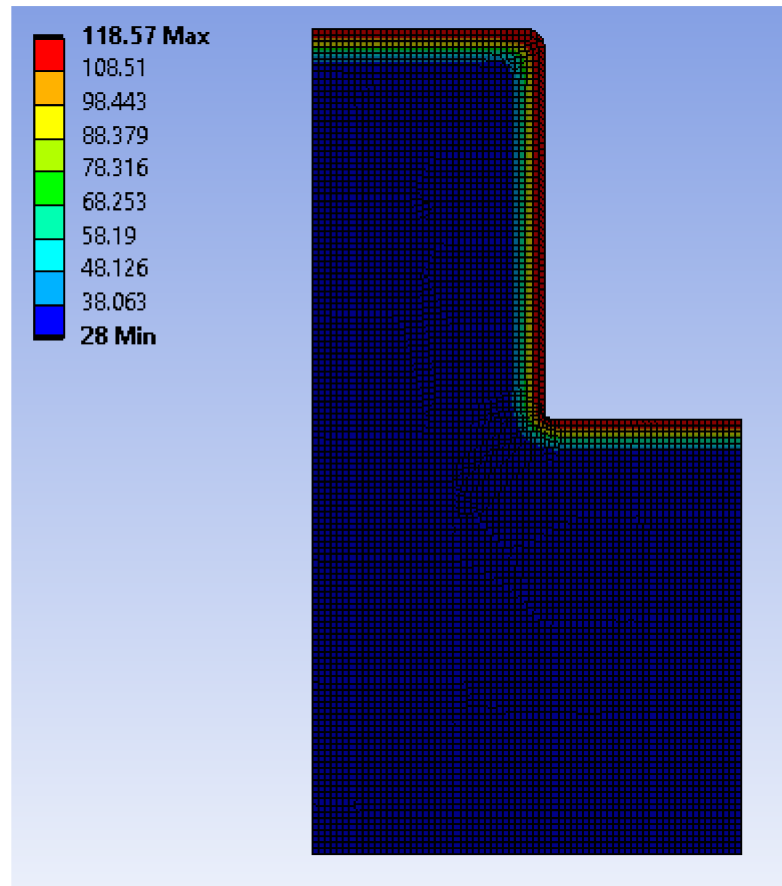
Figure 19. Temperature gradient on the M5 core pin; the pin is shown as a 2D axis symmetrical model.

The initial ambient temperature of the core pin was set at 28 °C. A 0.1 mm frozen layer was modelled around the pin based on the frozen layer ratio of 6% on a 1.5 mm thick part. The temperature of this frozen layer (boundary condition) was the simulated temperature at the surface of the core pin as a time-dependent variable based on the flow simulation results from Moldex3D. The time frame considered was from the start to the end of the injection cycle (0.2 s). After this period, the bending and shear forces are zero during the cooling stage, even if the pin does continue to absorb more heat. Figure 19 shows the thermal distribution across the pin at the end of the injection cycle. It is observed that the heat does not penetrate the central locations of the pin. Figure 20 shows the temperature distribution with respect to height measured at a distance of 3.58 mm from the outside surface. Figure 21 shows the temperature distribution with respect to the radius of the core pin measured at a height of 3.175 mm from the base of the pin.

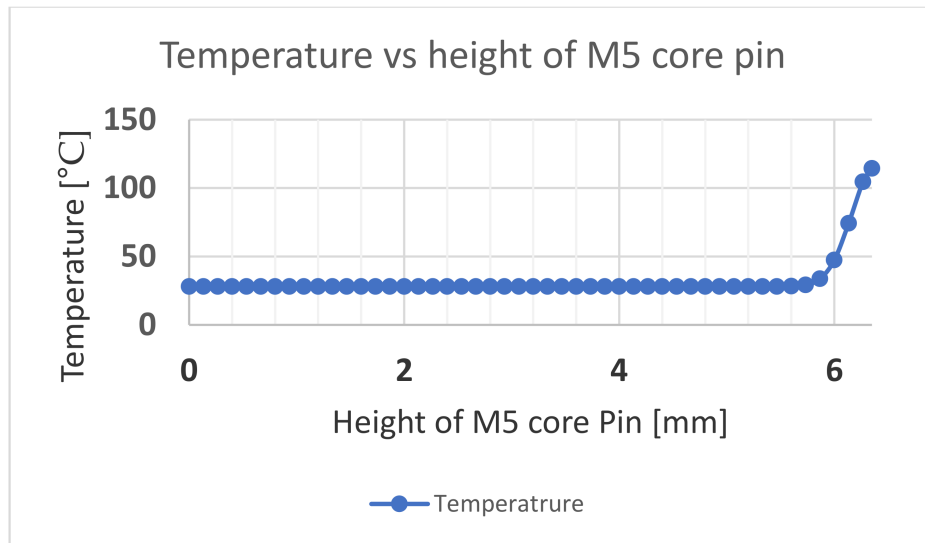
Figure 20. Temperature vs. the height of the core pin measured at a distance of 3.58 mm from the outer surface.

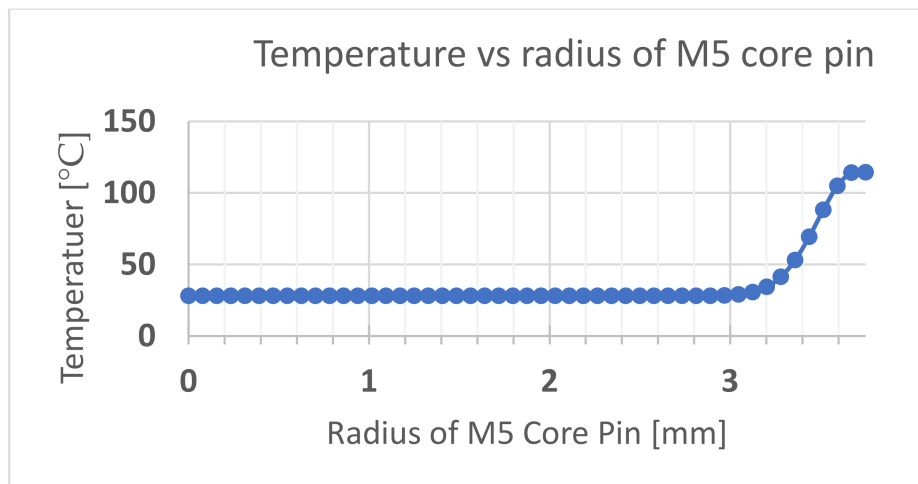
Figure 21. Temperature vs. the radius of the core pin measured at a height of 3.75 mm from the base of the pin.

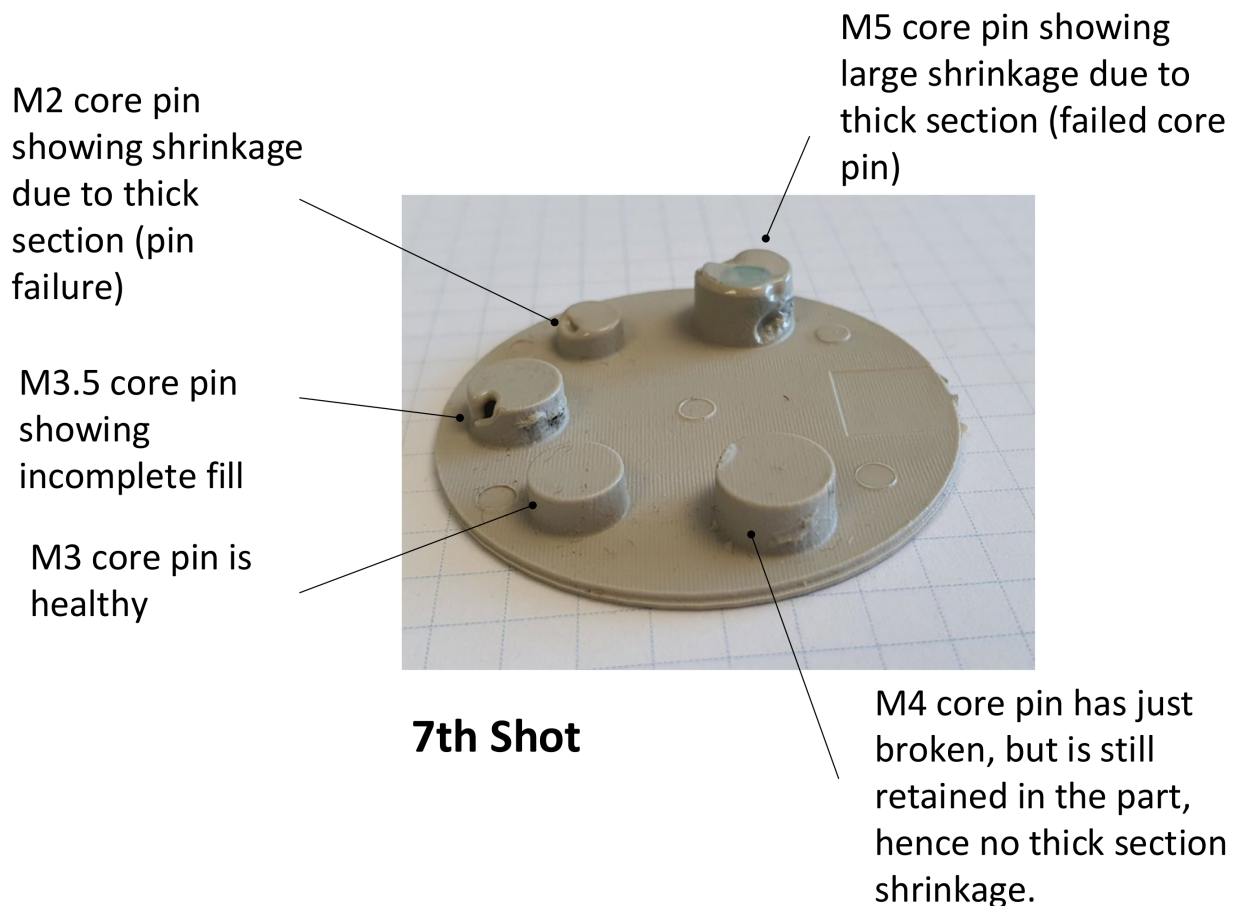
Figure 23. Part 7, showing a number of different defects on the cavity face.

The incomplete fill in shots 1–3 shown in Figure 22 is due to the deliberate use of lower shot volume at the start of the moulding cycle. This is common practice in the industry and is intended to avoid safety hazards (e.g., blockages and pressure drops). Incomplete fills from shot 6 onwards have a different reasoning. The cause is attributed to the diversion of shot volume into the space vacated by the broken M2 core pin and subsequently the broken M5 core pins. On the failure of the M5 core pin, the area which was supposed to be a cored hole with 1.5 mm wall thickness is replaced with a cylinder (thick section) of diameter 7.16 mm. Consequently, there is less volume available for elsewhere in the part and the deficit is apparent at the furthest distance from the gate, which is around the M3.5 core pin. This not only causes short fills, but also causes non uniform flow and shrinkage due to thick sections. The deficit does not manifest in exactly the same way each time. This variability is evident to some extent in Figure 22a and more so in Figure 22b. A close-up image of Shot 7 cavity face is shown in Figure 23, with an explanation of the various defects.

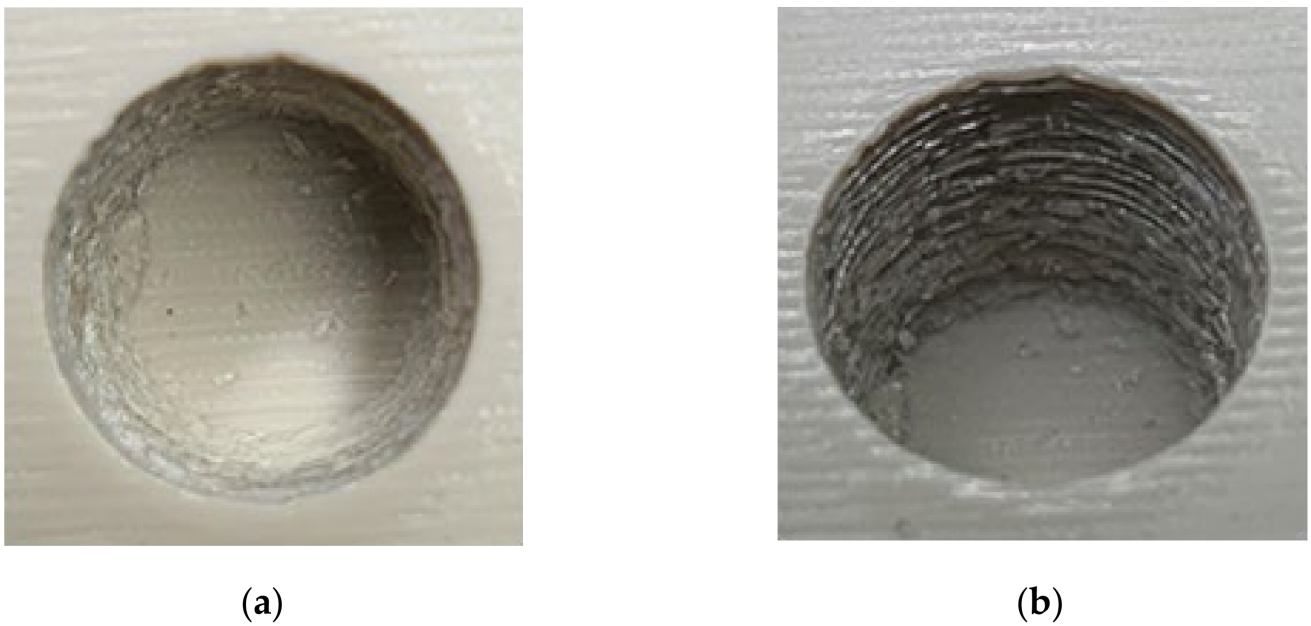
Figure 25. (a) Top view of M5 core on the pin on 5th part showing no signs of deterioration; (b) orthographic view of M5 core hole on 5th part showing no signs of deterioration.

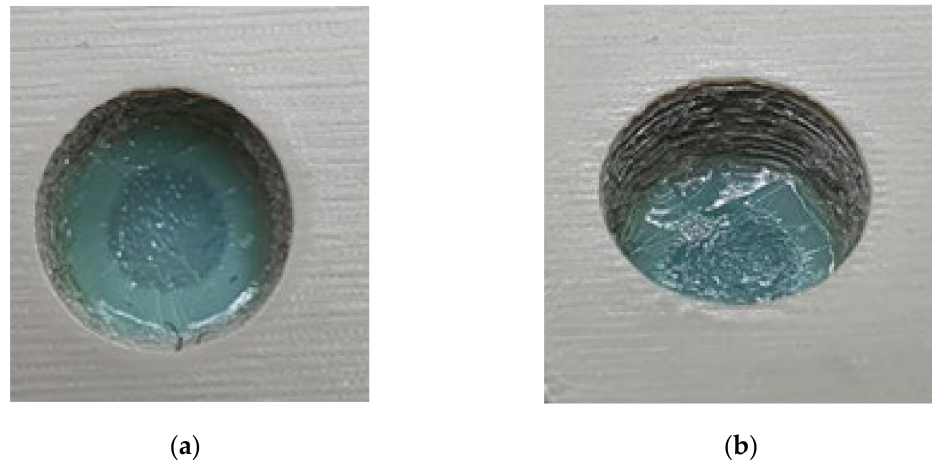
Figure 26. (a) Top view of M5 core on pin 6th part showing a small chunk of green 3DIM material of core pin stuck inside; (b) orthographic view of M5 core hole on 6th part showing a small chunk of green 3DIM material of core pin stuck inside.

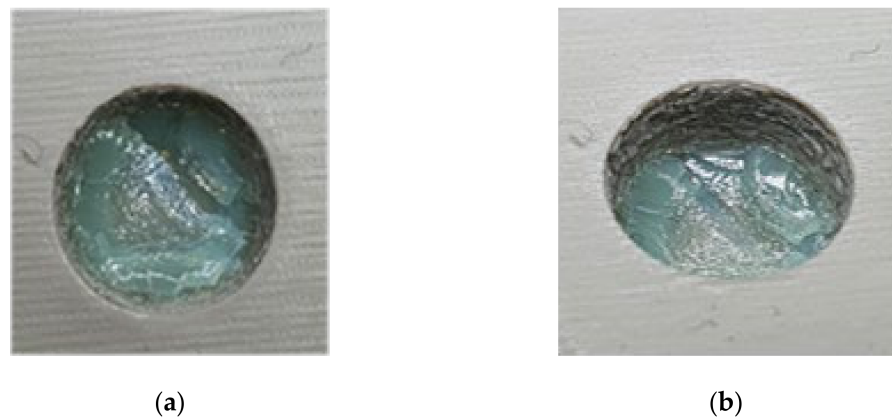
Figure 27. (a) Top view of M5 core on pin 8th part showing a small chunk of green 3DIM material of core pin stuck inside; (b) orthographic view of M5 core hole on 8th part showing a small chunk of green 3DIM material of core pin stuck inside.

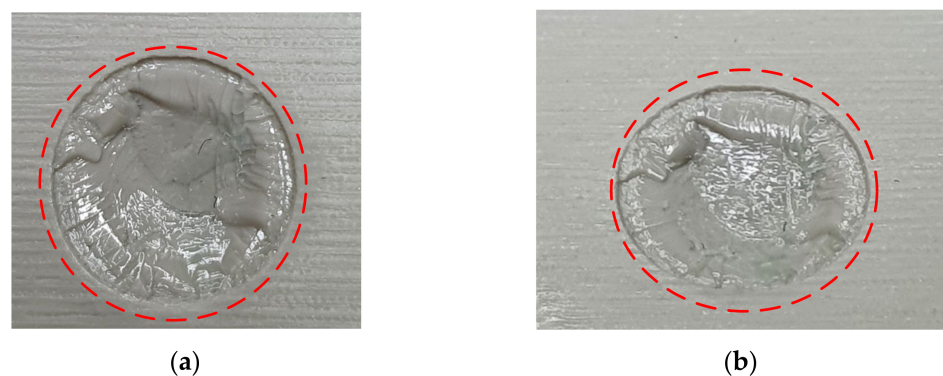
Figure 28. (a) Top view of M5 core on pin 12th part showing a small chunk of green 3DIM material of core pin stuck inside; (b) orthographic view of M5 core hole on 12th part showing a small chunk of green 3DIM material of core pin stuck inside.

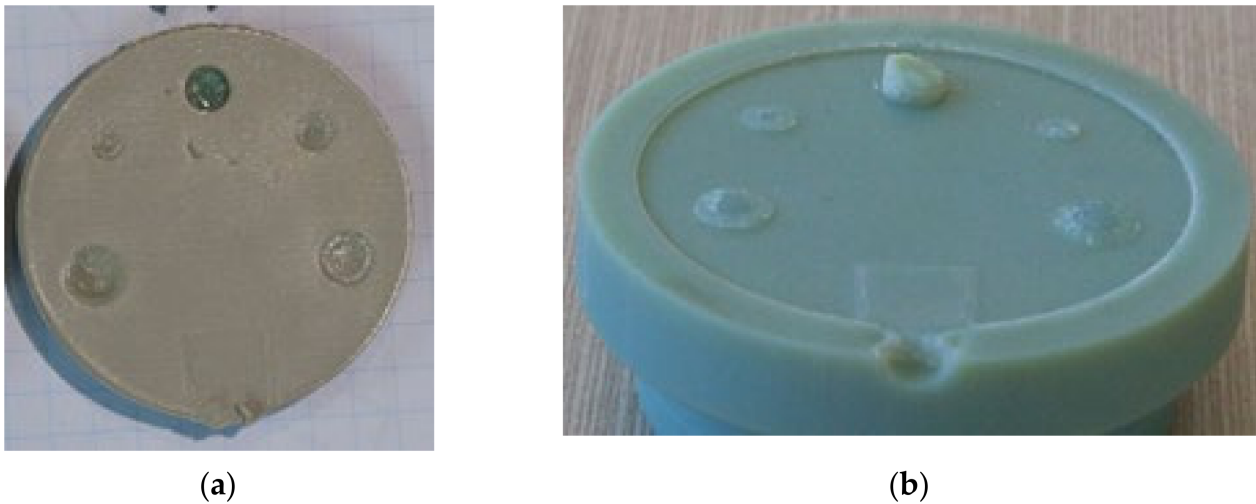
Figure 29. (a) 12th moulded part showing defects (b) State of core pins (broken) on the 3DIM after 12 shots. The moulded parts have no cored holes as the core pins on the tool are completely broken.

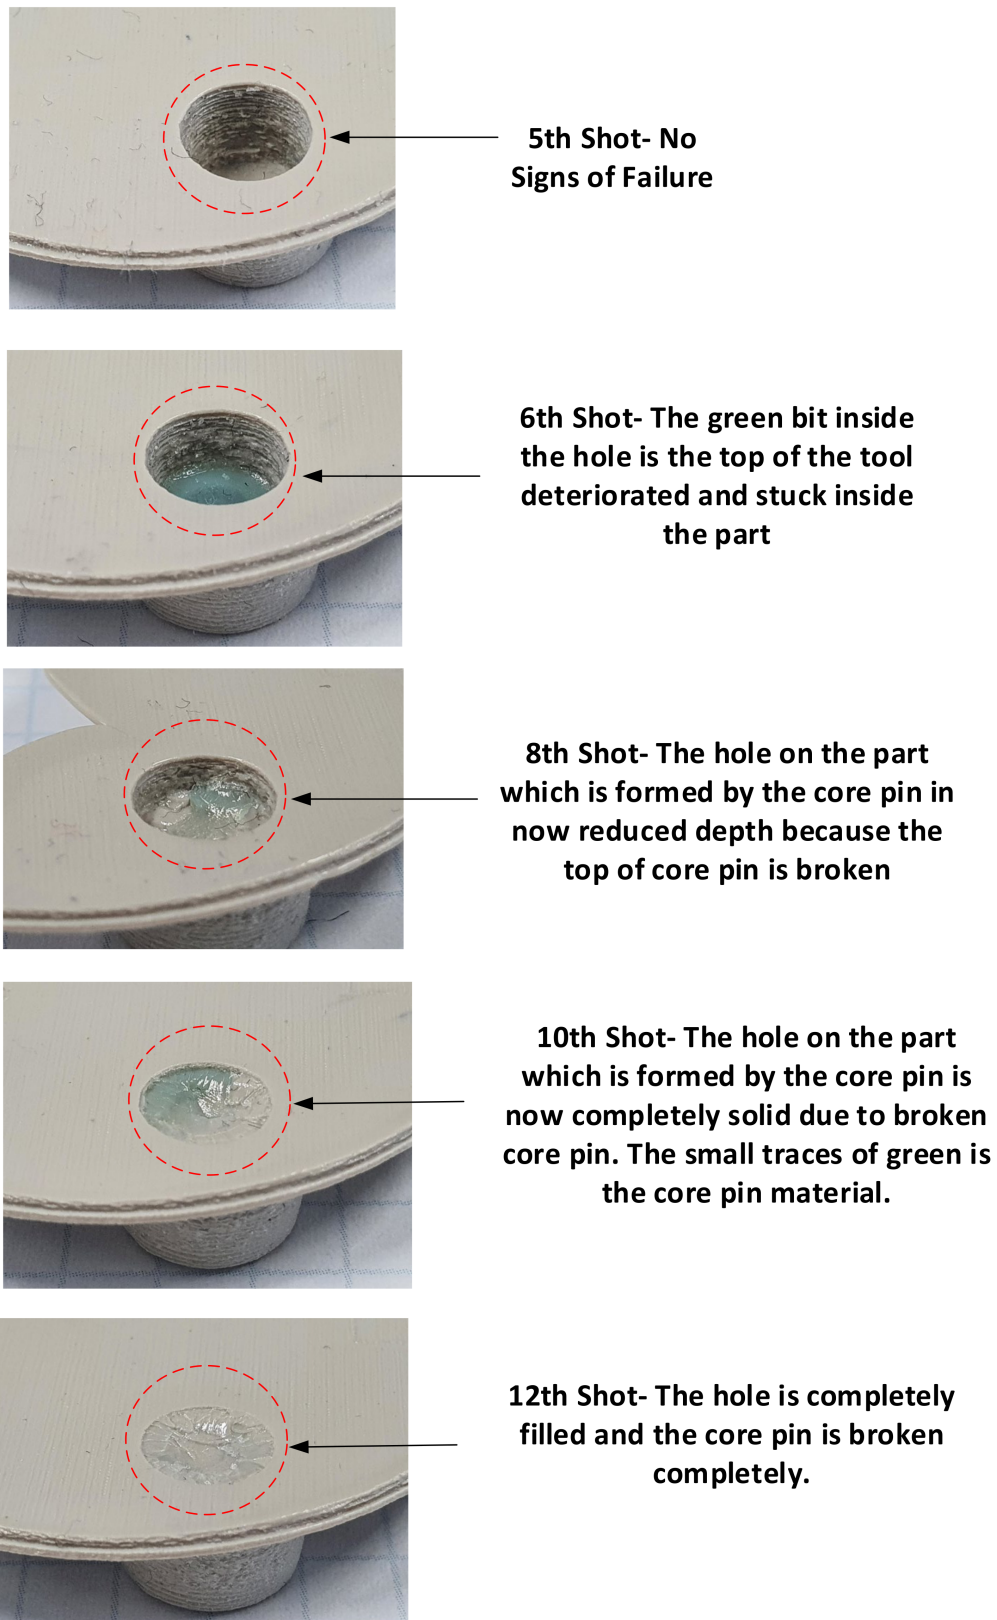
The complete progressive deterioration of the core pin can be seen in Figure 30 and to validate this we also measured the hole size after each shot. When the core pin starts deteriorating, the hole size on the part should reduce and this was validated and is shown in Table 8.

Figure 30. Progressive reduction in depth of the M5 core hole as a result of deterioration of the M5 core pin.

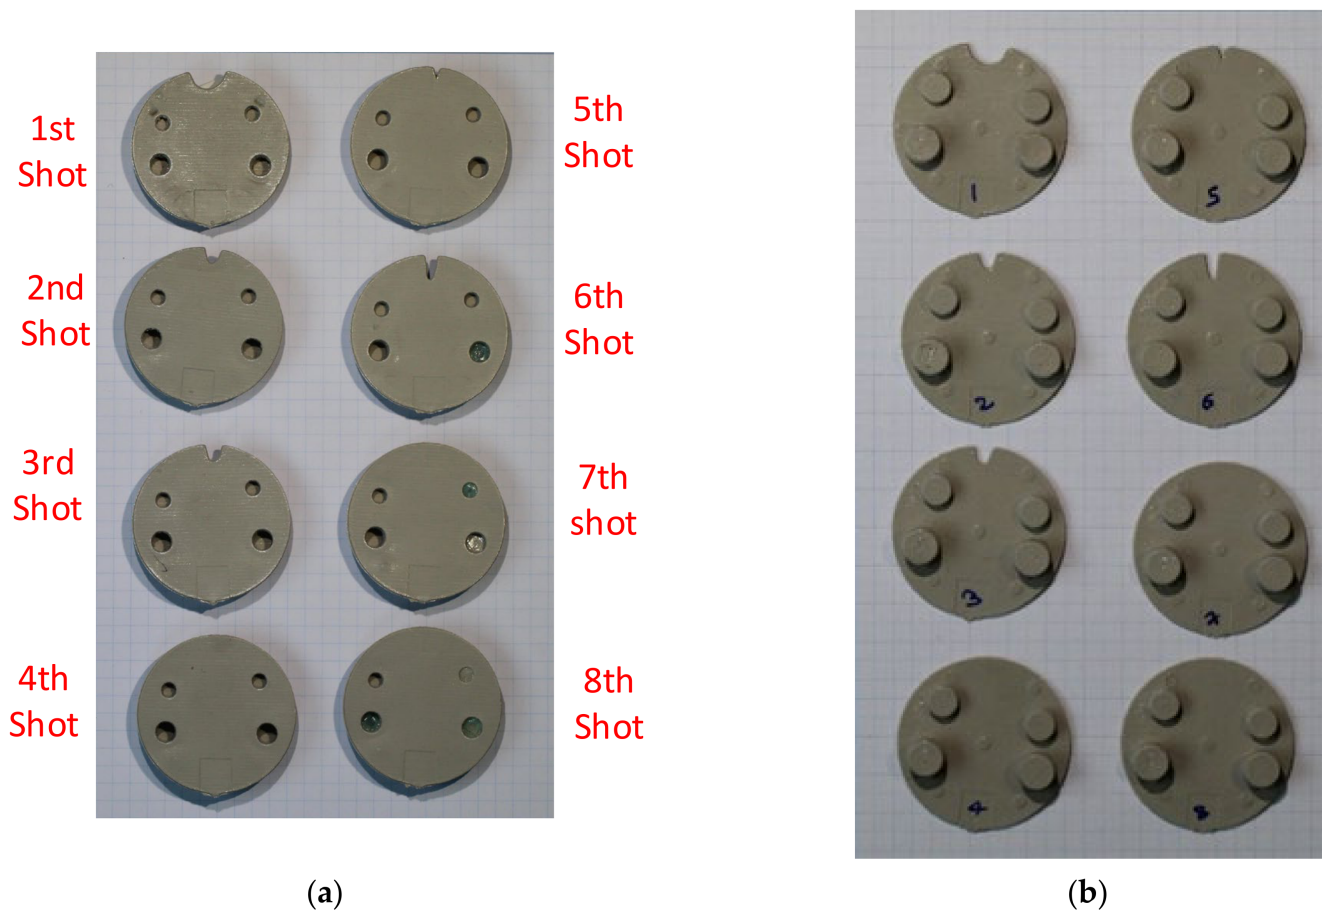
The failure sequence of the core pins is highlighted in Figure 31 and was as follows:

3DIM insert C also showed progressive deterioration and eventual failure of the core pins. However, the failure sequence of the core pins was different from inserts A and B. Initial experiments using 3DIM inserts A and B showed that even though there is progressive deterioration and failure, the smaller M2 and M3 core pins were the ones that deteriorated and failed initially leading to the failure of M4 and M5 inserts. However, in the case of 3DIM insert C, the bigger M5 insert started to fail first leading to the failure of the smaller core pins.

Figure 31. (a) Core face of the moulded part showing signs of progressive deterioration; (b) cavity side of the moulded showing no signs of progressive deterioration (moulded using insert C).
