Analysis of Raised Feature Failures on 3D Printed Injection Moulds

Abstract: Background: Polymer-based 3D Printed Injection Mould (3DIM) inserts are used as a cost-effective method for low volume injection moulding (50–500 parts). However, abrupt failure leading to a short tool life is a common shortcoming of 3DIM. Need: The underlying causes of raised feature failures on 3DIM are not well known. Failure is commonly attributed to bending or shearing of raised features on the tool. Understanding the causes may help in delaying the failure and increasing tool life. Approach: Tool failure was analysed from a first-principles perspective, using pressure and temperature fields as determined by mould flow simulation. Experimental results were also obtained for two types of tool material (Visijet M3-X and Digital ABS) with polycarbonate (Lexan 943A) as the part material. Findings: Results find against the idea that pin failure in 3DIM tools is caused by bending and shear failures induced by injection pressures. We also conclude that failure of raised features is not necessarily an abrupt failure as mentioned in the literature. Originality: The generally accepted explanation for the failu

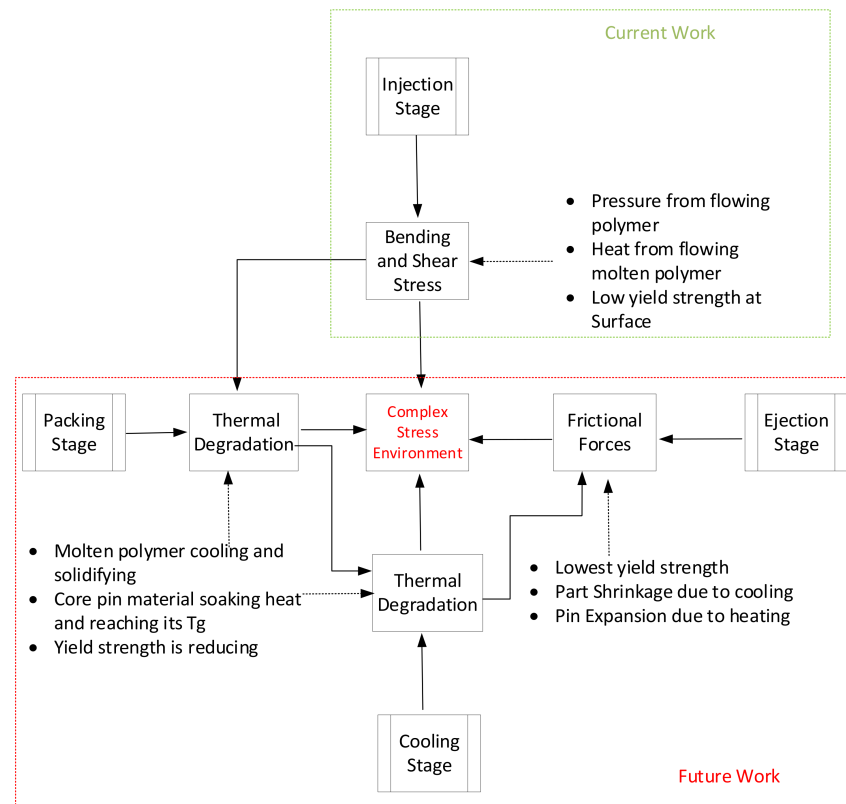
Based on the findings, we propose a new theory: that the failure of raised features is due to the combined effect of stresses developed during the injection stage, thermal degradation during the cooling stage, with shrinkage and frictional forces during the ejection stage of injection moulding. Figure 32 shows the potential causes of failure.

Figure 32. Potential causes of failure of core pin.
