Article

Chloride Distribution and Steel Corrosion in a Concrete Bridge after Long-Term Exposure to Natural Marine Environment

Abstract: Chloride-induced steel corrosion is The most concerning issue for The durability of concrete structures. Concrete and steel samples were obtained from a 30-year-old reinforced concrete bridge. The chloride content was measured by a potentiometric titration method and The microstructure of concrete was obtained by scanning electron microscopy and mercury intrusion porosimetry. The rust phases of The steel were detected by X-ray diffraction and Raman analysis. It was found that The convection depth for chloride transport in cracked concrete was significantly larger than that in uncracked concrete. The concrete in a pier column facing upstream had greater porosity due to The water impact and calcium leaching. The coefficients of variability of chloride diffusivity of concrete for The bridge deck and The pier column were significantly different. Rust phases including lepidocrocite, goethite, akaganeite, magnetite, and maghemite were detected using Raman spectroscopy and X-ray diffraction. The major phases of steel rust in The atmospheric zone were le

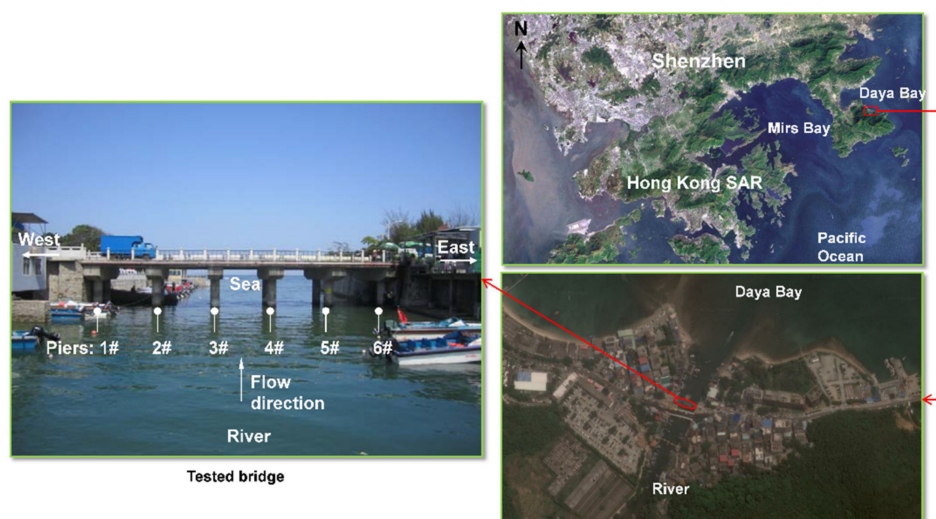
Figure 1. Geographic location of The tested bridge.

The aim of the research is to clarify the behaviors of chloride penetration and steel corrosion in a real marine environment. The chloride distribution in concrete, rust compositions, and morphology of embedded steel in a bridge will be tested. The tested bridge spans the entrance of a river into the Daya Bay on the Dapeng peninsula in the city of Shenzhen, China. The geographic location of the bridge is shown in Figure 1. It is a cast-in-situ RC bridge with a service time of around 30 years. The bridge has five spans, each with a length of 6.4 m. The clearance above the water level is 5.0 m. The superstructure was a 450 mm-thick continuous RC slab, and the substructure was capping beams and 1 m-diameter RC double-column piers. A photo of the bridge is shown in Figure 1, including numbering of the bridge piers.

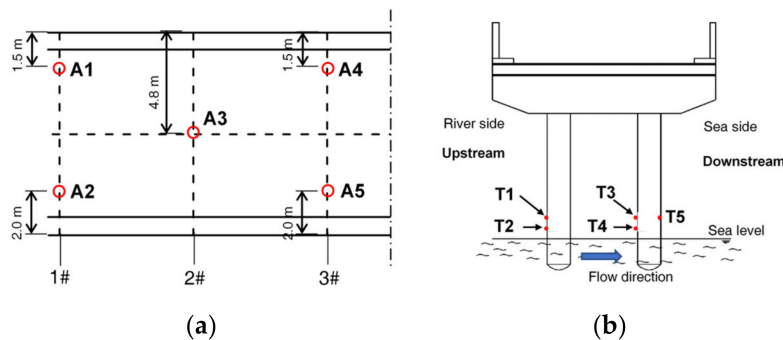
Ten concrete samples were cored out, with a diameter of 70 mm and a height of 50 mm. As shown in Figure 2a, five concrete samples (A1–A5) were cored out along The western half of The bridge deck, representing The concrete exposed to The atmospheric environment. Four of them were close to The deck side and The other was in The middle of The deck half. Another five concrete samples (T1–T5) were cored out in The tidal zone on The columns of pier #1, as shown in Figure 2b. Pier #1 was selected for testing due to its visible degradation as well as The convenience for sampling. The effect of different altitudes on The column was considered. The samples T1, T3, and T5 were 500 mm above The lowest sea level, and samples T2 and T4 were 100 mm above The lowest sea level. Samples T1–T4 were on The front faces of The column to The water flow, and sample T5 was on The back face. Steel samples were cut out close to A1 and T1 for The tests of steel corrosion in The atmospheric and tidal zones, respectively. The steel samples had a diameter of 20 mm and a length of 250 mm.

Figure 2. Locations of concrete samples: (a) Bridge deck; (b) Pier #1.

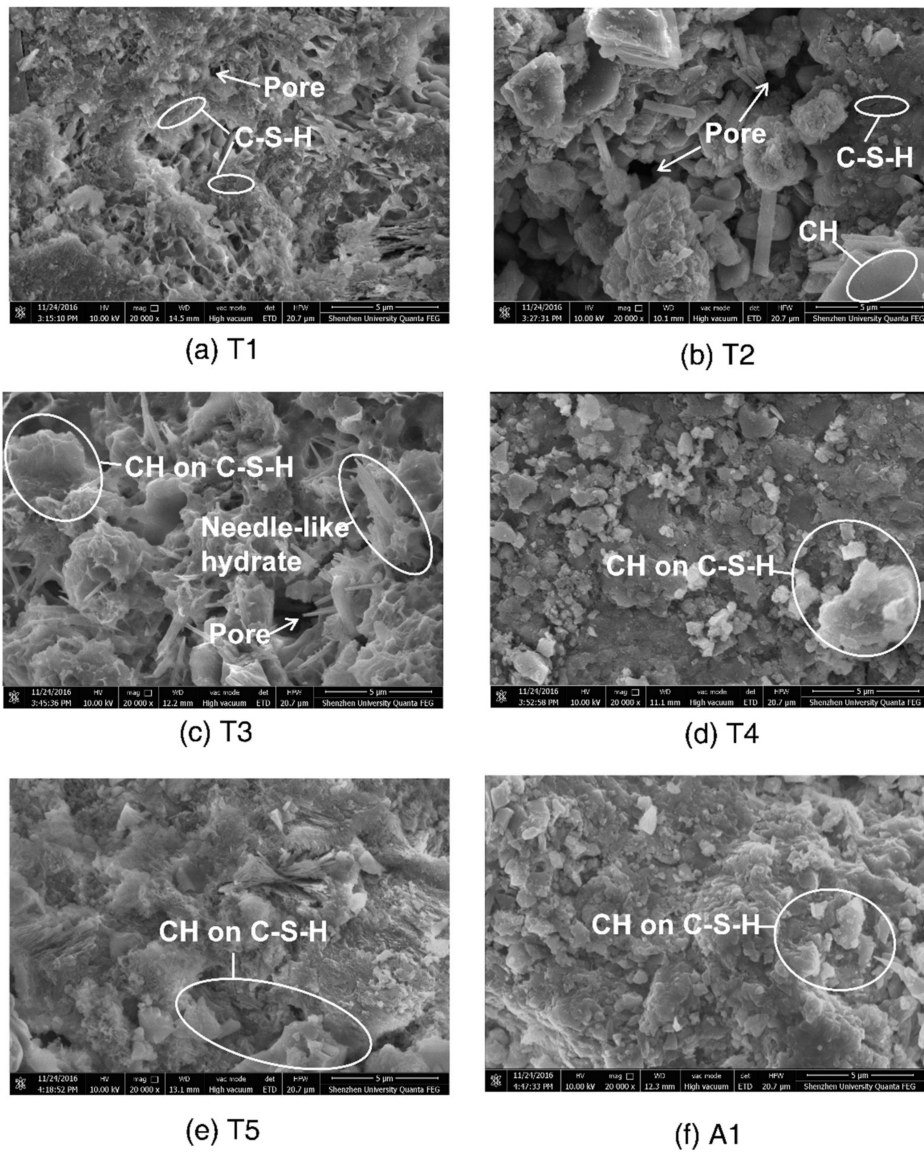
SEM micrographs of The concrete samples from The atmospheric and tidal zones are shown in Figure 3. In typical micrographs, C-S-H, $\text{Ca}(\text{OH})_2$ (denoted as CH) grains and needle-like ettringite crystals were found. Samples T1–T3 exhibited a looser and more porous structure. By contrast, samples T4, T5, and A1 had more compact structures with well-distributed hydration products. XRD spectra of concrete samples A1 and T1 are shown in Figure 4. The most intense peaks in both spectra were attributed to SiO_2 . CH was detected in A1 but not in T1. This result could possibly be explained by The leaching of solid CH in concrete subjected to flowing river water. CH leaching resulted in more pores and produced more passages for calcium ion diffusion towards The external water, which further promoted leaching [39]. Additionally, cracks were observed on The pier, as shown in Figure 5. The cracking was probably due to mechanical loads and/or expansion of corroded steel bars, as rust stains were seen on The surface of The pier. Water flowed within The cracked concrete more quickly and thus The leaching was accelerated.

Figure 3. SEM micrographs of concrete samples from The atmospheric and tidal zones (magnification by 20,000 times): (a) T1; (b) T2; (c) T3; (d) T4; (e) T5; (f) A1.

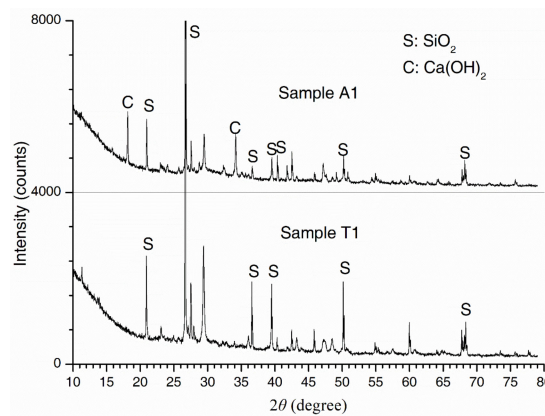
Figure 4. XRD spectra of concrete samples.

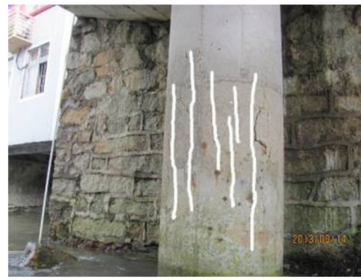
Figure 5. Cracks on The surface of pier #1.

Before The test, a thorough inspection of The bridge was carried out. Significant steel corrosion in most pier columns was detected by visual inspection. The steel corrosion in The bridge decks was also detected by a half-cell potential method, but corrosion degrees were not determined. By using a rebound method, The measured concrete strengths in piers and decks were 39.4 and 55.3 MPa, respectively. Regular reinforcing steel for steel bars in The RC structures was used in The bridge. For bridge piers, The average thickness of concrete covers for transverse and longitudinal reinforcements was 51.6 and 74.2 mm, respectively. For bridge decks, The average cover thickness for transverse and longitudinal reinforcements was 21.2 and 32.6 mm, respectively. By using phenolphthalein as an indicator, The measured carbonation depths for The pier and deck were 1.0 and 2.5 mm, respectively, which were well within The range of The concrete covers.

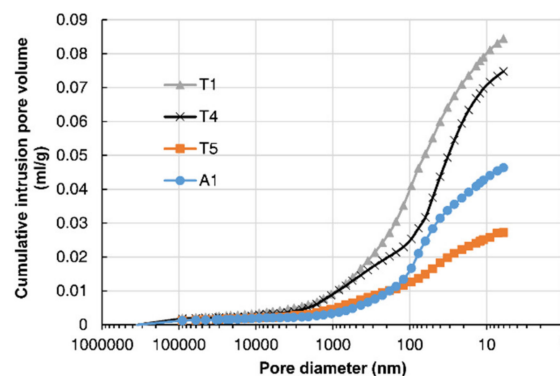
MIP results for concrete samples from The piers and deck of The bridge are shown in Figure 6. The cumulative intrusion volume was plotted against The pore diameter of The concrete. The comparison of The pier's results showed that The porosities of concrete samples T1 and T4 were significantly larger than The porosity of T5. Concretes T1 and T4 faced upstream and The water impact on them was greater, which caused damage to The cover concrete. Consequently, The effect of The solid CH leaching on increasing porosity was also more significant. It was also found that T1's porosity was higher than T4's. The log differential pore size distribution was obtained by dividing The cumulative intrusion volumes at two adjacent sizes by The difference of their log sizes. The pore size distribution in Figure 7 indicated that concrete sample T4 had a larger proportion of small pores than T1, probably due to The effect of chloride binding on The concrete's microstructure, which will be discussed in The following section.

Figure 6. Cumulative intrusion pore volume measured by MIP.

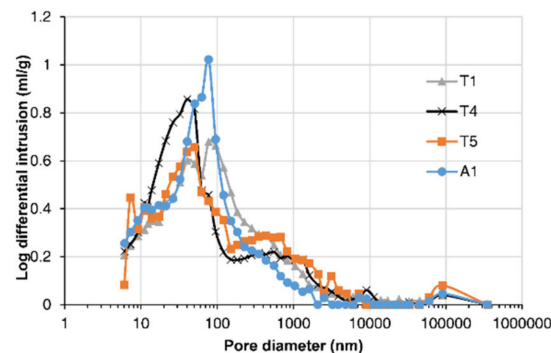
Figure 7. Comparison of measured pore size distributions.

The rate of chloride transport in concrete was influenced by The concrete's microstructure. Chloride transport in concrete could also in turn influence its microstructure. In Figure 7, The comparison

between pore size distributions of T1 and T4 indicated that large pores were filled, leading to a finer pore structure for T4. This was probably due to the influence of chloride binding on the concrete's microstructure. As shown in Figure 8b, the chloride content for T4 was larger than T1's, so the effect of binding on decreasing the concrete's porosity was more significant for T4. Chloride in the concrete was bound by physical adsorption to the solid surface and chemical reactions with C_3A , C_4AF , and their hydration products to form Friedel's salt [41]. Chloride binding could decrease concrete porosity as a result of a filling effect. Yuan et al. [42] demonstrated this effect by comparing MIP results of the concrete after a steady-state chloride migration test to the concrete stored in saturated limestone water.

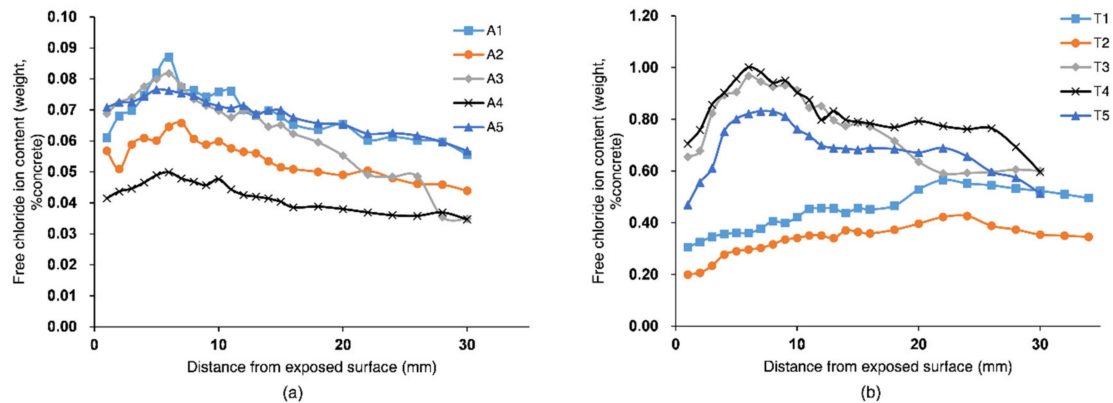
Distributions of chloride ions within The concrete in The atmospheric and tidal zones are shown in Figure 8. Chloride ion content first increased to a peak value and then decreased with The distance from The exposed surface. This was due to The periodic wetting and drying conditions. It was noted that The wetting period for The deck concrete was mainly caused by rainfall. During The wetting

period, chloride ions in The external water were brought into The concrete rapidly, along with water absorption, resulting in a peak near The exposed surface. During The drying period, chloride diffused from The high-chloride-content region near The exposed surface to The deeper region with The low chloride content. The external seawater with chloride ions moved into The concrete and chloride diffused into The deeper concrete throughout The wetting-drying cycles.

Figure 8. Chloride profiles within The concrete: (a) in The atmospheric zone and (b) in The tidal zone.

The depth for The convection zone of The chloride profile is related to The influencing depth for water adsorption. The convection depth was defined as The distance from The exposed surface to The peak of a chloride profile. The results in Figure 8 show that The convection depths for T1 and T2 were 22–24 mm, while other samples' convection depths were 6–7 mm. Greater convection depths for T1 and T2 were possibly due to cracking on their pier, as shown in Figure 5. This was consistent with Ye et al.'s result [40], who found that The convection depth for sound concrete was 5–15 mm and The convection depth for cracked concrete was greater, which depended on The crack width. The convection depths ranged from 20 to 35 mm when The crack width increased from 0.1 to 0.2 mm. The comparison of concrete samples at different altitudes in Figure 8 showed that The chloride profiles for T3 and T4 were quite similar, while The profile of T1 was noticeably above T2's. Concrete at different altitudes in The pier column had different drying times in The tidal cycle. During drying periods, due to The cracking of T1 and T2, The drying rates for T1 and T2 were higher than The rates for T3 and T4. Then, more seawater with chloride ions was brought in during The subsequent wetting periods. As The drying time increased with increasing altitude, concrete near The exposed surface for T1 was dried more sufficiently than T2. Consequently, a greater amount of chloride was absorbed for T1 during The subsequent wetting. According to Zhang and Jin's work [10], as The altitudes further increased, The chloride content in The concrete would decrease, due to The decreased time for The seawater adsorption.

The comparison of chloride profiles in Figure 8 showed that chloride content in The tidal zone was significantly larger than that in The atmospheric zone. This was due to different boundary conditions for The chloride transport. Chloride ion was absorbed from seawater continually under cyclic wetting-drying conditions in The tidal zone, while in The atmospheric zone, surface chloride accumulated from chloride in The atmosphere and then diffused into The concrete. The results also showed that The chloride profiles for T1 and T2 were lower than The profiles for other pier concrete samples. This was because The concrete samples T1 and T2 were closer to The river water, where ambient chloride concentrations were lower. The chloride content for T5 was also lower than T3 and T4's, even though these concrete samples were located next to each other and had similar boundary chloride concentrations. This could be explained by The lower porosity of T5, as shown in Figure 6. The lower porosity led to a decreased number of pathways for chloride transport within the concrete.

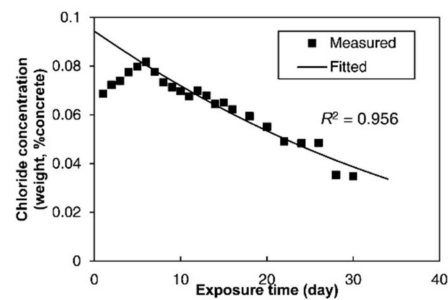
In Equation (5), two key parameters, C_{sa} and D_c , determine the evolution of chloride distribution within the concrete. These two parameters were obtained by fitting the diffusion part of the measured chloride profiles at the inner region based on Equation (3), as shown in Figure 9. The fitted chloride diffusivity and surface chloride concentration at different locations of the bridge are presented in Table 2, and the coefficients of determination are also presented. The results showed that the diffusivity of the concrete in the upstream column T1 was the largest, while that at the center of the deck A3 was the smallest. The chloride diffusivity can be related to the pore structure of concrete since the chloride diffuses through the pore networks in the material. The detected pore volume by MIP in Figure 6 indicated that the concrete T1 had the greatest porosity, which was consistent with the result that T1 had the largest chloride diffusivity. The influence of the porosity on the diffusivity was also detected by the field tests under a marine environment carried out by Zhang et al. [45]. However, the concrete T4 had greater porosity than A1 and T5, while the chloride diffusivity of T4 was smaller than that of A1 and T5. This was possibly due to the smallest critical pore size at the peak of the pore size distribution for T4. The results may indicate that both porosity and critical pore size influenced the chloride diffusion rate. It was also found by Yang [46] that the chloride migration coefficients were linearly related to the critical pore diameter.

Figure 9. Fitting of The measured chloride profile based on Fick’s equation.

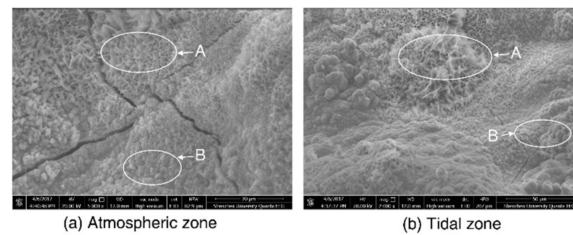
The corrosion products of steel are composed of various oxides and oxyhydroxides, The formation of which depends on steel composition and environmental conditions. The morphologies of The rust surfaces for S_t and S_a were detected by SEM, as shown in Figure 11. The formation “A” was composed of thin plates with sharp edges in a honeycomb-like or net-like pattern, while The formation “B” was composed of dense sandy grains. According to Razvan and Raman’s work [48], formations “A” and “B” corresponded to α -FeOOH and γ -FeOOH, respectively.

Figure 11. Scanning electron images of steel rust in The (a) atmospheric and (b) tidal zone.

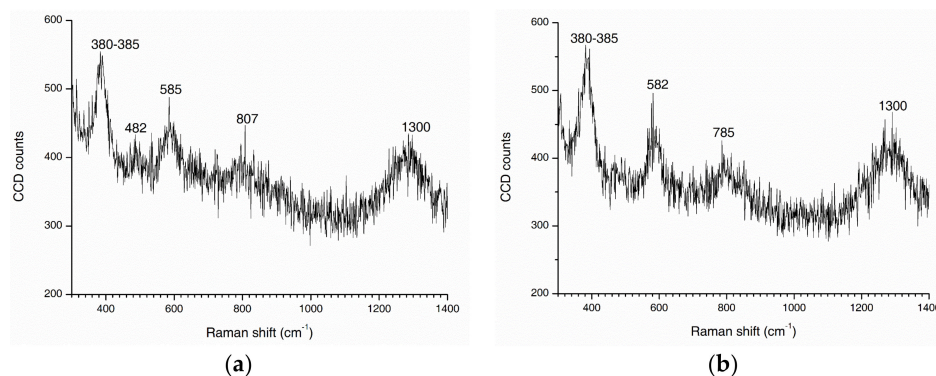
Raman spectra of steel rust in The atmospheric and tidal zones are shown in Figure 12. The peaks of The spectra correspond to specific rust phases. De la Fuente et al. summarized wavelength shift ranges for each rust phase based on different bibliographic sources in a recent paper [49]. Comparison between measured and reported results indicated that The strongest peak at $380\text{--}385\text{ cm}^{-1}$ in Figure 12 possibly corresponded to a mixture of $\alpha\text{-FeOOH}$, $\beta\text{-FeOOH}$, and $\gamma\text{-FeOOH}$. Peaks at 482 and 1300 cm^{-1} corresponded to $\alpha\text{-FeOOH}$ and $\gamma\text{-FeOOH}$, respectively. However, The intense peaks at $582\text{--}585$, 785 , and 807 cm^{-1} could not be clearly assigned to any rust phase. This may be because of different degrees of crystallinity of The measured steel exposed to The marine environment and The reference samples. The sample from The tidal zone also had a stronger peak at $380\text{--}385\text{ cm}^{-1}$ than The sample from The atmospheric zone. This indicated a greater degree of corrosion of The steel in The tidal zone.

Figure 12. Raman spectra of rust samples in (a) The atmospheric zone and (b) The tidal zone.

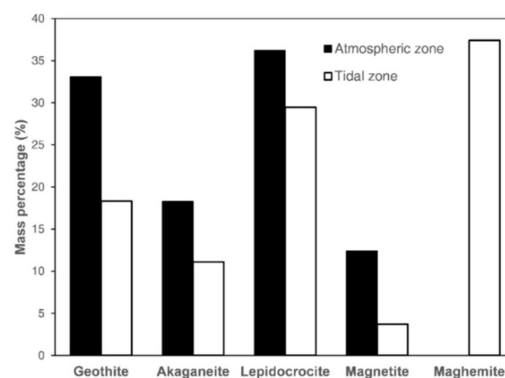
Based on The XRD results, a quantitative analysis was conducted by using a reference intensity ration (RIR) method. The results in Figure 14 show that γ -FeOOH and α -FeOOH were detected as major rust phases in The atmospheric zone, while lower proportions of β -FeOOH and Fe_3O_4 were detected, and $\gamma\text{-Fe}_2\text{O}_3$ was not found. For The rust in The tidal zone, The proportions of α -FeOOH, γ -FeOOH, β -FeOOH, and Fe_3O_4 decreased, while The proportion of $\gamma\text{-Fe}_2\text{O}_3$ significantly increased and became The major phase. This implied that Fe_3O_4 was transformed to $\gamma\text{-Fe}_2\text{O}_3$ only when steel corrosion exceeded a certain extent. Similarly, The investigation of a RC beam exposed to a marine environment by Poupard et al. [25] also indicated that rust was only composed of Fe_3O_4 in low-corroded regions, while rust was mainly composed of α -FeOOH and $\gamma\text{-Fe}_2\text{O}_3$ in high-corroded regions. These results could possibly be explained by cracking of rust layers. Fe_3O_4 was formed at The steel substrate–rust interface, where a consolidated rust layer was covered and oxygen was initially depleted. With the progress of steel corrosion, The rust layer cracked more extensively or even was exfoliated, so oxygen could possibly reach The steel substrate and react with Fe_3O_4 to form $\gamma\text{-Fe}_2\text{O}_3$.

Figure 14. Mass fractions of rust phases by XRD.
