Surgical technique

Extraction of a well fixed but fractured ceramic acetabular liner

David Ferguson, MB ChB, BSc (Hons), FRCS^{*}, Robert Metcalf, FRCS

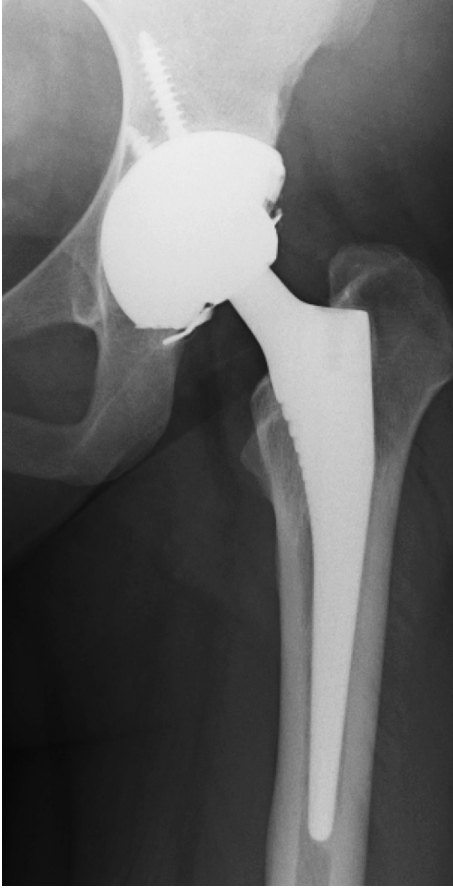
(Depuy Int., Leeds, England), and a ceramic-on-ceramic bearing (BioloX delta, Plochingen, Germany). A ceramic liner fracture involving the rim was noted post-operatively (Figure 1), but the liner remained securely fixed. We investigated the hip joint for infection and loosening, but ruled these out as causes for her symptoms. The computed tomography (CT) scans of her hip did show a prominent screw head between the cup and liner, which was later confirmed during surgery and removed. We believe that this was the cause of the liner malpositioning during the primary surgery and resulted in fracture during liner impaction. This phenomenon has previously been reported [6]. During the revision surgery, we exposed the acetabular and femoral components through the previous posterior approach scar. The femoral stem was securely fixed and the soft tissues around the hip looked healthy. The ceramic head was removed to increase exposure of the acetabulum. We found the lip of the ceramic liner was deficient inferiorly and the liner itself was not concentric within the cup. There was no movement between the liner and the cup. Attempts to remove the liner with the Pinnacle extraction tool (Depuy Int., Leeds, England) were unsuccessful, leading us to remove the liner by causing further ceramic fracture. In order to do this we created a small hole in the centre of the ceramic liner using two 1 mm ConMed Osteon (ConMed Linvatec, Largo FL, USA) diamond tipped burs operating at 40,000 rpm and attached to an Osteon Handpiece (ConMed Linvatec, Largo FL, USA). It was not necessary to bur through the entire thickness of the ceramic, which took approximately 20 min (Figure 2). Continuous irrigation and suction was used throughout the process to optimize ceramic debris removal. The use of a small bur prevented the irrigation fluid and ceramic

Fig. 1. Postoperative radiograph showing fracture of the acetabular ceramic liner.
