Strengthening of defected beam–column joints using CFRP

Mohamed H. Mahmoud, Hamdy M. Afefy *, Nesreen M. Kassem,
Tarek M. Fawzy

Structural Engineering Department, Faculty of Engineering, Tanta University, Tanta, Egypt

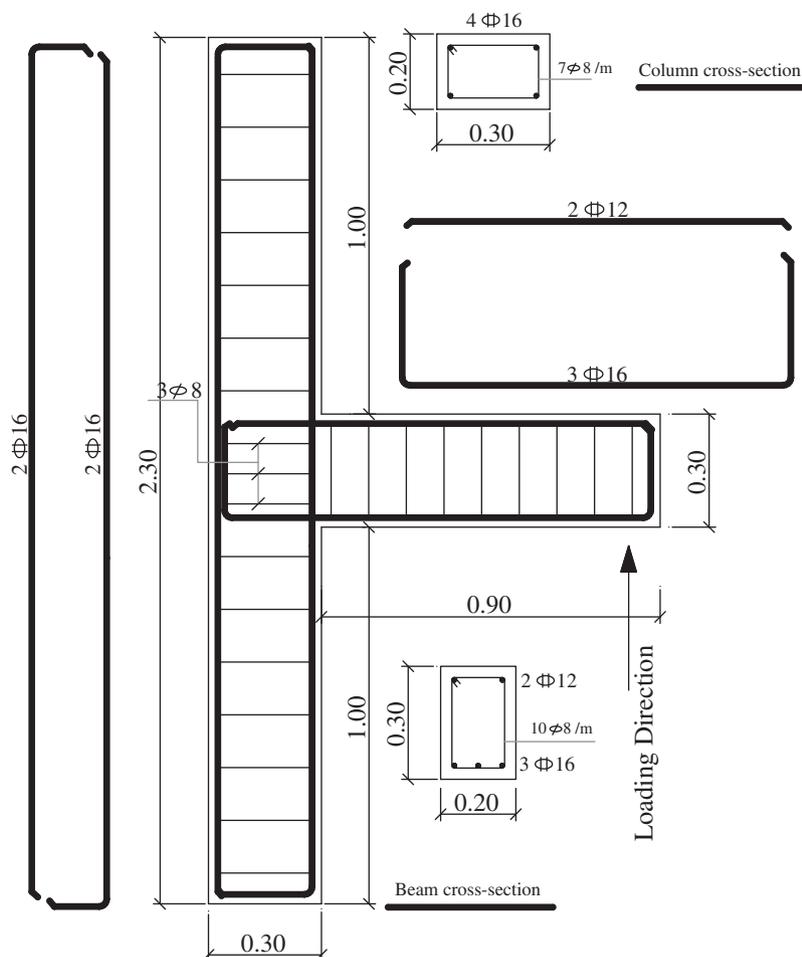
Fig. 1 Concrete dimensions and reinforcement details for the base control specimen, J0.

A total of eleven half-scale beam–column *T*-joints were prepared and cast in the current study. The first specimen, J0, was considered as the base control specimen. It had an extruded beam of 900 mm length and cross-sectional dimensions of 200 × 300 mm. This beam was connected to a column at its mid-height point. The cross-section of the column was 200 × 300 mm. The total length of the columns was 2.3 m divided into two equal parts, lower part and upper part.

The upper and lower reinforcement of the beam in addition to the main longitudinal steel reinforcement of the column were made from high tensile steel. The main steel reinforcement of the beam was three bars of 16 mm diameter, while the secondary steel reinforcement was two bars of 12 mm diameter. On the other hand, the column was reinforced with four bars of 16 mm diameter at each corner of the column cross-section. The stirrups for both beam and column were mild steel bars of 8 mm diameter and spaced every 100 mm and 150 mm for the beam and the column, respectively. In addition, three stirrups were added at the beam–column joint. Fig. 1 shows the concrete dimensions and reinforcement detailing for the base control specimen provided that the loading

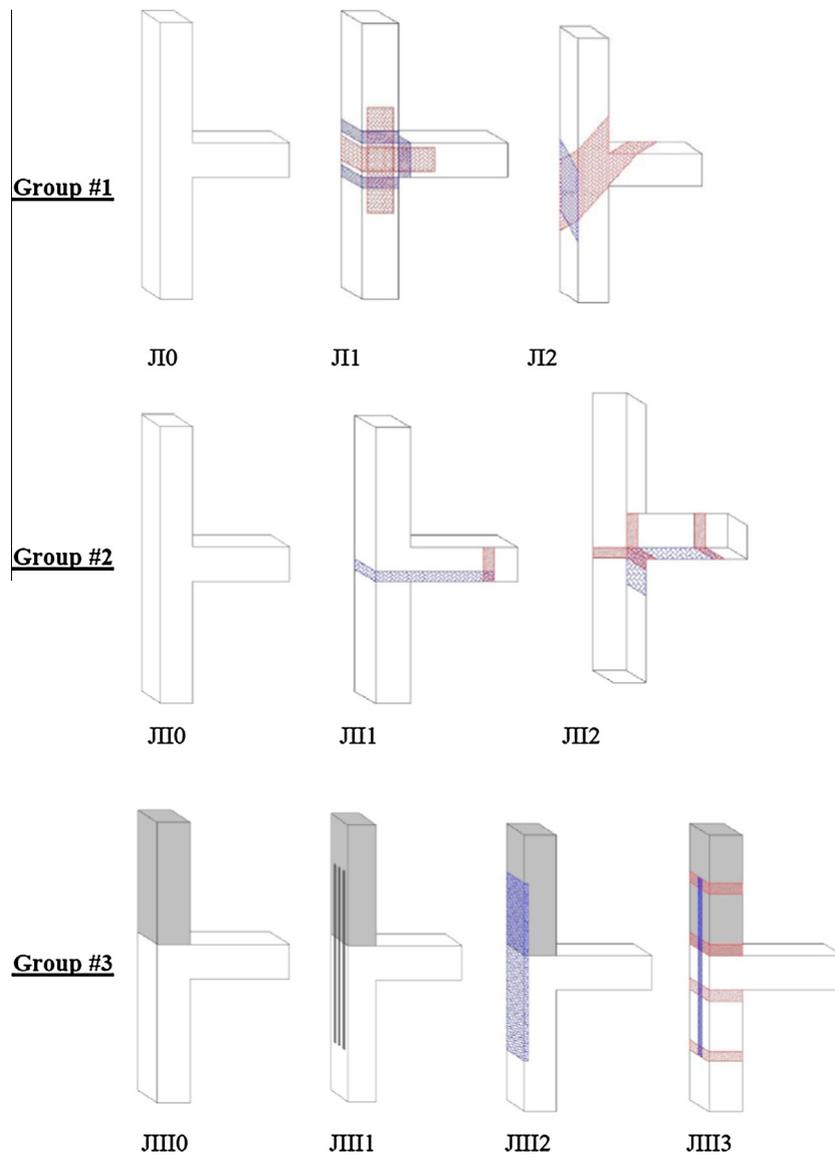
Fig. 2 Schematic representation for the considered three groups.

The remaining 10 specimens were divided into three groups representing the considered three defects as shown in Fig. 2. The first group, group #1, contained three specimens: JI0, JI1, and JI2, representing the reference specimen and two strengthening configurations, respectively. This group represented the first defect which was the absence of the stirrups at the beam-column joint. Group #2 represented the defect of insufficient bond length for the beam main steel reinforcement. This group contained three specimens: JII0, JII1, and JII2 representing the reference specimen for such group and two strengthening configurations, respectively. Group #3 represented the third defect that was deficiently executed implanted column on an old one. This group contained four specimens that were one reference specimen along with three different strengthening configurations. Fig. 3 represents the three defects of the beam-column joints. Group #3 was executed in three steps: the first step was the casting of the lower column along with the extruded beam monolithically. The second step was the drilling of four 50 mm depth holes to accommodate the longitudinal steel reinforcement for the upper column then the holes were filled with epoxy to hold the steel bars in their positions. The third step was the preparing of the surface of old concrete then casting the upper column as shown in Fig. 4.

For group #1, the first strengthening configuration represented two perpendicular overlaying fabric sheets on the beam-column joint. One layer of 200 mm width and 1000 mm length parallel to the column axis was bonded to each side of the column. Then a horizontal U-shaped layer of 200 mm width and extended by 600 mm length parallel to the beam axis was bonded to each side. Finally, three 100 mm in width U-shaped sheets were used at the joint in order to prevent the premature peeling of the sheets at the

beam–column joint [16,17]. The three anchorages U-shaped sheets were bonded in the transverse direction of the beam at the column face and in the transverse direction of the column just below and up the beam faces. The second configuration represented a 45° inclined one layer of a 500 mm wide U-shaped bonded at each side covering the beam–column joint.

As for group#2, the first strengthening configuration represented four layers of 100 mm wide sheets in the form of U-shape that were bonded to the lower side of the beam parallel to its axis. The sheets were designed to compensate the main steel of the beam with an efficiency factor of 0.5. These sheets were placed so that they covered the column width and ran up both sides of the beam to a length of 1000 mm. 100 mm in width U-shaped sheet was used at the end of the horizontal layers in order to prevent the premature peeling of the sheets. The second configuration represented two 200 mm in width L-shaped sheets bonded to the lower face of the beam and extended by 300 mm in the direction of the lower column. Three 100 mm width U-shaped anchorage strips were used at the free end of the sheet, the beam at the column face and the lower column at the beam face, respectively.

Three strengthening configurations were used in group #3 making use of CFRP fabric sheets and CFRP plates. The most important criterion for the three configurations was that the area of either CFRP plates or the fabric sheet was the same. The first configuration represented near-surface mounted, NSM. NSM FRP technique does not require extensive surface preparation work and, after groove cutting, requires minimal installation time compared to externally bonded FRP laminates [18]. Three CFRP strips inserted into grooves cut at the outer surface of the column were used. The strips, as provided by the manufacturer have a nominal width of 50 mm and a total thickness of 1.2 mm. In order to insert the strips within a typical concrete cover used for concrete members, the strips

were cut into three equal parts each, 16.6 mm wide. Using a concrete saw, approximately 5 mm wide and 17 mm deep and 1500 mm long grooves were cut into the outer surface of the column [19]. The grooves were injected with epoxy adhesive to provide the necessary bond with the surrounding concrete. The strips were carefully placed into the grooves to ensure that they were completely covered with the epoxy. The second configuration represented two layers of CFRP fabric sheets having 1500 mm in length which were bonded to the outer column surface. In order to obtain the same area of the former configuration, the sheets were extended 15 mm in the column sides. The third configuration represented the externally bonded CFRP plate of cross-sectional dimensions of 12 × 50 mm and extended 1500 mm in the column direction. Four 100 mm U-shaped anchorage strips were used to hold in position the CFRP plate as shown in Fig. 2.

In accordance with ACI 440 [15] recommendations, seven specimens were strengthened with either CFRP fabric or CFRP strips as shown in Fig. 2. Based on the failure patterns of the base control specimen and the reference specimens included into the three groups, the strengthening configurations were proposed. For both group #1 and group #2, two strengthening configurations were proposed, while three configurations were considered for group #3.

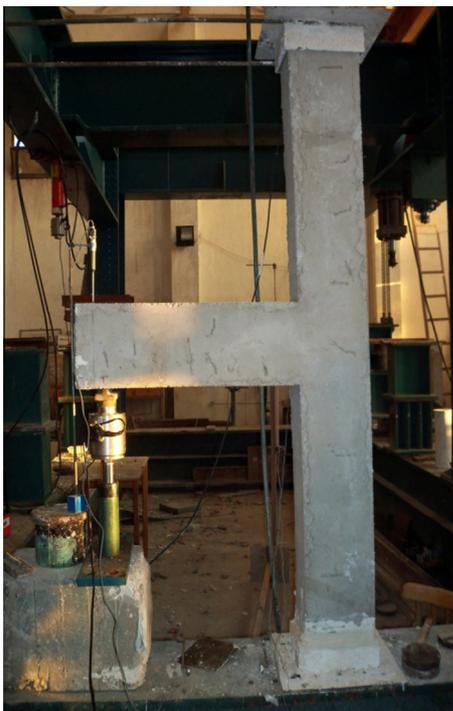
Fig. 5 Test setup.

One bay of three-dimensional steel frame of Concrete and Heavy Structures Laboratory, Faculty of Engineering, Tanta University, was equipped and used to carry out testing as shown in Fig. 5. The specimens were considered hinged at both column ends. Steel caps were used at both ends of the column to distribute the column compression load at the upper end and to support the column lower end at the testing frame. In addition, a threaded rod was wrapped around the upper steel cap and fastened to the column of the testing frame to prevent any tilting of the specimen during testing.

100 mm LVDT was used in order to measure the vertical displacement at the tip of the beam. 10 mm strain gauges were used to measure the developed strains on reinforcement at the tension sides for beam, columns, stirrups and FRP. A compression load equals to 200 kN, simulating the load in a real structure, was first applied to the column before the beam was loaded. Such column load was kept constant during the loading phase. Therefore, in several steps the beam was loaded up to failure. The loads on both column and beam were mea-

sured by a load cell of 600 kN capacity. Before fastening the specimen to the testing frame, a laser level was used to insure the verticality of the column and to ensure the coincidence of the axes of the specimen, the load cell on the upper column and the load cell on the beam.

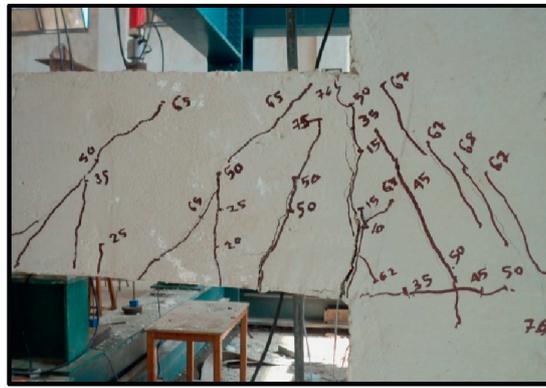
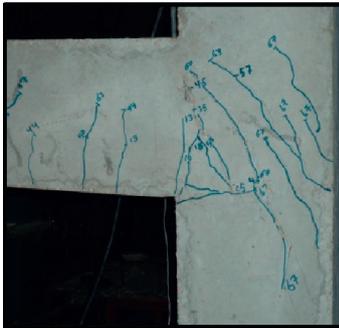
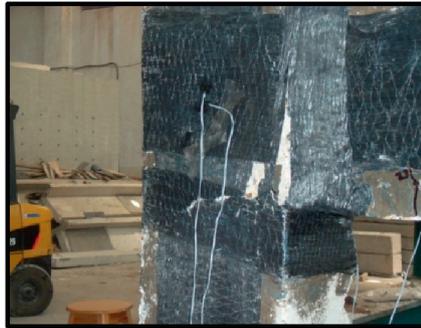
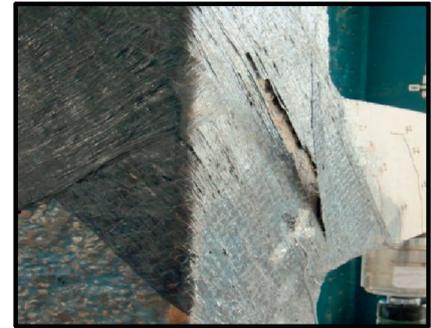
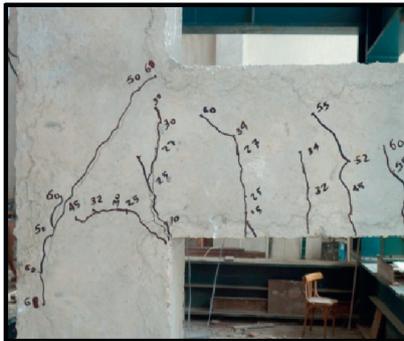
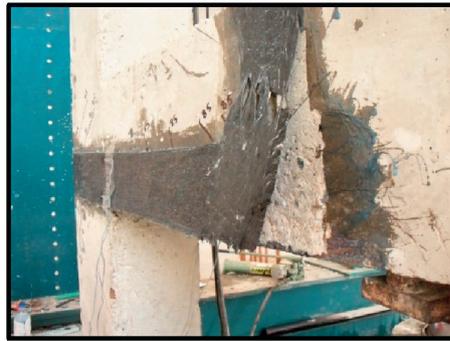
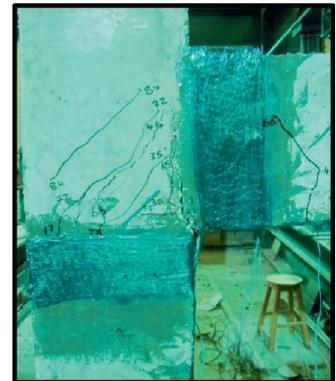
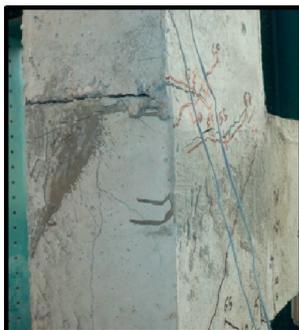
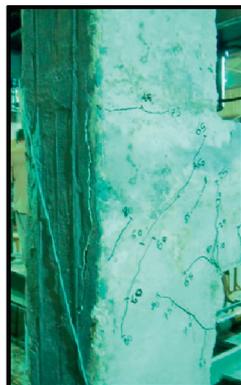
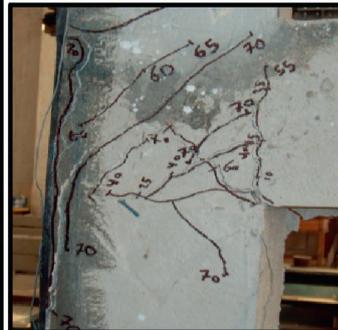
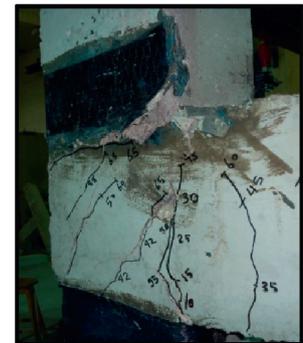
Fig. 6 Failure shapes of all specimens.

Cracks began to appear at the tension side of the beam at a vertical load of about 10 kN for the base control specimen in addition to all reference specimens for the three groups. For the base control specimen, J0, increasing the vertical load led to increasing the propagation of cracks on the beam tension side up to a vertical load of about 25 kN. Then, cracks began to appear at the tension side of the lower column at a vertical load of about 45 kN where diagonal shear cracks began to appear inside the beam–column joint. Increasing the load further increased the size of cracks further till the failure occurred due to the flexural mode at the interface of the beam to the column at about 80 kN.

As for the first group, group #1, that represented the defect of the absence of stirrups at the beam–column joint, the reference specimen, J10, showed approximately the same behavior of the base control specimen, J0, except that the diagonal shear cracks began to appear at a vertical load of about 40 kN which is lower than that of the base control specimen. This can be attributed to the absence of transverse reinforcement. The diagonal shear failure was controlled the failure of such specimen at about 67 kN vertical load which is lower than the failure load of the base control specimen. Strengthening the joint using CFRP sheets yielded the increased ultimate capacities of

the joint by about 55% and 61% as for specimen J11 and J12, respectively, compared to that of the reference specimen, J10. Specimen J11 began to crack at the same load as that of the reference specimen but cracks began to appear at higher load for specimen J12 which was about 58 kN. The proposed configurations for strengthening this defect showed their efficiency in increasing the ultimate capacity of the joint. In addition, the failure of both configurations occurred on the CFRP sheets by rupture of the sheets at the joint.

Group #2 represented the second defect which is the insufficient bond length of the main tensile steel of the beam. The failure of the reference specimen J110 was flexural failure accompanied with debonding of the beam main steel. The failure of this specimen occurred at lower vertical load compared to that of the base control specimen, J0. The ultimate capacities of the two proposed configurations were higher than that of the reference specimen J110 by about 21% and 28%, respectively for specimen J111 and specimen J112. On the other hand, these increases were 6.4% and 12.5%, respectively, compared to that of the base control specimen J0. This means the proposed configurations were not strong enough for significant gain in strength and additional layers of CFRP are recommended. The failure of the first strengthening configuration was characterized by the peeling off the CFRP layers while the rupture of the CFRP sheets characterized the failure of the second configuration.

Group #3 represented the defect of poorly spliced implanted column. The failure of the reference specimen, J1110, was characterized by splitting of the upper implanted column at about a vertical load of about 65 kN which is lower than that of the base control specimen by about 19%. The most appearing phenomenon for all specimens of this group was that all of them began to crack at the same vertical load, and then different behavior was noticed till the complete failure had occurred. The failure of both specimens J111 and J112 was due to the peeling off of either the CFRP NSM or CFRP sheet. On the other hand, rupture of the anchorage U-shaped characterized the failure of specimen J1113.

For all specimens, the cracking load for the beam, column and the joint in addition to the mode of failure are included in Table 2. In addition, failure shapes of all specimens are presented in Fig. 6.

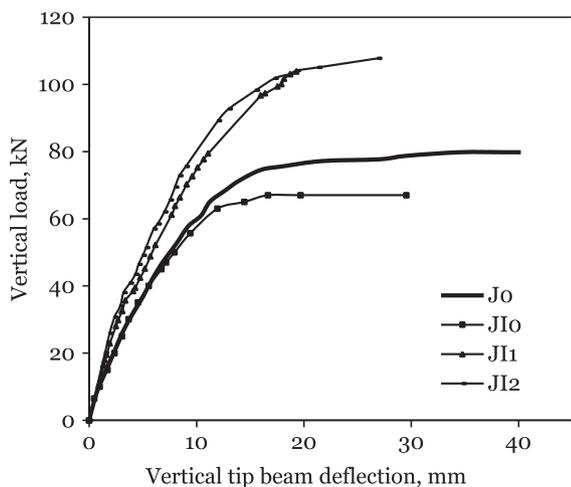
Fig. 7 Vertical load versus vertical deflection at the beam free end for all specimen of group #1.

Fig. 7 shows the load–deflection relationship for all specimens of group #1 in addition to the response of the base control specimen. At the beginning of loading, all specimens approximately showed the same deflection till a value of about 10 kN then, both specimens J0 and J10 showed identical response up to about 45 kN. On the other hand, the strengthened specimens, J11 and J12, showed different response up to failure where specimen J12 (strengthened using diagonal CFRP sheets) showed lower deflection compared to that of specimen J11 at the same loading level. In the continuation of the loading phase, the reference specimen J10 showed the highest corresponding deflection at the same loading level compared to that of the base reference specimen in addition to the strengthened specimens.

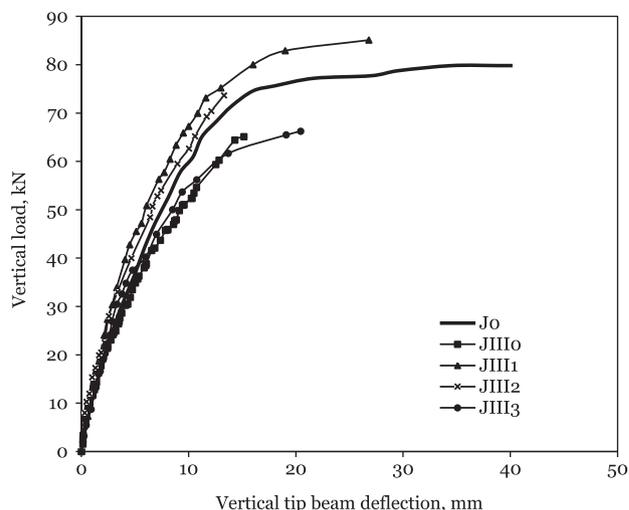
Fig. 9 Vertical load versus vertical deflection at the beam free end for all specimen of group #3.

Fig. 9 shows the load–deflection response for group #3. The same trend as that of the former groups regarding the reference specimens and the strengthened specimens was noticed. However, the variations among the responses were smaller than that exhibited by the former groups. This is the only group that used both CFRP sheets and plates. NSM strips, showed the lowest vertical deflection at the same loading level among the group.

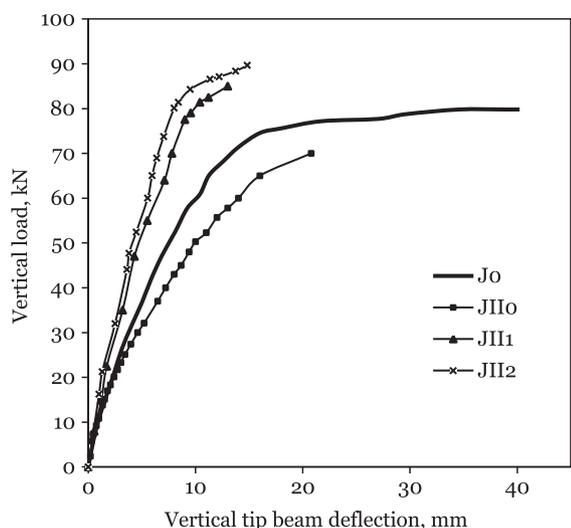
Fig. 8 Vertical load versus vertical deflection at the beam free end for all specimen of group #2.

Fig. 8 shows the same trend for all specimens of group #2. The reference specimen J110 showed the highest corresponding

vertical deflection at the same loading level. In the same way, the strengthened specimens showed lower deflections compared to that of both the reference specimen, JII0, and the base control specimen, J0. However, the responses for group #2 showed noticeable variations in contrast to that of group #1.

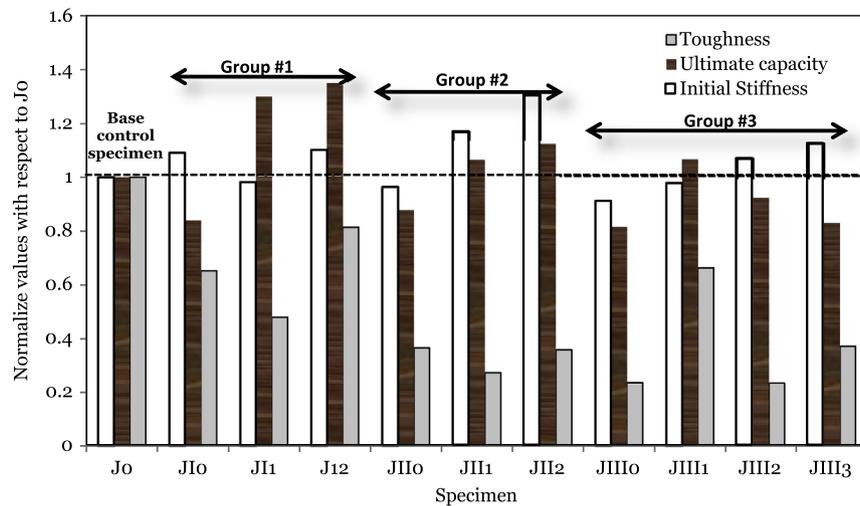
Fig. 10 Comparison among all specimens concerning ultimate capacity, initial stiffness and ductility.

As for group #1, the strengthened specimens, JI1 and JI2, showed an increase in the ultimate capacity by 55% and 61% compared to the reference group JI0, respectively, while these increases were 30% and 35%, respectively, compared to that of base control specimen, J0. This indicates that the strengthening configuration for that defect is properly chosen based on the ultimate capacity viewpoint. In addition, the diagonal overlaying sheets showed higher performance than that of the orthogonal overlaying. The strengthened specimens of group #2 showed lower percentages of capacity gain compared to that of group #1. This is reasonably good because the strengthening configurations were chosen in order to compensate only the beam main steel not to increase the ultimate capacity. The percentages of increases in the ultimate capacities for specimens JII1 and JII2 were 21% and 28%, respectively, compared to that of reference specimen JII0 and were 6.5% and 12.4%, respectively, compared to that of the base control specimen, J0.

As for group #3, one configuration (NSM) only gave higher capacity compared to that of the base reference specimen, J0. That increase was about 6.6% compared to that of the specimen J0. While, the specimens having overlaying sheet or plate exhibited higher capacity compared to the reference specimen JIII0, they did not convey the capacity to that of the base reference specimen, J0. Although, the specimen JIII1 and specimen JIII3 had the same area of the CFRP plate, NSM showed higher capacity due to the good orientation of the plates in the direction of higher stiffness of these plates. Fig. 10 shows a comparison among all the specimens considering the ultimate capacity. It can be noted that specimen JIII1

showed a reasonable increase in the ultimate capacity compared to that of the properly detailed specimen, J0. However, specimens JIII2 and JIII3 showed lower ultimate capacities compared to that of specimen J0. This means that those former two strengthening configurations do not represent the best solution.

As for the initial stiffness, Fig. 10 shows that all reference specimens (JI0, JII0 and JIII0) exhibited lower initial stiffness compared to that of the base control specimen, J0. In addition, approximately all strengthened specimens showed higher initial specimen compared to that of specimen J0. In addition, Figs. 7–9 show that during the loading course all strengthened specimens yielded higher instantaneous rate of stiffness compared to that of the base control specimen, J0.

Ductility may be broadly defined as the ability of a structure to undergo inelastic deformations beyond the initial yield deformation with no decrease in the load resistance. Toughness of the system can be defined as the maximum energy that can be sustained by the system up to failure. It can be used as an indicator for the ductility where higher toughness means higher dissipation of energy, until the failure occurred leading to higher ductility. The toughness can be defined as the area under the load–deflection curve. Fig. 10 shows comparison among all specimens from the ductility viewpoint. It can be concluded that both reference un-strengthened specimens and strengthened specimens for the three defects exhibited lower ductility compared to that of the base control specimen J0. The most important phenomenon is that it is not necessarily that the specimen having higher strength yielded lower ductility. That happened for specimens JIII2 and JIII3 where both of them showed lower strength and lower ductility compared to specimen J0. In addition, the strengthened specimen JI2 which had the maximum capacity showed also the highest ductility among its group.
