## Metallosis and elevated serum levels of tantalum following failed revision hip arthroplasty – a case report

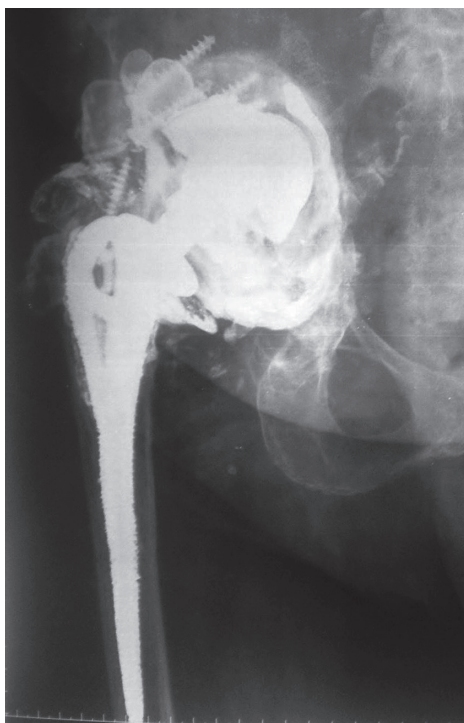
Figure 1. Pre-revision radiograph. An unexplained “halo formation” can be seen surrounding the acetabular components.

she was referred to us for an additional revision. The preoperative radiographs showed a peculiar “halo formation” surrounding the acetabular component (Figure 1). Extensive metallosis of this surrounding tissue was found intraoperatively. Black pigmentation was also found in the overlying skin (Figure 2). Following the removal of the loose Hillock cup, the tantalum augment was found to be non-osseointegrated, severely worn, and broken (Figure 3). Debridement and synovectomy was performed and a modified cup-cage construct technique was used to address the existing pelvic discontinuity.

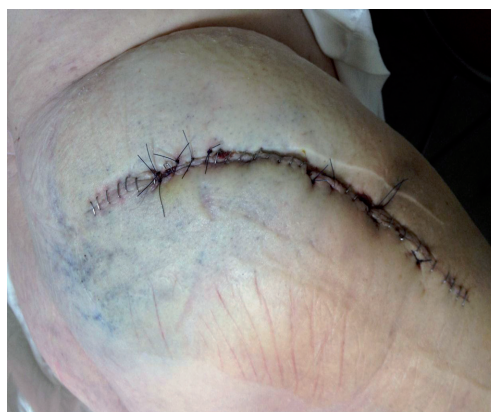
Figure 2. Skin pigmentation immediately after revision.

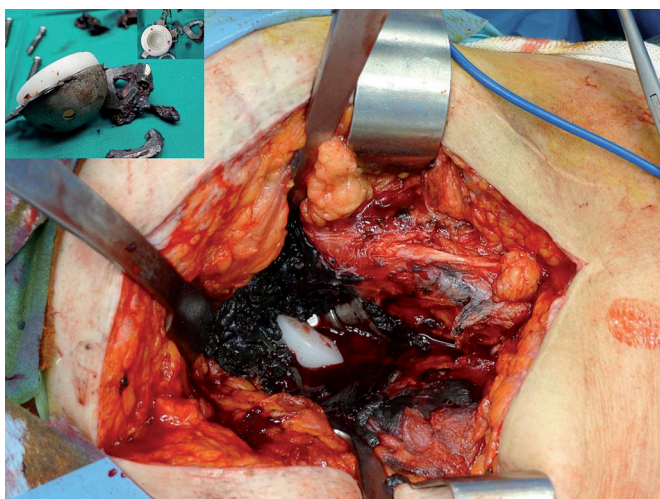
Figure 3. Intraoperative findings. Extensive periprosthetic metallosis and wear of the tantalum augment and the adjacent porous titanium and hydroxyapatite-coated acetabular SYMBIOS cup. Ta particles were embedded in the polyethylene surface (black stains).

In our case, the previous surgeon used a tantalum augment to support a titanium HA-coated cup without the use of polymethylmethacrylate (PMMA) between the augment and the cup, as has been suggested by the manufacturers of tantalum augments (Issack et al. 2009, Nehme et al. 2004, Zimmer INC. 2006). Moreover, in the presence of pelvic discontinuity, this construct was unstable from the beginning and none of the implants osseointegrated. As a consequence, micro- and even macromotion and friction between the cup and the augment led to excessive corrosion, metallosis, and dissemination of tantalum particles into the peripheral serum. Thus, the cause of failure in our case was probably iatrogenic because the surgeon failed to put PMMA in the interface.

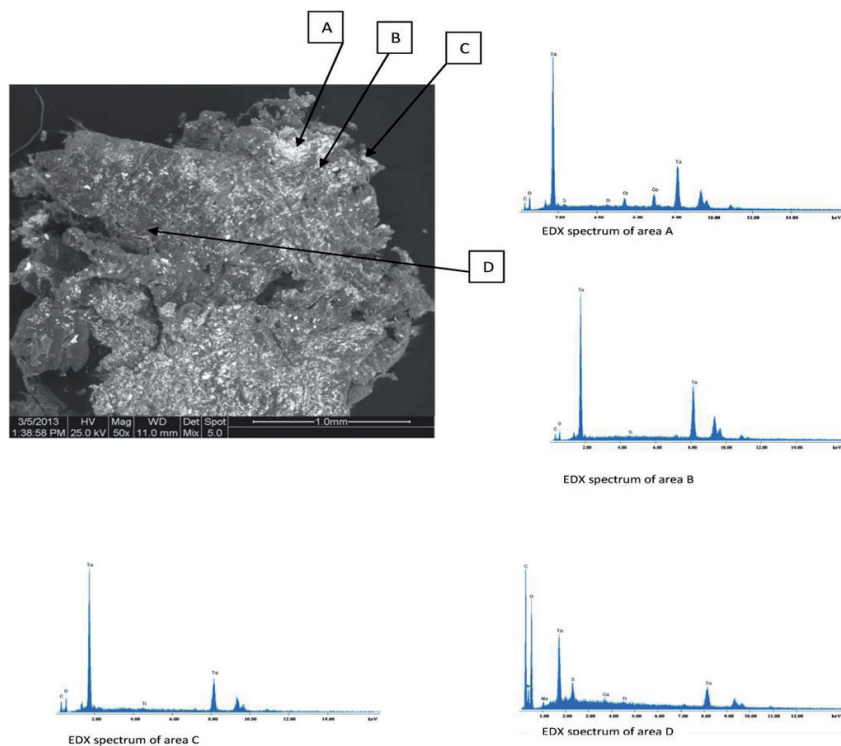
The SEM image showed an alteration on the surface of the largest part of the tissue (Figure 4). The semi-quantitative EDX analysis of area A revealed a composition with Ta as the predominant element, accompanied by Cr and Co (Ta: 76.2%; Co: 6%; Cr: 2.9%; C: 6.3%; O: 7.3%; S: 0.7%; and Ti: 0.6%).

Spot analyses of areas B and C showed almost pure pieces of Ta (88% and 75%, respectively) laid on the tissue. Area C showed a small increase in the titanium concentration (1%). EDX analysis of area D, considered to be rather free of depositions, showed a composition of C: 31%; N: 18%; O: 32%; Na: 0.5%; S: 1%; Ca: 0.4%; Ta: 18%; and Ti: 0.3%) with a reduced content of Ta in comparison to the previous examined spots B and C. The Ti level was close to the detection limit.

Figure 4. SEM image and results of EDX analysis of areas A, B, C, and D revealing the predominance of Ta.

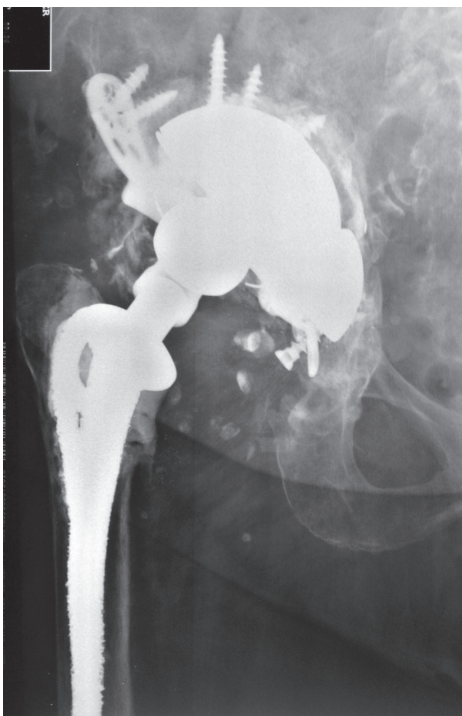
6 months after revision, the serum tantalum levels were 15 µg/L, a decrease of 25% compared to the levels found in the serum just before revision operation. The patient had no pain (Figure 5).

Figure 5. 6 months after re-revision of the acetabular components. A modified jumbo Ta cup-Ti cage construct and peripheral Ta augment were used due to pelvic discontinuity. The patient had no pain at the latest follow-up.

At re-revision, as there was pelvic discontinuity we used a modified cup-cage concept using a jumbo Ta acetabular cup and distal augment, which were protected by a Ti Burch Schneider-type reconstruction ring—Contour (Smith and Nephew, Memphis TN)—with Palacos cement in all implant interfaces.

Although elevated systemic serum levels of ions other than Ta have been identified in many cases of failed metal-on-metal hip arthroplasty, there have been no reports of substantially elevated serum tantalum levels (Lavigne et al. 2011). We found a 2,000-fold increase in serum tantalum concentration after significant tantalum metallosis, which had dropped by 25% six months postoperatively even though tantalum cup and augments were used in the re-revision (Figure 5).
