Case Report

Prosthodontic Rehabilitation of the Patient with Severely Worn Dentition: A Case Report

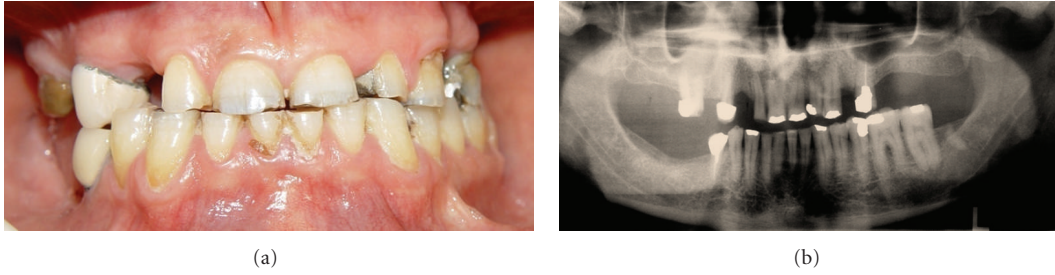
2.1. Examination. A 63-year-old man was referred to the Department of Prosthodontics in the Faculty of Dentistry at Isfahan University of Medical Sciences, Iran, for prosthodontic treatment. The patient's chief complaint was the restoration of worn teeth, in addition to the replacement of unacceptable restorations and missing teeth. An initial evaluation of the patient indicated a history of depression, and also, parafunctional habits of bruxism and clenching. Oral hygiene was fair, and there was no periodontal problem. Clinical and radiographic examinations and diagnostic casts revealed severe attrition, especially on anterior teeth and an

FIGURE 1: Frontal view of teeth in occlusion (a) and panoramic radiograph (b) before treatment.

uneven occlusal plane (Figure 1). The causes of the severe wear were parafunctional habits, unsuitable restorations, and a lack of stable posterior occlusion.

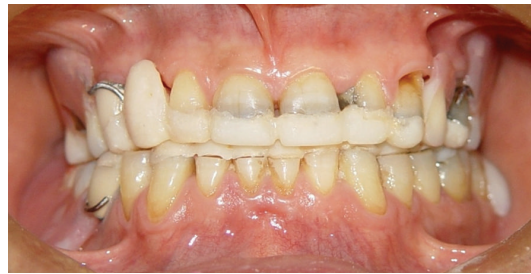
FIGURE 2: Removable provisional prostheses in place.

2.2. Treatment. After oral hygiene instructions, making impressions and diagnostic workup, removable provisional prostheses were fabricated with correct occlusal plane and adjusted clinically for achieving good aesthetics, phonetics, and OVD. This removable prosthesis was used to evaluate the OVD and patient tolerance (Figure 2).

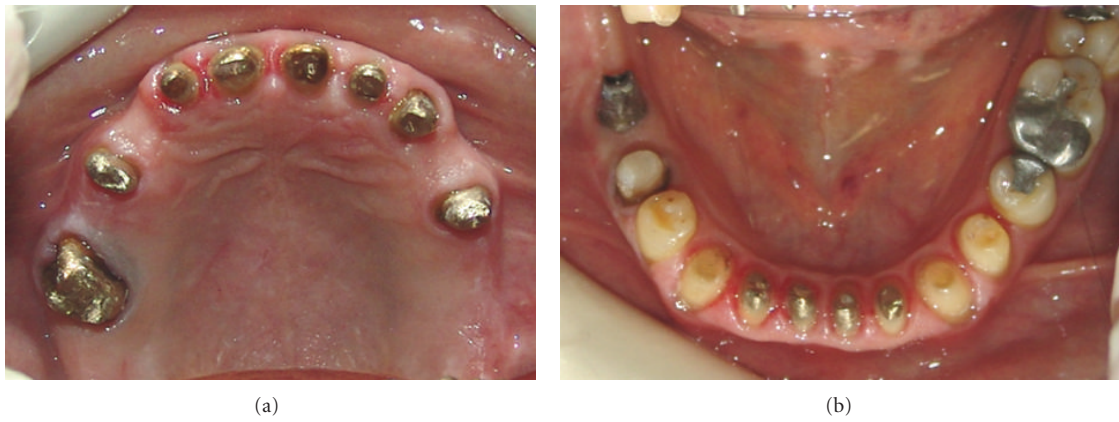
FIGURE 3: Cast posts and cores.

precise clinical and radiographic evaluation and diagnostic waxup using surgical stent. Root canal therapy (RCT) of anterior worn teeth and retreatment of teeth with unacceptable RCTs were performed, and casted posts and cores were fabricated (Figure 3). Fixed and removable provisional restorations were inserted and adjusted until patient acceptance achieved. These restorations were fabricated according to the diagnostic waxup (Figure 4), for which the Broadrick flag analyzer was used to determine the curve of occlusal plane. Impressions were made from provisional restorations, and casts were transferred to the Denar Mark II articulator (Teledyne Water pik, Fort Collins, CO, USA) using the Denar Slidematic facebow (Teledyne Water pik, Fort Collins, CO, USA). Then, an anterior guide table was customized by pattern resin (Duralay, Reliance Dental MFG Co., Worth, CO, USA). After completion of teeth preparations, the final impressions were made with silicon impression material (Speedex, Coltene AG, Alstatten, Switzerland/impergum, 3 M ESPE), and metal-ceramic restorations were fabricated. In the maxillary restorations, rest seats, guide planes, and retentive undercuts were formed in the RPD abutments. A Kennedy class II mode 1 maxillary RPD was fabricated and delivered (Figure 5). Finally, the occlusion of restorations was adjusted so that equal-intensity centric contacts were established on all teeth (Figure 6(a)), and anterior guidance discluded all posterior teeth in eccentric jaw movements. A maxillary occlusal splint was fabricated for protecting

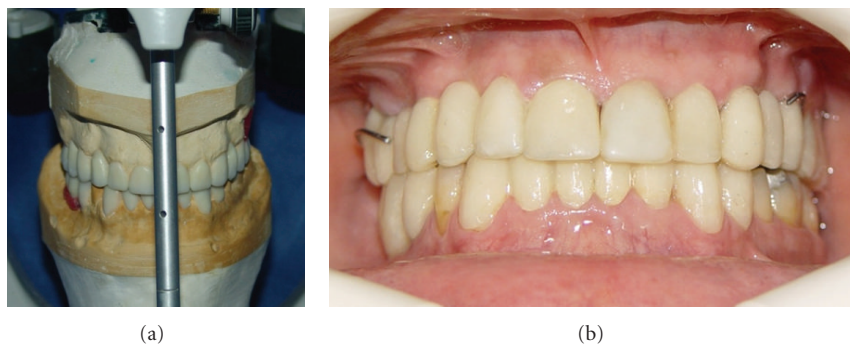
FIGURE 4: Diagnostic waxup (a); fixed and removable provisional restorations in place (b).

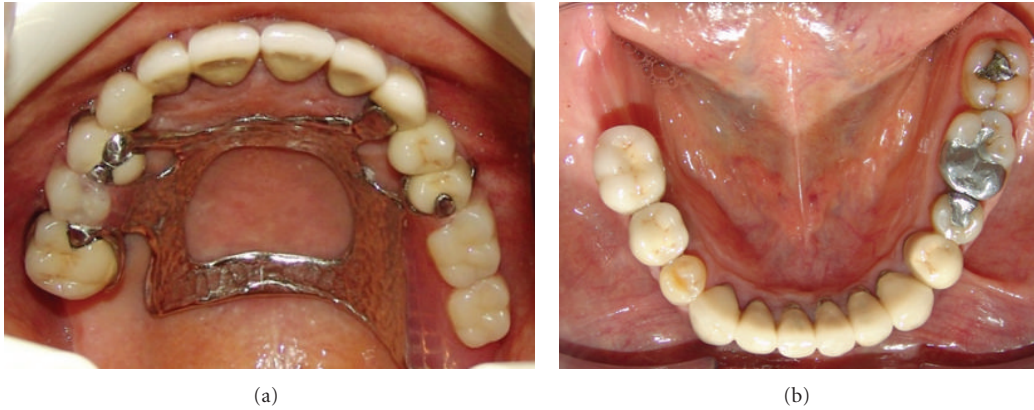
FIGURE 5: Occlusal view of the maxillary (a) and mandibular (b) arch after treatment.

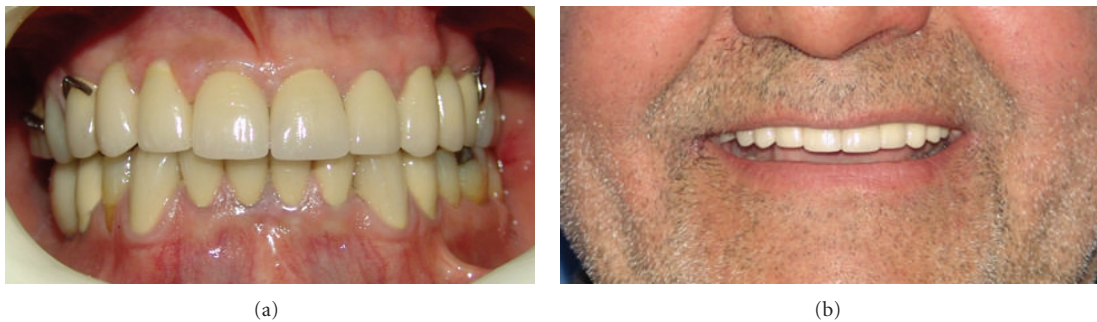
FIGURE 6: Frontal view of teeth in occlusion after treatment (a); smile view after treatment (b).

the restorations from patient's parafunction. The smile view of patient after treatment is shown in Figure 6. One-year followup showed no problem in teeth, restorations and temporomandibular joints and Figure 7 show the panoramic image after this period.

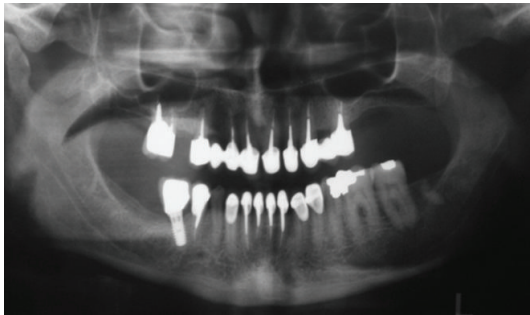
FIGURE 7: Panoramic view of 1-year-followup.
