Article

Multi-Variant TLS and SfM Photogrammetric Measurements Affected by Different Factors for Determining the Surface Shape of a Thin-Walled Dome

Grzegorz Lenda *

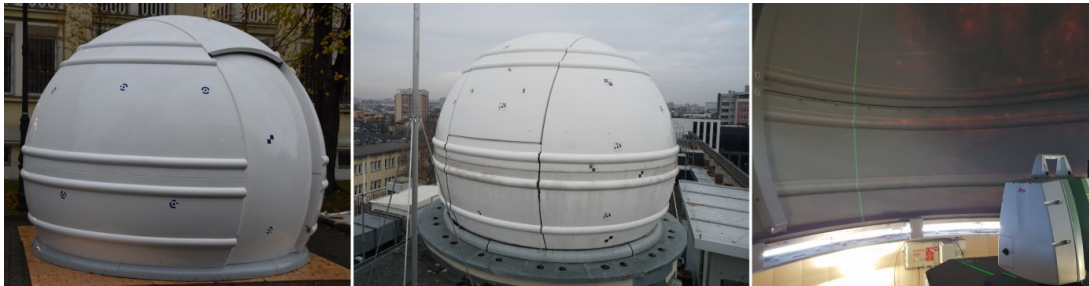
Figure 1. (Left) Dome after assembling; (Center) roof-mounted; (Right) internal view.

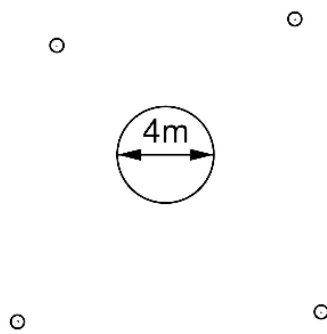
The initial measurement determining the geometry of the dome once it had been assembled was taken with a Leica ScanStation C10 laser scanner with an accuracy of 6 mm and precision of 2 mm. Divergence of the laser beam was 0.1 mrad. The measurement was taken from four scanner stations located around the dome at a distance of 4–6 m from the object (Figure 2). The scanner locations' heights were slightly above the middle stiffening extrusions of the dome. The connection of neighboring point cloud pairs was based on targets in the form of markers placed on the dome surface. Adjacent clouds overlapped by about 50%, but some of the targets were measured at unfavorable incident angles of the beam. Therefore, between each pair of scans, four of them were selected, which gave the smallest registration errors. In total, 16 targets were used (4 targets between every 4 pairs of scanner locations). The mean error of the point clouds' registration in Leica Cyclone was 1 mm. The resultant cloud had an average resolution of 2 mm and it was similar for all subsequent experiments.

Figure 2. Scanner stations in relation to the dome.

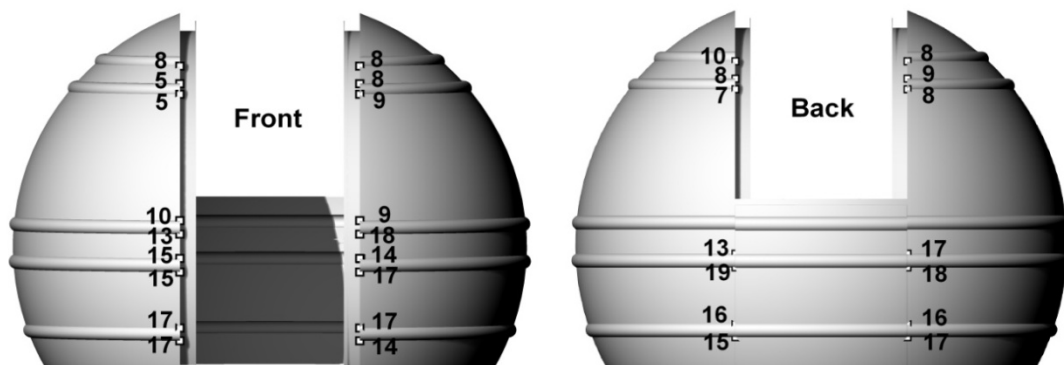
The resulting cloud was compared with the solid design model. In order to make the comparison possible, it was necessary to transform the point cloud into a solid model coordinate system based on selected homological points. Transformation by applying specific translations and rotations by means of rigid body transformations was performed in Leica Cyclone. The only points that could be clearly distinguished in the cloud on the shell object were at the intersection of the edge of the slide gate and the horizontal stiffening extrusions, but due to local laser obscurations, not all of them could be used. The selected homological points are marked in Figure 3. As a result of the transformation, significant deviations were determined at some homological points. Deviations at the top of the dome were, on average, 8 mm, and at the bottom, 16 mm. Their values and locations indicate that the dome was deformed along the slide gate. Under the pressure of the upper fragments, larger deviations appeared in the lower part of the dome, which ceased to be a spherical object.

Figure 3. Deviations at points (mm) after a transformation using all the points.

Deformations of the object have a negative effect on the accuracy of matching the entire cloud to the design model. In addition, during the transformation of point clouds obtained from scanning and photos during subsequent experiments, there were problems in selecting the same homological points as in Figure 3. This was due to the lower position of the scanner in relation to the dome, which eliminated points in its upper part, and the low precision of point clouds obtained from UAV images. Thus, for each of the subsequent experiments, the cloud transformations to the design model coordinate system would be based on different homological points with different accuracy, and the comparison of the subsequent results would be distorted. However, since the analyzed object is a sphere, it was possible to perform free Least Squares Method (LSM) sphere fitting into the point cloud. Then, for each of the analyzed cases, deviations from the surface of the sphere were determined, allowing for direct comparison of the results. The values of deviations and their distribution are the basic criteria to determine the differences in the results of individual methods. Before the LSM method was applied, all elements not constituting the surface of the homogeneous sphere, i.e., horizontal stiffening extrusions and points located on a movable slider, had to be removed from the point clouds.

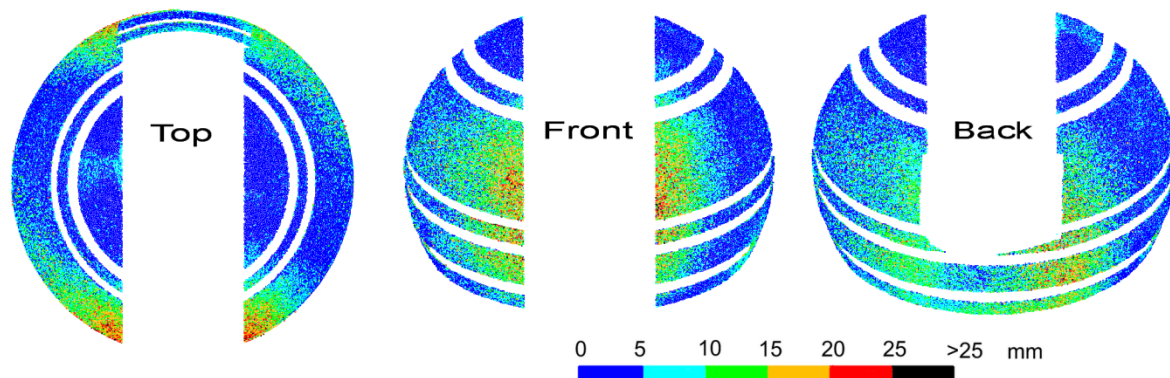
The result of the fitting is shown in Figure 4, containing the deviations of points from the model sphere, grouped in intervals of 5 mm. Similar fits were made for all other experiments.

Figure 4. Laser scanning after the dome was assembled. Deviations of a point cloud from a free fitted sphere. The object was covered with rain drops.

The deformations of the sphere that occurred at the homological points during the transformation are fully visible. They are located along the edge of the slider in the lower-central section. Larger deformations occur on the front side, which does not have a stiffener at the bottom of the dome. The deviation values are consistent with the transformation error values at the homological points and, at the top of the edge, have values up to 10 mm, and at the bottom—up to 20 or even 25 mm. However, deviations greater than 20 mm are distributed sporadically and randomly. They do not form continuous areas and do not correspond to the smooth surface of the dome. Furthermore, in other areas of the dome, random scattering of deviations of smaller values can be observed, which may suggest local, slight irregularities of the dome. In fact, the surface of the dome is smooth, but the random scattering of the results is due to the scattering of the laser beam when measuring a dome covered with small droplets of water after precipitation. In the article, two cases related to the scattering of the laser beam, which causes changes in the measured lengths, are examined. The first one is scattering on water drops, which randomly covered the dome and gave a random distribution of deviations of different values. The second, described in Chapter 6, is the refraction of light in the glass fiber layer, which changed length by a constant value. The authors conducted research related to changes in the measured length of the light scattering in surface structures (synthetic materials) [11]. Most synthetic materials cause changes in measured lengths and can be systematized. Drops of liquids, on the other hand, may have a different surface area, height, volume, and temperature, may cover different types of surfaces, and the light beam will fall at a different angle in each of them. Such measurements cannot be systematized because each result may be different. It is visible in the random dispersion of deviations over the entire surface of the object.

The average deviation of the sphere fit was 5.7 mm, and 0.075% of the points had deviations greater than 25 mm, which exceeds the values resulting from visible deformations of the dome along the slide gate. Deviations at the level of 25 mm were taken as a limit during further experiments. The radius of the fitted sphere was 1.996 m and is close to the design radius of 2.000 m.

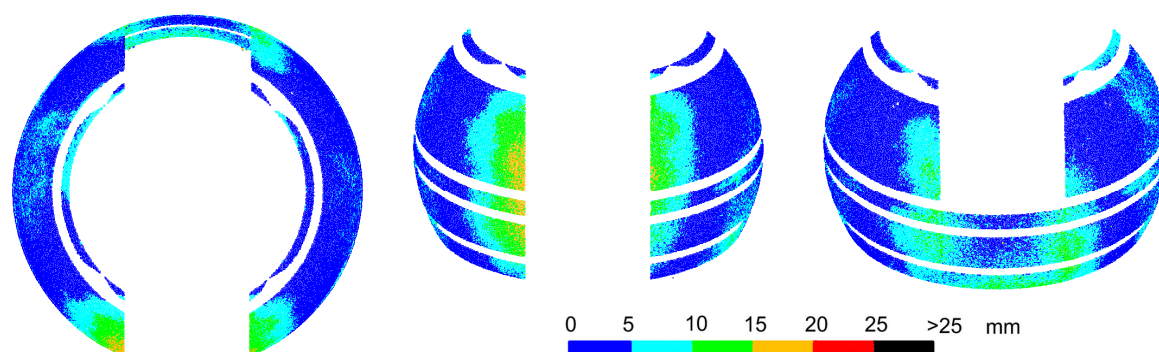
After the measurement, on the basis of experience from the previous point (comparing the cloud transformations to the design model and the free fitting), free fitting of the sphere into the point cloud was chosen. Next, the deviations of points from the sphere were determined in intervals of 5 mm. The results are shown in Figure 5.

Figure 5. Laser scanning after transport and fixing of the dome. Deviations of a point cloud from a free fitted sphere. Dry object.

The point cloud maintained consistency, and there were no visible, mutual shifts of quarters of the sphere which could occur if the dome were not rigid during rotation. The object had the same shape as when measured from four stations. The fragment of the upper surface of the dome was not measured because the scanner station was lower than the station from the previous experiment. The cloud had much less randomly scattered deviations, which is the result of the measurement of a dry object. Random deviations of values exceeding 25 mm occurred only for 0.002% of points, i.e., approximately 40-times less frequent than for an object covered with rain drops. The average sphere fitting deviation, which was 4.7 mm, was also smaller, indicating a general improvement in the precision of measurement for a dry object. Deformations of the sphere were distributed in the same places as for the dome after assembly, and they also had the same ranges of deviation values. This means that the transport and fixing of the dome did not cause any additional deformation. The radius of the determined sphere was 1.997 m and differed by 1 mm from the radius of the previous measurement.

In conclusion, the results of measuring the dry surface of the dome have noticeably better precision. The locations and values of the dome deformations from the previous measurement were confirmed. The object was not deformed during transport and fixing. Rotation of the dome, used during scanning from one station, also did not cause the dome to deform.

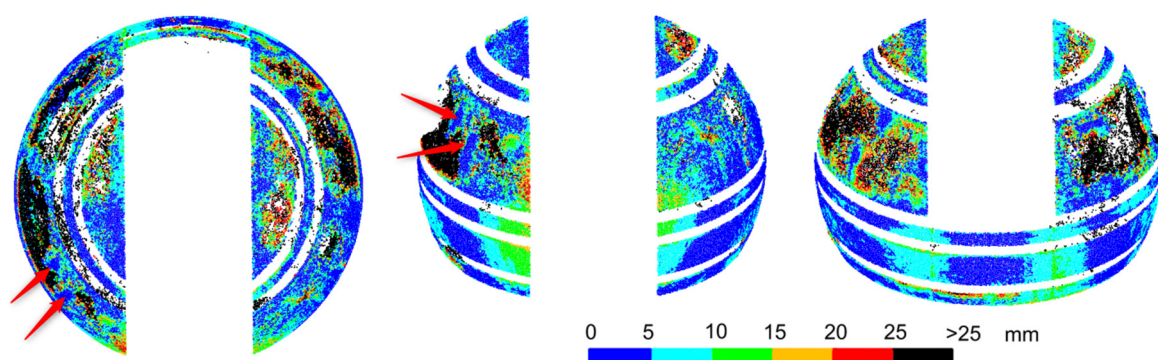
The results obtained for both programs were significantly different from those obtained with a laser scanner. For Agisoft Photoscan, the radius of the freely fitted sphere was 1.966 m, and for ContextCapture, 1.972 m. In both cases, it differed by about 30 mm from the designed radius. It was decided to compare the point clouds to the sphere determined from laser scanning, whose radius differed only by 3 mm from the designed one. Deviations from the sphere for the Agisoft Photoscan point cloud are shown in Figure 6, and from ContextCapture, in Figure 7. As the control points used for scaling the photogrammetric point cloud originated from the TLS measurement, the problem of error propagation arose. In the upper part of the dome, small, regular areas of deviations with the smallest values, i.e., up to 5 mm, were visible (partially in Figure 6, especially in Figure 7). These are the places where the control points were glued. At these points, the UAV and TLS clouds differed from the sphere by no more than 5 mm. The influence of scanning accuracy on the photogrammetric measurements was, therefore, within this range, although it was not strictly determined. The point cloud obtained in Agisoft Photoscan had a high noise level. Some points were located at a distance of several dozen centimeters from the sphere surface. In Figure 6, they are partially covered by points with smaller deviations. The average deviation from the sphere was 44 mm. Overall, 30% of the points had deviations greater than 25 mm, while for scanning measurements, such deviations were very few (0.075% for the wet dome and 0.002% for the dry dome). In terms of overall statistics, similar results were obtained for the cloud from ContextCapture. The average deviation was smaller and reached 35 mm, while more deviations—as many as 36%—exceeded 25 mm. A comparison of Figures 6 and 7 shows that the results of the two programs differ substantially. As mentioned above, the point cloud from Agisoft Photoscan has significant noise, but after filtering out the points with large deviations, obscured by points with smaller deviations, there remains a relatively significant surface area whose deviations are within 25 mm. The cloud from ContextCapture has much less noise; the points do not obscure each other, but after the removal of deviations of more than 25 mm, very little observation remains for the upper part of the dome. None of the results are comparable to laser scanning and are not suitable for assessing the shape of an object, but Agisoft Photoscan provides better results.

Figure 6. Comparative photogrammetric unmanned aerial vehicle (UAV) measurement. Deviations of the Agisoft Photoscan point cloud of the sphere from laser scanning (arrows indicate examples of target placement).

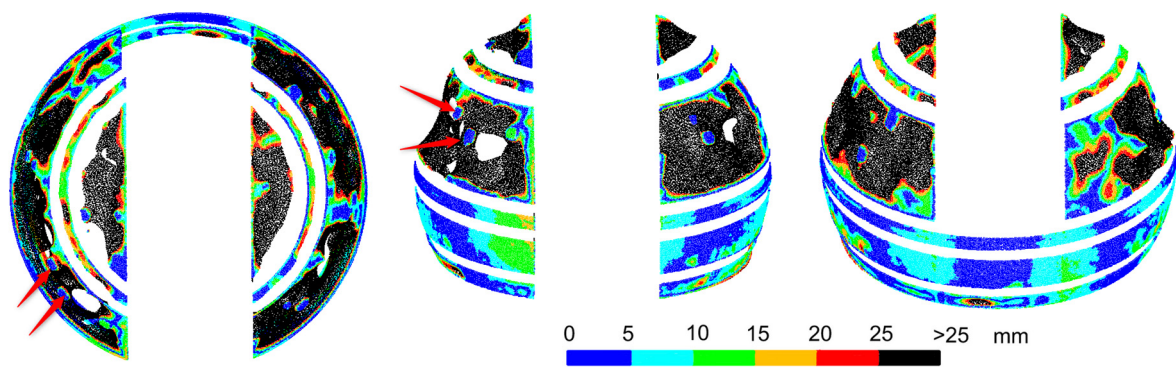
Figure 7. Comparative photogrammetric UAV measurement. Deviations of the ContextCapture point cloud from the sphere from laser scanning (arrows indicate examples of target placement).

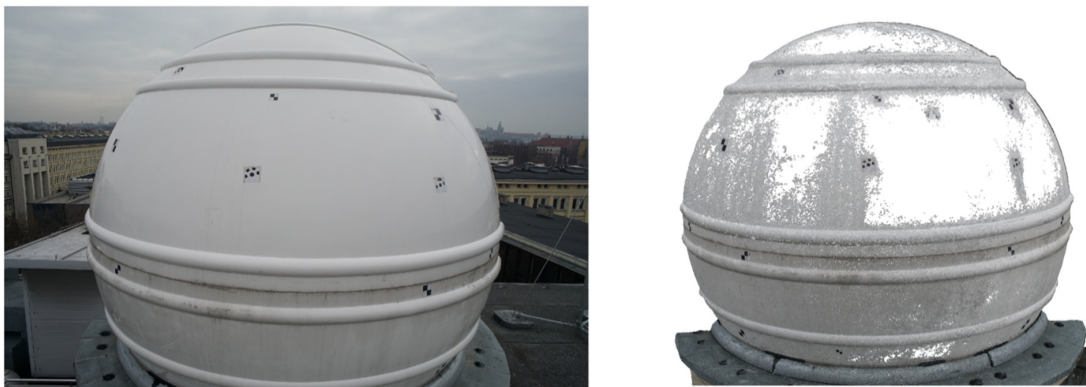
The comparison of the deviations on the upper and lower parts of the dome appears interesting. At the top, rainfall washes away pollutants, leaving the surface shiny and reflecting environmental elements that affect the captured image. In both programs, large deviations occurred at this part of the dome. The pollutants washed away from the top accumulated on the bottom part, making it more matte, which prevented reflections (Figure 8).

Figure 8. Comparison of the regions with pollutants and without. A photo of the dome (left) and the point cloud generated from Photoscan (right). To make the drawing easier to read, points with deviations over 25 mm have been removed from the cloud.

The lower part of the dome from both programs has deviations of much smaller values. The dirt on the surface was the only noticeable and distinct factor that differentiated the top and bottom of the dome, causing the bottom to be matte, without reflections and with visible streaks, and the top to shine. The matte spots gave a smaller distortion of the sphere and the regions with a glossy surface were covered with a bigger distortion or lack of measurement. It is an interpretation supported by research from other authors showing problems with reflections [24,27]. For Agisoft Photoscan, larger differences from the scanner occurred only in a narrow strip in the lower, central part of the back of the dome. For ContextCapture, the deformations of the object were also in the same places and with similar values as observed by the scanner. However, apart from these, there were also deviations of the same size at different points in the lower part of the dome. Without comparison with scanning results, it would not be possible to recognize which of them are the real deformations of an object and which are the result of errors in cloud modeling by the software.

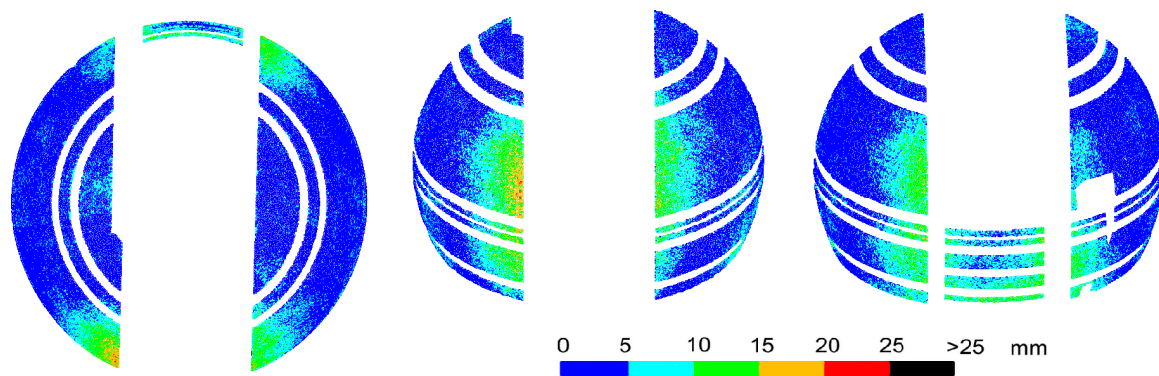
Figure 9. Laser scanning of the dome interior. Deviations of a point cloud from a free fitted sphere.

The locations and values of the deviations correspond to the results for measuring the external surface of the dome. The outer side had a smooth surface, while the inner side, made by the boatbuilding method, had unevenly distributed surface roughness with an amplitude estimated at about 2–3 mm. To some extent, they may have affected small differences in deviation between the internal and external surfaces. The average deviation from the sphere was 4.3 mm (4.7 mm for the external surface). For both surfaces, deviations exceeding 25 mm were at the same level of 0.002%. The determined radius of the sphere was 1.994 m, which means that with an external sphere radius of 1.997 m, the wall thickness is only 3 mm, whereas the design is 6 mm. Most synthetic materials, including the glass fiber, of which the dome was made, scatter the laser beam within their structure, increasing the length measurement result. Thus, the following experiment was carried out: a scan of a fragment of the external and internal sides of the dome was performed, and then, the measurements were repeated after sticking a sheet of paper tightly adjacent to the dome in the same place. The sheet of paper prevented the laser from penetrating the synthetic material. Then, the distance between the covered cloud and the uncovered one was compared. The difference for the external surface was 0.3 mm, taking into account the thickness of the sheet, which can be considered negligible. The difference for the internal surface was 2.1 mm. The external surface was covered with a thick lacquer coating, effectively protecting against penetration of the laser beam into the fiberglass. On the internal surface, however, a thin, transparent layer of lacquer was applied, which did not sufficiently protect against the penetration of the laser into the structure of the material. This increased the measured length by a determined value of about 2 mm. Taking into account such a correction, the wall thickness was 5 mm. In addition,

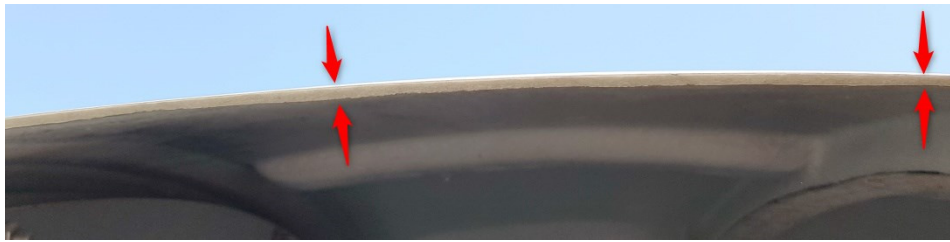
taking into account the above-mentioned unevenness of the inner surface, as shown in Figure 10, it can be estimated that the value of 5 mm corresponds to the actual average wall thickness of the dome.

Figure 10. Unevenness of the internal surface, affecting the thickness of the dome wall.

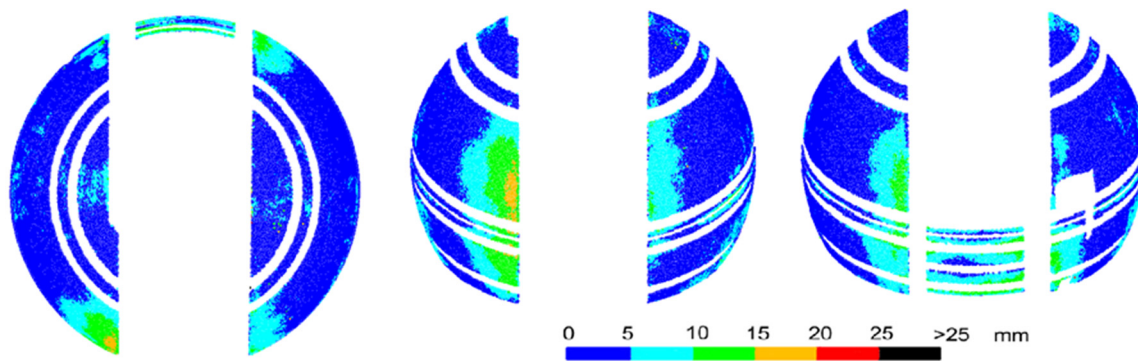
After creating point clouds in Agisoft Photoscan and ContextCapture, the spheres were fitted into point clouds that had a radius of 1.991 m in both cases. Taking into account the sphere radius of the external scanning (1.997 m), the wall thickness of the external and internal dome was 6 mm, which was the same as the design. Taking Figure 9 into consideration, it can be estimated that the average wall thickness may have been slightly smaller than the design one. However, the internal radius from photogrammetric measurements was closer to the design than the radius from scanning inside the object, without taking into account any reduction in the laser penetration of the dome material. For external photogrammetric measurements, the values of the spherical radius were significantly different from the real radius, so the cloud deviations were related to the sphere determined from the scanning. For internal photogrammetric measurements, the sphere radius values were similar to the TLS results, and the deviations of the point clouds could be determined with respect to these spheres. The deviations of the point cloud from Agisoft Photoscan from the fitted sphere are shown in Figure 11, and from ContextCapture, in Figure 12.

Figure 11. Comparative photogrammetric measurement of the dome interior. Deviations of the point cloud from the Agisoft Photoscan structure from motion (SfM) from a sphere freely fitted into the point cloud.

Agisoft Photoscan's point cloud is highly consistent with the laser scanner measurements; the locations and values of the deviations were the same. The average deviation from the sphere was at a similar level (3.9 mm Agisoft Photoscan; 4.3 mm C10 scanner) and the percentage of deviations exceeding 25 mm was smaller, which was the lowest of all cases and was only 0.0002%. The results from ContextCapture were much worse. The mean deviation was 7.2 mm, but 2.77% of the deviations were greater than 25 mm. Many significant deviations occurred in areas where the object had not been deformed, making it impossible to determine the actual surface deformation.

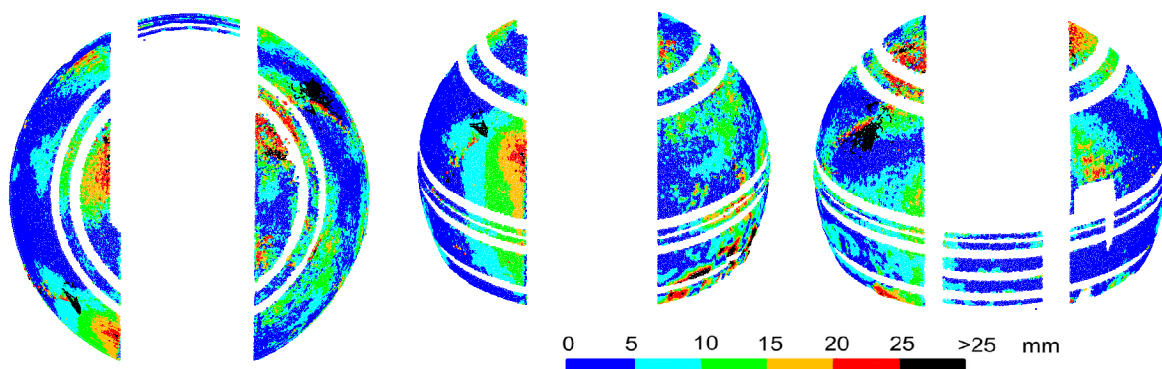
Figure 12. Comparative photogrammetric measurement of the dome interior. Deviations of the point cloud from the ContextCapture SfM from a sphere freely fitted into the point cloud.
