CT Appearance of Absorbable Suture Clips Following Nephron Sparing Surgery

Absorbable suture clips used during partial nephrectomy may be recognized as small hyperdensities near the excision site at 5 months after implantation. They may be completely resorbed and no longer visible at 11 months after implantation.

Case Report

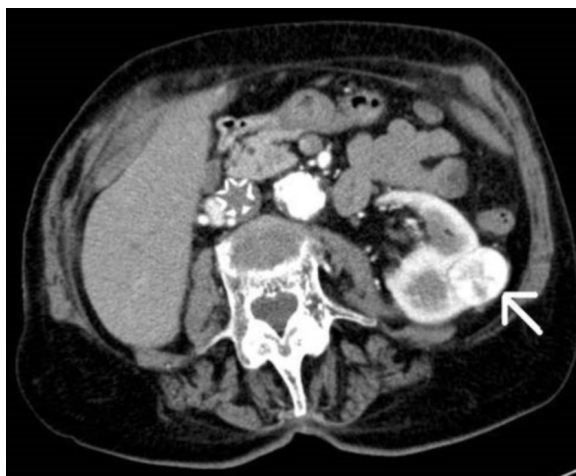
Figure 1. 77-year-old woman with renal tumor. Pre-operative CT. There is a 2.8 cm strongly enhancing, sharply margined mass (arrow) arising from the left kidney.

A 77-year-old woman underwent a left partial nephrectomy with local excision of the mass for renal cell carcinoma (Figure 1). LAPRA TY absorbable suture clips (Ethicon Endosurgery, Cincinnati, OH) were utilized in apposing the normal renal parenchyma where the tumor had been excised. Pathology of the renal lesion demonstrated a typical clear cell renal cell carcinoma. Follow-up CT 5 months later demonstrated post surgical changes including three 1mm hyperdensities near the periphery of the kidney adjacent the tumor excision site (Figure 2). These densities corresponded to the LAPRA

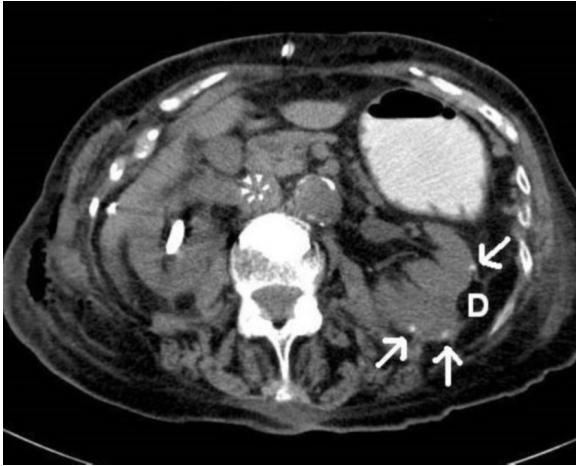
Figure 2. Unenhanced CT of the left kidney at the level of the excised mass, 5 months following tumor excision. The scan is at the same anatomic level as Figure 1. There are three small densities (arrows) in the periphery of the left kidney, adjacent to the surgical defect (D).

edge of the excision site (Figure 2). In our case, they were visible 5 months following tumor excision. It is important to recognize these suture anchors as a normal, anticipated post operative change rather than new areas of calcification on noncontrast enhanced CT scans or new areas of enhancement on enhanced CT scans [2]. Postsurgical calcification or enhancement may suggest local recurrence of tumor or granulomatous response to foreign material introduced during surgery [3]. True local recurrence at the excision site generally demonstrates a mass with marked early contrast enhancement during the corticomedullary phase [2].

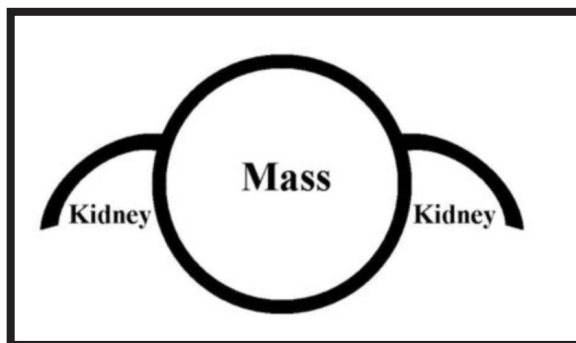
Figure 5A. Diagrammatic representation of the use of absorbable suture clips in nephron-sparing renal tumor resection. Kidney with mass.

Lapra Ty absorbable suture clips (Figure 4) may be used to anchor the sutures approximating the remaining normal renal parenchyma (Figure 5). Once the mass is excised, bleeding vessels are then sutured and any collecting system defect is closed (Figure 5B). The parenchymal defect is then filled with bolsters of Surgicel (Johnson & Johnson Gateway) (vicryl) absorbable mesh (Figure 5C). The surrounding parenchyma is compressed against the bolsters with vicryl sutures for improved hemostasis.

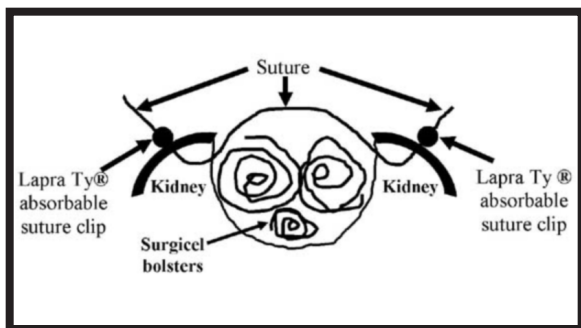
Figure 5D. The surrounding parenchyma is compressed against the bolsters with vicryl sutures for improved hemostasis. The ends of the vicryl sutures are held in place with an absorbable suture clip (Lapra Ty).

The ends of the vicryl sutures are held in place with a LapraTy absorbable suture clip (Figure 5D). As the sutures across the excision site are tightened, the edges of the kidney are drawn closer together (Figure 5E).

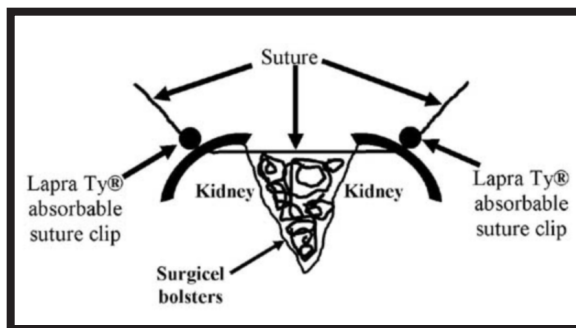
Figure 5E. Suture across excision site is tightened, and edges of the kidney are drawn closer together.
