Cement Augmentation of Suture Anchor During Arthroscopic Rotator Cuff Repair in Case of Proximal Humeral Bone Deficiency Due to Osteoporosis

Abstract: One of the technical challenges during arthroscopic rotator cuff repair is bone deficiency in proximal humerus to get adequate fixation of suture anchors. The typical scenarios that result in bone deficiency at rotator cuff footprint are older individuals, females, osteoporosis, and revision rotator cuff repairs with failed anchors from previous surgery. One of the ways to secure fixation of suture anchors in deficient bone is augmentation with polymethyl methacrylate cement. We present a stepwise technique of cement augmentation of suture anchor during arthroscopic rotator cuff repair to achieve secure fixation of suture anchor and avoid spillage of cement in the subacromial space.

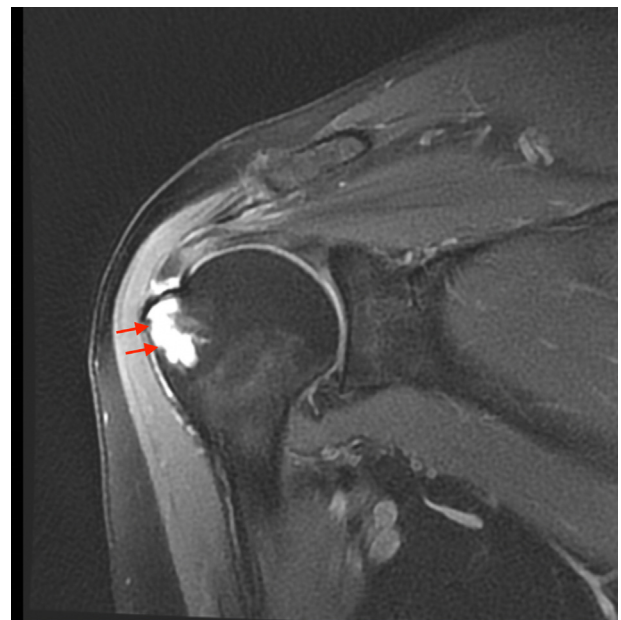
Fig 1. Preoperative magnetic resonance image of a patient in T2-weighted coronal image shows cyst (red arrows) in the supraspinatus footprint region with a near-full-thickness supraspinatus tear. The presence of cyst in the proximal humeral region prompts a possible requirement of cement augmentation of the suture anchor fixation during rotator cuff repair.

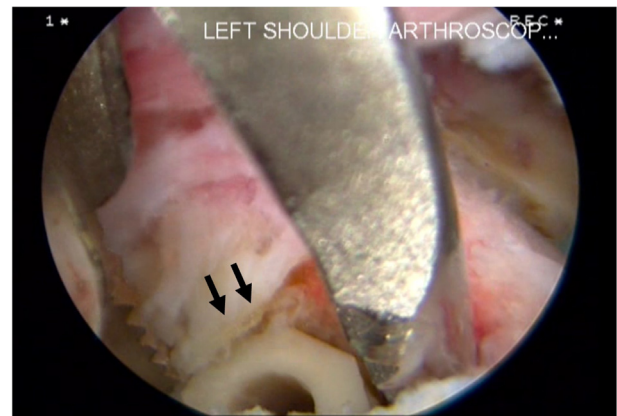
Fig 4. Arthroscopic image of subacromial space during rotator cuff repair as seen from posterolateral portal, showing an arthroscopic grasper device used to remove the failed anchor from the bone defect (black arrows).

a similar step is attempted for anterior lateral row anchor, the anchor screw becomes loose due to poor-quality bone (Fig 2). About 10 mm × 10 mm of cortical bone chip also comes off adjacent to the suture insertion which is removed (Fig 3). The failed anchor is then removed (Fig 4). Overall, we are left with a cortical bone deficit of about 2 cm × 2 cm with depth of 2.5 cm (Fig. 5).

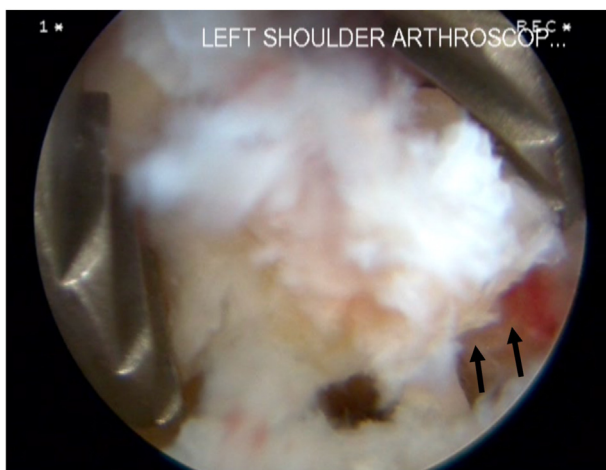
Fig 3. Arthroscopic image of subacromial space during rotator cuff repair, as seen from posterolateral portal, showing an arthroscopic grasper being used to remove the cortical bone chip (black arrows) that became loose after failure of suture anchor.

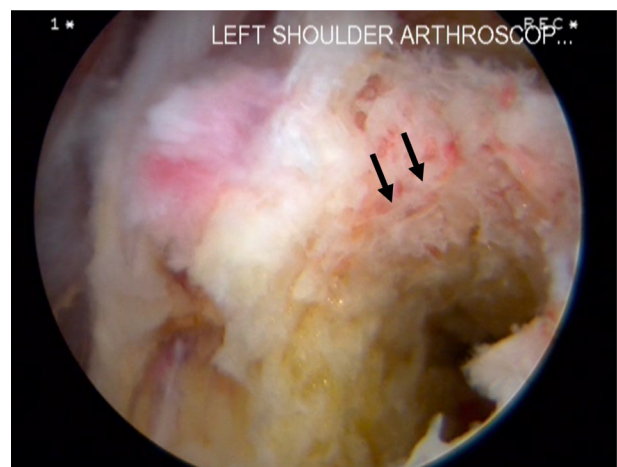
Fig 5. Arthroscopic image of subacromial space during rotator cuff repair, as seen from posterolateral portal, showing a total cortical bone loss (black arrows) after removing the anchor measuring 2 × 2 cm and depth of about 2.5 cm. This is a substantial bone defect in the rotator cuff footprint, requiring cement augmentation to hold the lateral row suture anchor.

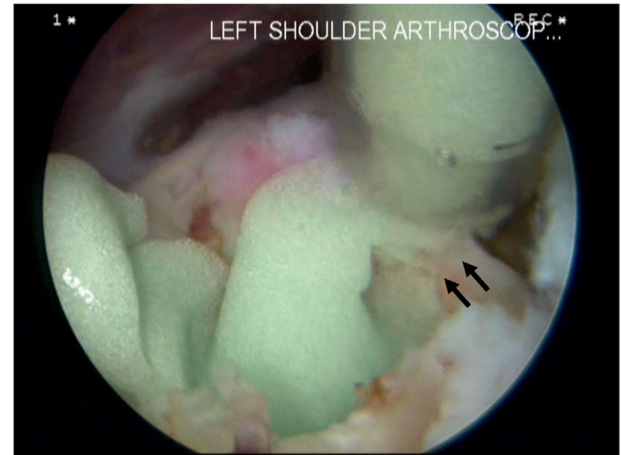
Fig 8. Arthroscopic image of subacromial space during cement augmentation of suture anchor for rotator cuff repair, as seen from posterolateral portal. After adequate cement is injected in the bone defect and the cement is nonsticky, the syringe is removed from the subacromial space. While removing the syringe, to avoid cement spillage in subacromial space, the syringe is rotated until the inserted cement is disconnected (black arrows) from the remaining cement in the syringe.

disconnected from the remaining cement in the syringe (Fig 8). Third, the extra cement in subacromial space is removed using arthroscopic grasper (Fig 9). The lateral row Pushlock anchor loaded with medial row suture tapes is then quickly inserted in the cemented bone defect (Fig 10). The suture tapes are tightened to ensure that the cuff tendon is reduced to the footprint. Once

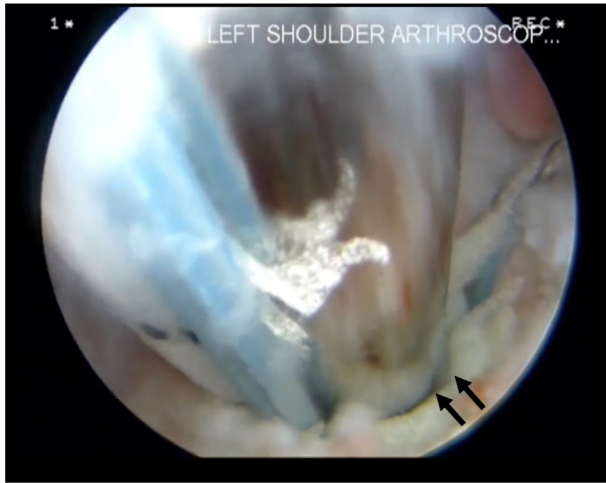
Fig 10. Arthroscopic image of subacromial space during cement augmentation of suture anchor for rotator cuff repair, as seen from posterolateral portal. After cement injection in bone defect, the lateral row suture anchor (black arrows) should be quickly inserted in the cemented bone defect and held in that position until cement cure. The saline inflow should be stopped after anchor insertion until cement cure.

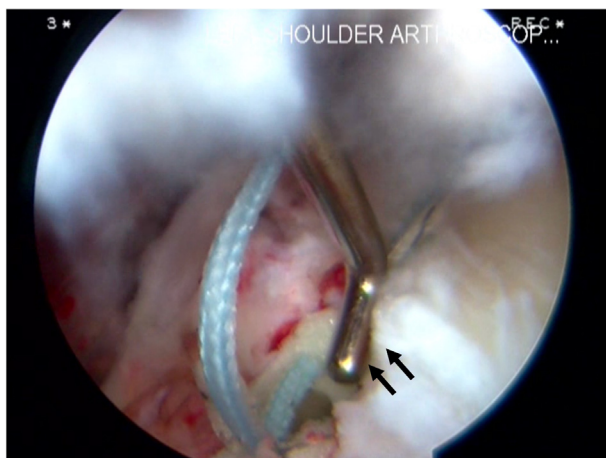
Fig 11. Arthroscopic image of subacromial space after cement augmentation of suture anchor for rotator cuff repair as seen from posterolateral portal. An arthroscopic probe (black arrows) was used to confirm the cement cure after the cement augmentation of the suture anchor in the bone defect.

final position of the anchor is achieved, the saline inflow is stopped, and the anchor is firmly held in the same position until the cement cure. An arthroscopic probe is used to confirm the cement cure and tension of the sutures after repair (Fig 11). Once ensured that the cement has cured, the subacromial space is inspected for any spillover cement, which is removed. This concluded the cement augmentation of suture anchor.

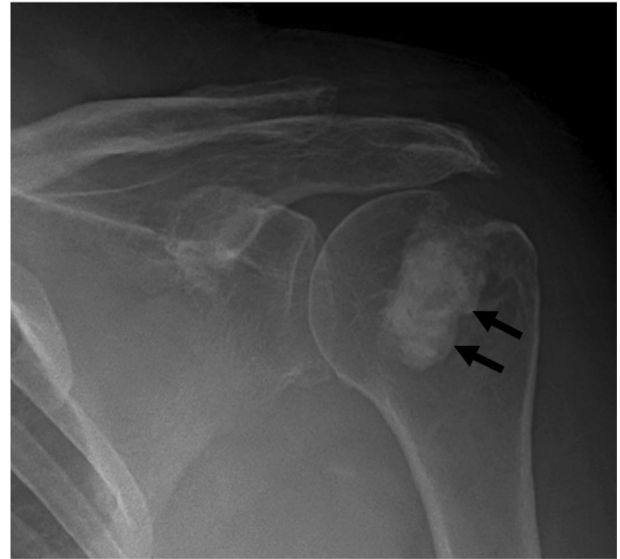
Fig 12. The plain radiograph of shoulder of patient at 2 years follow up after cement augmentation of medial row suture anchor during arthroscopic rotator cuff repair showing uniform distribution of cement (black arrows) in proximal humeral bone defect.

The postoperative rehabilitation protocol in cases of cement augmentation of suture anchor does not need to be changed from that applied for routine rotator cuff repair. The postoperative radiographs could be done to confirm the uniform cement mantle around the suture

anchor and cement incorporation in the bone defect (Fig 12). The magnetic resonance imaging could be done after 6 months to ensure healing of rotator cuff tear with intact cement-suture-bone construct (Fig 13).
